AC Inspection as Found
Almatis Inc/RCP Bauxite (10014)
4701 Alcoa Road
Bauxite, AR 72011

AC Inspection - Rev. 2

Description: 1.5 HP RELIANCE VIBE MOTOR

Hi-Speed Job Number: 102901

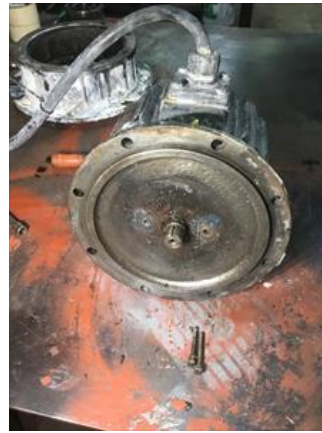
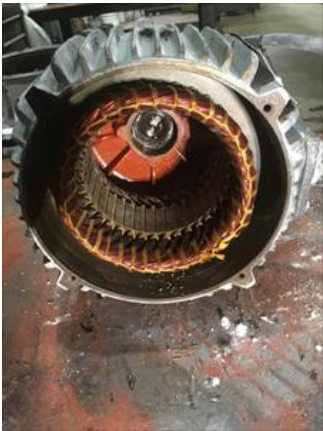
Bearing is off the shoulder.

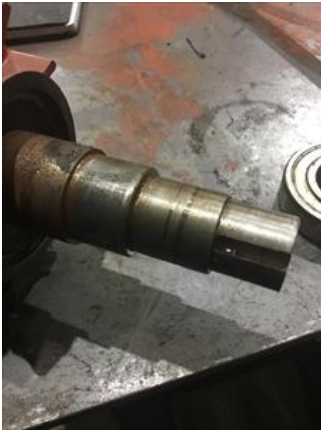
P7

7. Does Shaft Have Visible Damage?

(Yes) Yes

Seal surface worn.

63.	End Bell Air Seal Fits		
	Drive End Air Seal	Opposite Drive End Air Seal	
64.	List Machine Work Needed Below <i>Repair DE shaft seal surface. Repair De housing fit.</i>

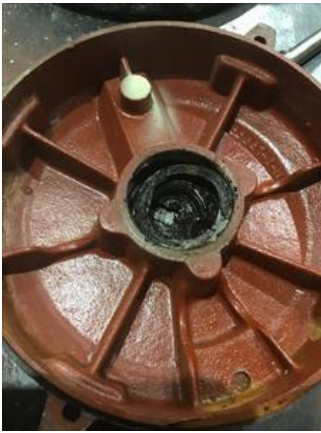
40. Opposite Drive End Bearing Condition

replace

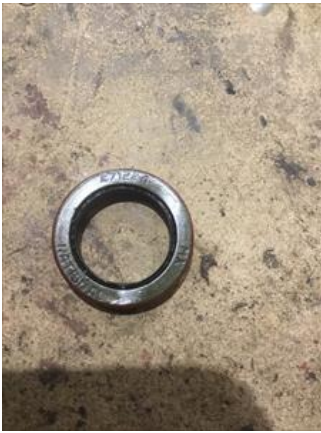
P41

41. Drive End Seal

National 471224

*Bearings, o-rings, DE housing seal, and shaft seal surface repair.
(2) 6311-2R S1NR/C3 GJN proprietary bearings (shaker assembly)
(1) 6206-2Z/C3 and (1) 6205-2Z/C3 bearing (motor)
(1) National 471224 seal. (DE housing)
Replace 2 ea. o-rings. (Oil basin cavity)*
