## AC Inspection as Found

Kroger

20820 interstate 30 N  
Benton, AR 72019

### AC Inspection - Rev. 2

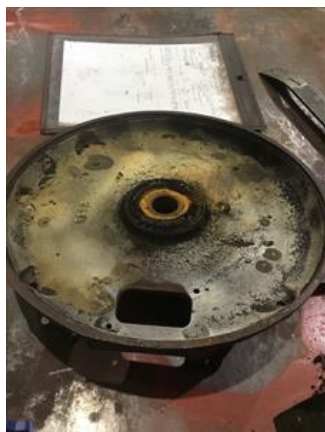
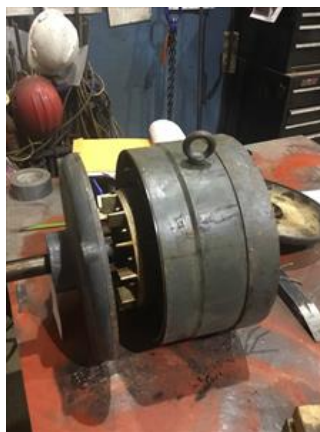
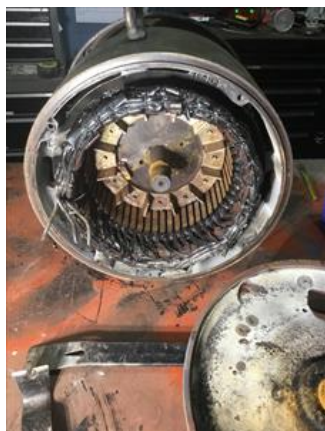
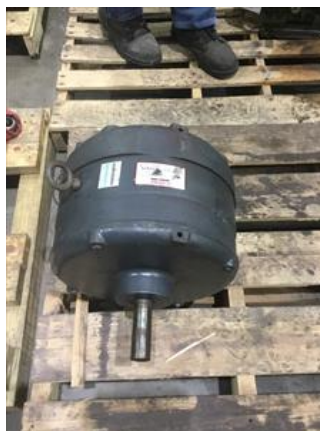
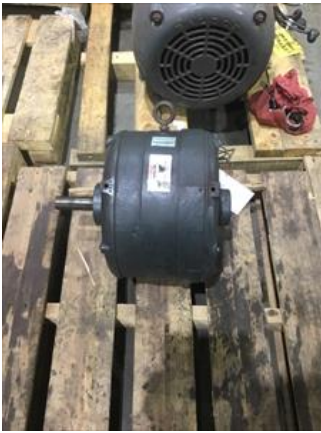
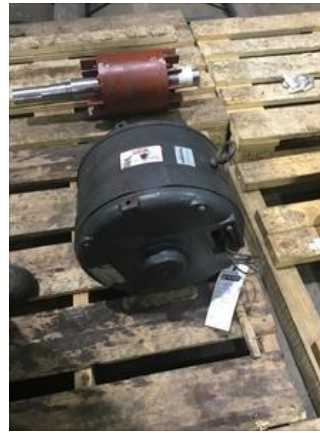
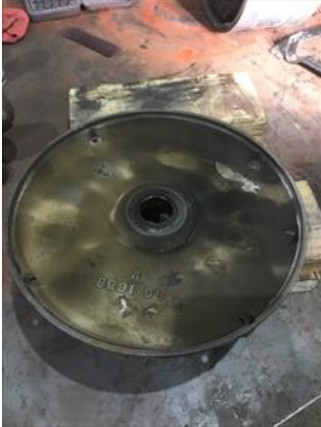
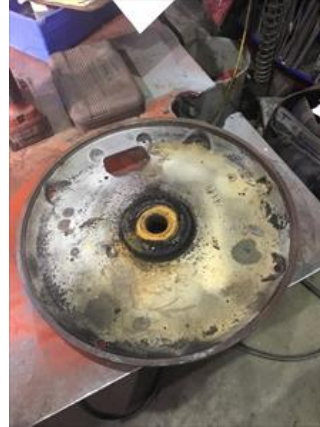
3. Photos of all six sides of the machine.

4. Describe the Overall Condition of the Equipment as Received  
*Serviceable*

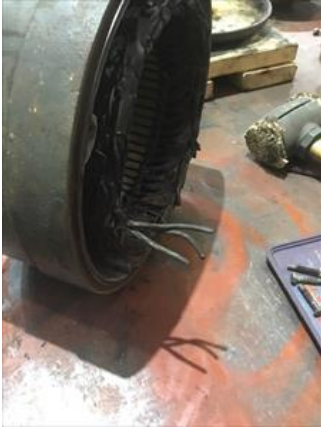
12. Lead Length

5.	Does Shaft Turn Freely?	(N) No
6.	Does the shaft require T.I.R in Lathe to identify additional repairs? <i>ODE bearing journal.</i>	(Yes) Yes
7.	Does Shaft Have Visible Damage?	(No) No
8.	Assembled Shaft Runout <i>Couldn't perform. Motor locked up.</i>	Inches
9.	Assembled Shaft End Play <i>Na</i>	inches
10.	Air Gap Variation <10% <i>Na</i>	
11.	Lead Condition	(P) Pass

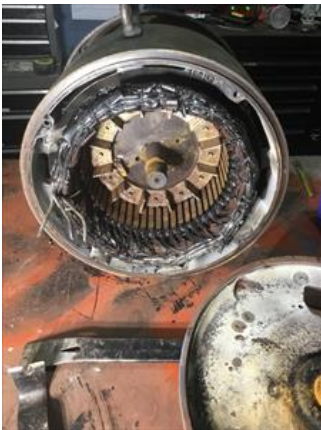
P57

Windings charred

21. Number of Stator Slots 54
22. Stator Condition rewind
23. Stator Thermistors/Ohms  
Na
24. Stator Overloads/Ohms  
Na

*Excessive amounts of moisture entered into the stator housings and bearings causing them to lock up. Also contributed to windings shorted to ground.*

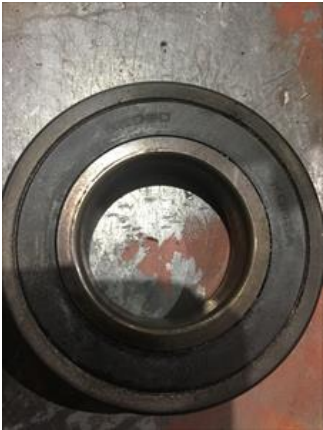
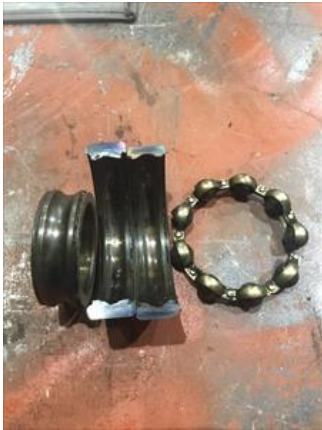
</div>		
27. Drive End Bearing Qty.	1	
28. Drive End Bearing Type	(Ball) Ball Bearing	
29. Drive End Lubrication Type	(Grease) Grease Lubricated	
30. Drive End Bearing Insulation or Grounding Device?	none	
31. Drive End Wavy Washer/Snap-Ring Other Retention Device?	none	
32. Drive End Bearing Condition	locked up	
33. Opposite Drive End Bearing Brand	JAF	
34. Opposite Drive End Bearing Number-		P99

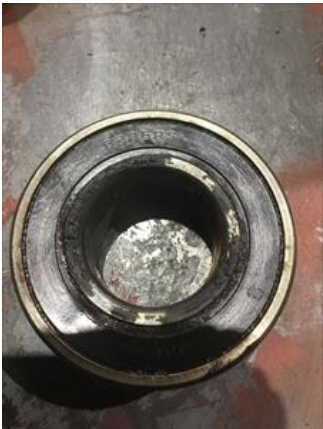
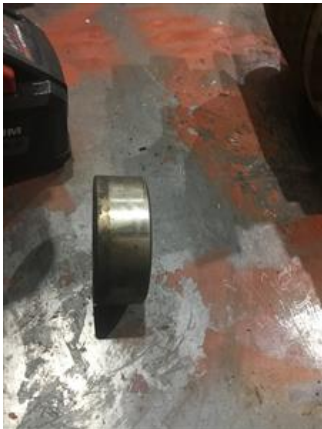
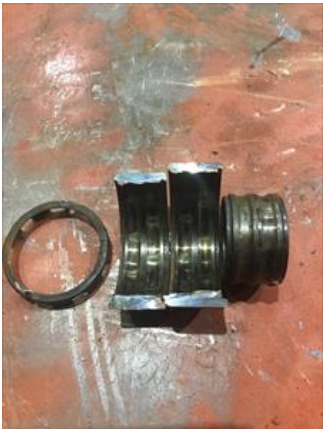
<b>Sealed double wide</b> </div>		
36.	Opposite Drive End Bearing Type	<b>(Ball) Ball Bearing</b>
37.	Opposite Drive End Lubrication Type	<b>(Grease) Grease Lubricated</b>

40.	Opposite Drive End Bearing Condition	<b>worn</b>
41.	Drive End Seal	<b>none</b>
42.	Opposite Drive End Seal	<b>none</b>
<div> <b>Rotor Inspection</b> <div>

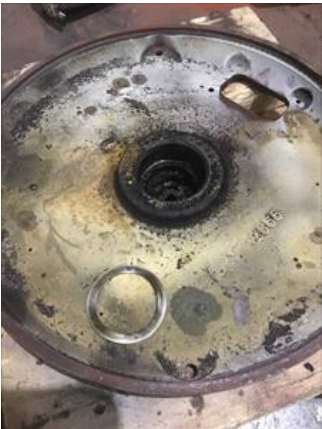
38.	Opposite Drive End Bearing Insulation or Grounding Device?	<b>none</b>
39.	Opposite Drive End Wavy Washer/Snap-Ring Other Retention Device?	<b>P114</b>
<div>

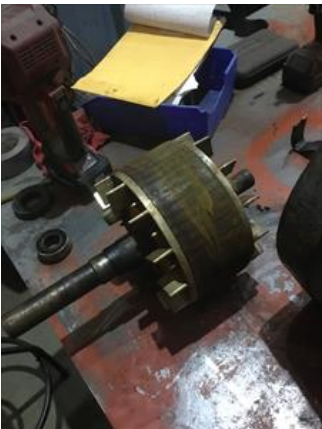
</div>		
44.	Growler Test	<b>(Pass) Pass</b>
45.	Number of Rotor Bars	<b>67</b>

46.	Rotor Condition	<b>pass</b>
47.	List the Parts needed for the Repair Below	
	<i>Bearings,</i>	
48.	Signature of Technician that Disassembled Motor	<b>Terrence Holland</b>
<div>
