AC Inspection as Found

Tyson Foods (10914)

AC Inspection - Rev. 2

Description: 5HP GOULDS PUMP

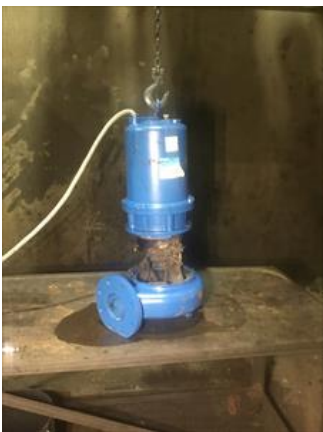
5. Does Shaft Turn Freely? (N) No P1

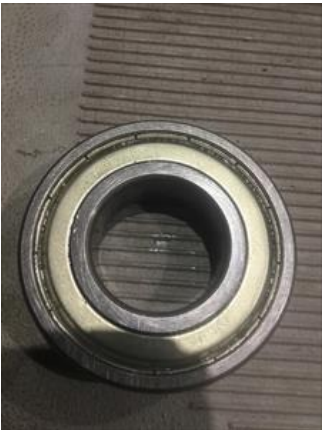
19.	Winding Resistance	
	1-2	1-3 2-3
20.	Perform Surge Test	
21.	Number of Stator Slots	36
22.	Stator Condition	pass
23.	Stator Thermistors/Ohms	
24.	Stator Overloads/Ohms	
Mechanical Inspection		
25.	Drive End Bearing Brand	NSK
26.	Drive End Bearing Number-	6206 P32

31.	Drive End Wavy Washer/Snap-Ring Other Retention Device?	none	
32.	Drive End Bearing Condition	replace	
33.	Opposite Drive End Bearing Brand	NSK	
34.	Opposite Drive End Bearing Number-	6204	P99

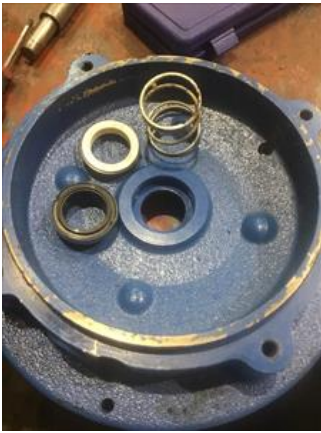
35.	Opposite Drive End Bearing Qty.	1	
36.	Opposite Drive End Bearing Type	(Ball) Ball Bearing	
37.	Opposite Drive End Lubrication Type	(Oil) Oil Lubricated	
38.	Opposite Drive End Bearing Insulation or Grounding Device?	none	
39.	Opposite Drive End Wavy Washer/Snap-Ring Other Retention Device?	wavy washer & snap ring	
40.	Opposite Drive End Bearing Condition	replace	
41.	Drive End Seal	sic,sic	P120

42.	Opposite Drive End Seal	carbon ceramic	P123

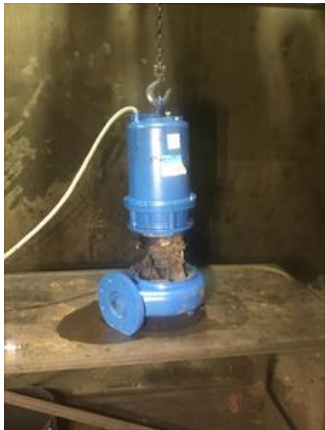
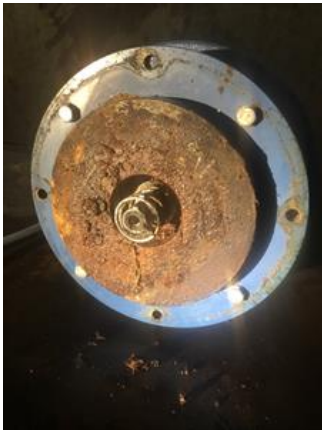
66.	Failure locations Impeller, and stator housings.		
67.	Root cause of failure Impeller was completely wrapped around with rags and cloth material. This contributed to the shaft being completely locked up and also caused premature seal failure.		
<div style="display: flex; justify-content: space-around;">
