AC Inspection as Found Tolm Group Inc (12758) 210 N Moose St

AC Inspection - Rev. 2

Description:110KW WEG EVAL

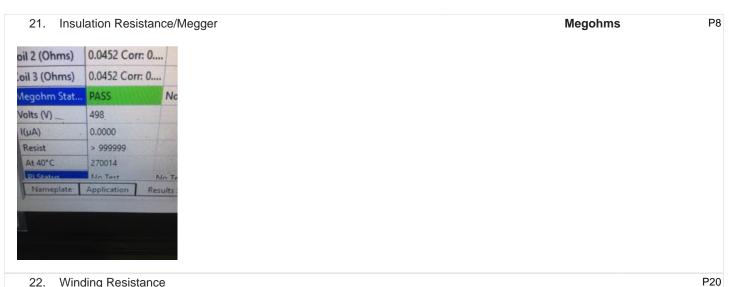
22. Winding Resistance
1-2
1-3
2-3
