AC Inspection as Found

Premier Technical Plastics

Location: LR Motor Shop

Description: 100HP RELIANCE 1185RPM

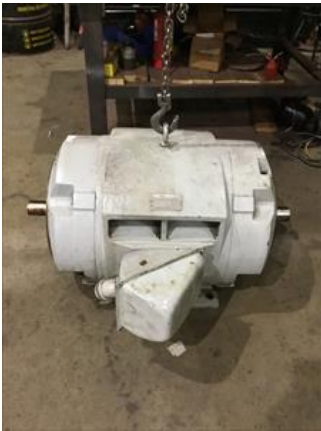
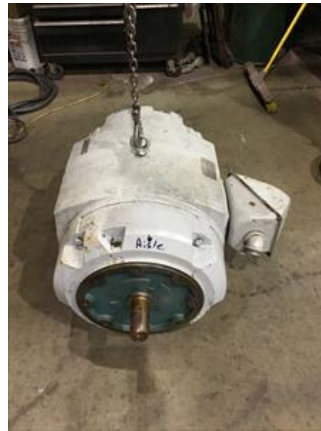
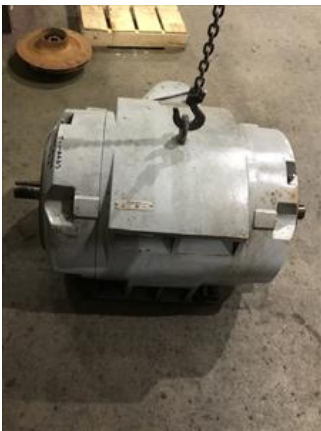
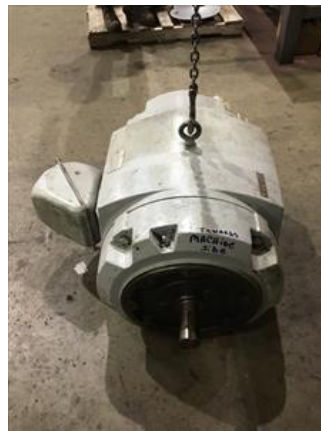
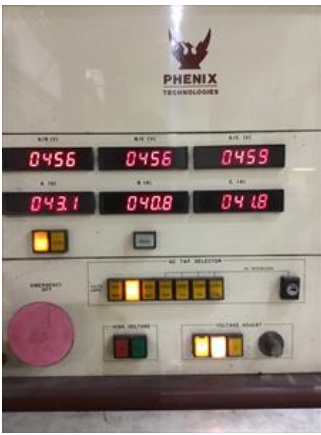
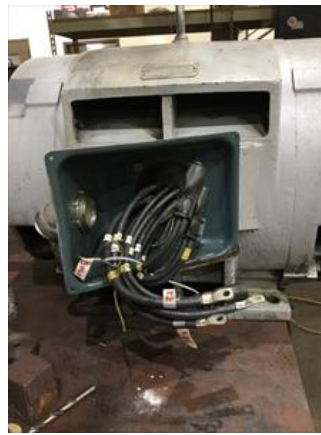
3. Photos of all six sides of the machine.

Serviceable but dirty

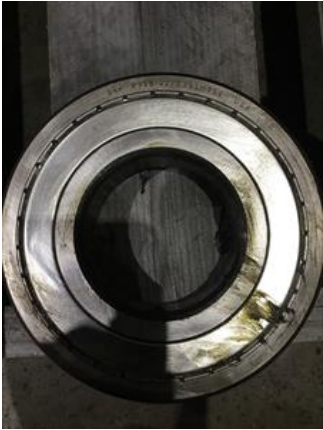
25.	Drive End Bearing Brand	SKF	
26.	Drive End Bearing Number-	6318-2Z/C3	P32

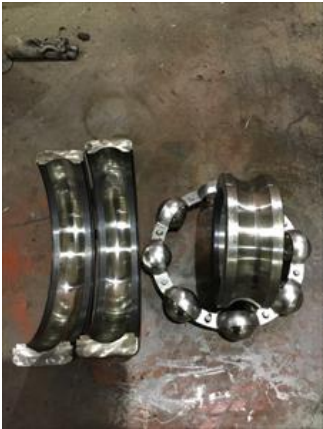
27.	Drive End Bearing Qty.	1	
28.	Drive End Bearing Type	(Ball) Ball Bearing	
29.	Drive End Lubrication Type	(Grease) Grease Lubricated	
30.	Drive End Bearing Insulation or Grounding Device?	none	
31.	Drive End Wavy Washer/Snap-Ring Other Retention Device?	none	
32.	Drive End Bearing Condition	worn	P82

| <i>Bearings</i> | |
