AC Inspection as Found
Phelps Fan Manufacturing Co.
10701 Interstate 30
Little Rock, AR 72209

AC Inspection - Rev. 2

Description: 125HP SIEMENS

Hi-Speed Job Number: 103310

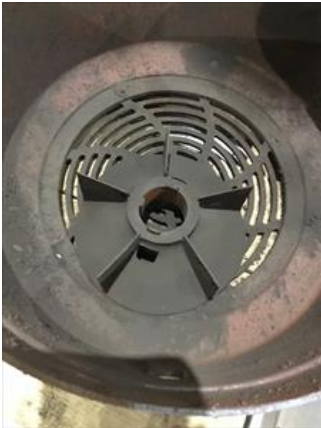
6.	Does Shaft Turn Freely?	(Y) Yes
7.	Does the shaft require T.I.R in Lathe to identify additional repairs?	(No) No
8.	Does Shaft Have Visible Damage?	(No) No
9.	Assembled Shaft Runout	0.002 Inches
10.	Assembled Shaft End Play	0 inches
11.	Air Gap Variation <10%	
12.	Lead Condition	(P) Pass
13.	Lead Length	15 Inches
14.	Does it have Lugs?, If so what is the Stud Size?	(No) No
15.	Lead Numbers	1-3
16.	Frame Condition	pass
17.	Fan Condition	(P) Pass

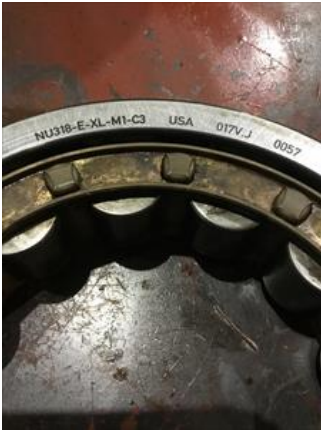
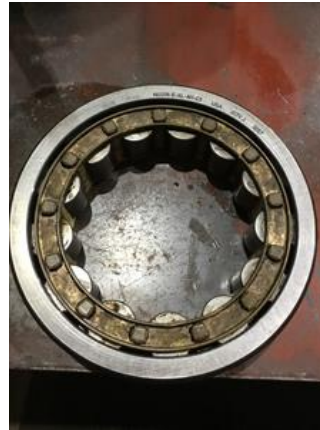
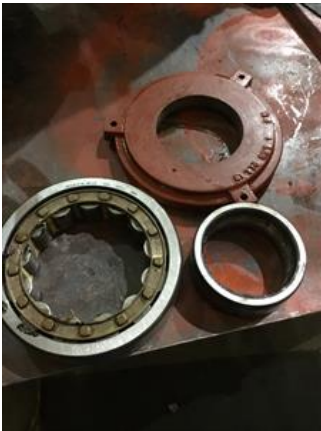
27. Drive End Bearing Number-

33. Drive End Bearing Condition

worn.

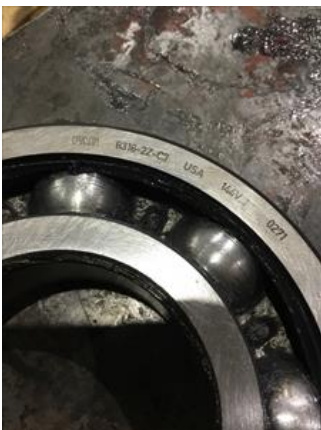
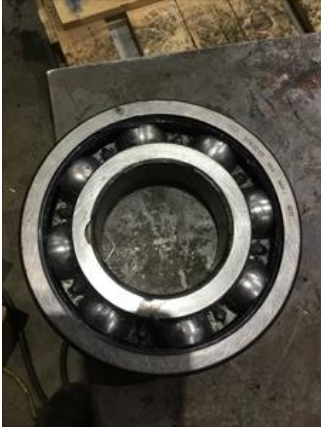
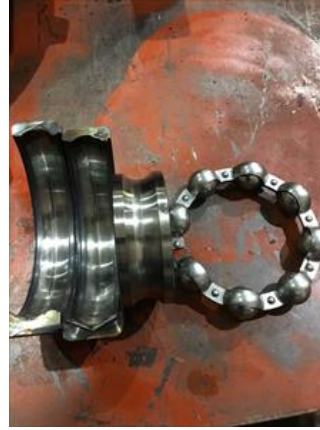
35. Opposite Drive End Bearing Number-

41. Opposite Drive End Bearing Condition

worn with signs of frosting

Contaminated bearing grease. Motor was over greased. ODE, bearing showed signs of misalignment

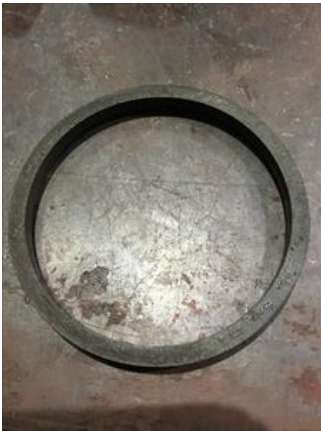
☒ 42. Drive End Seal

Dry rotted. Dust seal

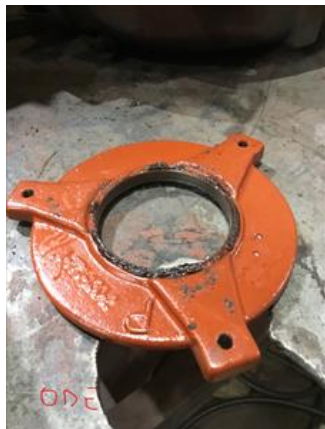
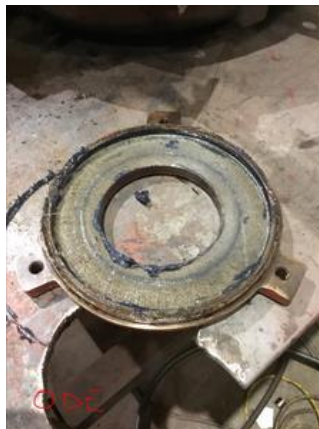
63. Bearing Cap Condition

Drive End Bearing Cap

Opposite Drive End Bearing Cap

pass
