AC Inspection as Found
Phelps Fan Manufacturing Co.
10701 Interstate 30
Little Rock, AR 72209

AC Inspection - Rev. 2

Description: 20HP/15KW TECO

Manufacturer: TECO Westinghouse

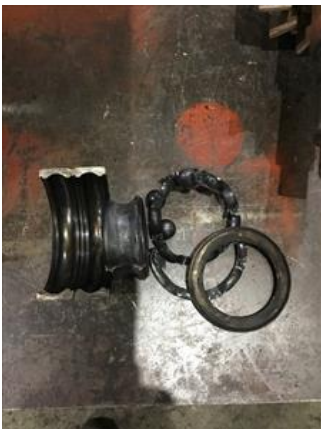
30. Drive End Lubrication Type	(Grease) Grease Lubricated
31. Drive End Bearing Insulation or Grounding Device?	none
32. Drive End Wavy Washer/Snap-Ring Other Retention Device?	none
33. Drive End Bearing Condition	<i>Bearing suffered catastrophic cage failure</i>
34. Opposite Drive End Bearing Brand	Taiwan
35. Opposite Drive End Bearing Number-	6307
36. Opposite Drive End Bearing Qty.	1
37. Opposite Drive End Bearing Type	(Ball) Ball Bearing
38. Opposite Drive End Lubrication Type	(Grease) Grease Lubricated
39. Opposite Drive End Bearing Insulation or Grounding Device?	none

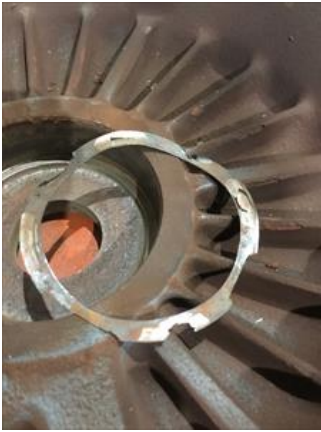
P115

wavy washer

Needs replacing

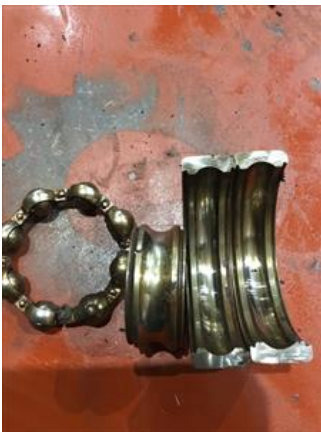
P119

41. Opposite Drive End Bearing Condition

worn

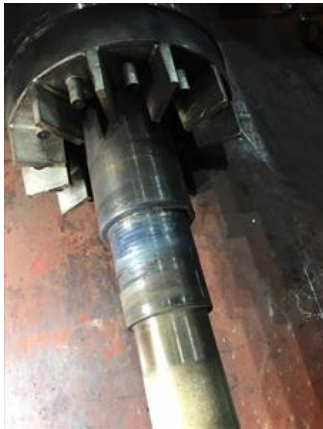
51.	Rotor Runout			
	Drive End Bearing Fit	Rotor Body	Opposite Drive End Bearing	
52.	Coupling Fit Closest to Bearing Housing			
	0 Degrees	90 Degrees	120 Degrees	
53.	Coupling Fit Closest to the end of the Shaft			
	0 Degrees	60 Degrees	120 Degrees	
54.	Drive End Bearing Shaft Fit			P79
	0 Degrees	60 Degrees	120 Degrees	
<div>Failed. Excessively wear from total bearing failure.</div>

55.	Drive End Bearing Shaft Fit Condition			(F) Fail
56.	Opposite Drive End Bearing Shaft Fit			
	0 Degrees	60 Degrees	120 Degrees	
	1.3783	1.3782	1.3782	
57.	Opposite Drive End Bearing Shaft Fit Condition			(P) Pass
58.	Shaft Air Seal Fits			
	Drive End Air Seal	Opposite Drive End Air Seal

Both housing fits.
D.E. housing shaft opening needs sleeving. Cracked in many places.
D.E. shaft bearing journal.

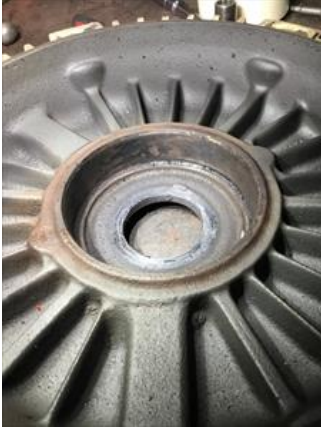
60. Drive End - Endbell Bearing Fit Condition

(F) Fail

Excessive wear and pitting

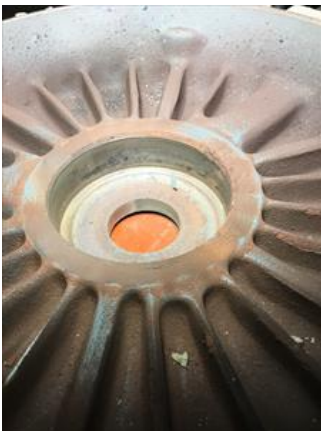
P30

62. Opposite Drive End - Endbell Bearing Fit Condition

(F) Fail

Excessive wear and pitting

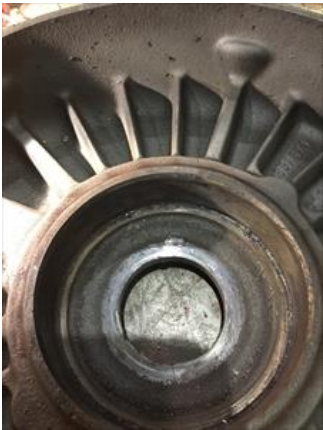
64. End Bell Air Seal Fits

fail

Cracked in multiple places.
