AC Inspection as Found

Union Pacific-Vine St 10945

AC Inspection - Rev. 2

Description: 1.13/6.8HP OMI HOIST MOTOR

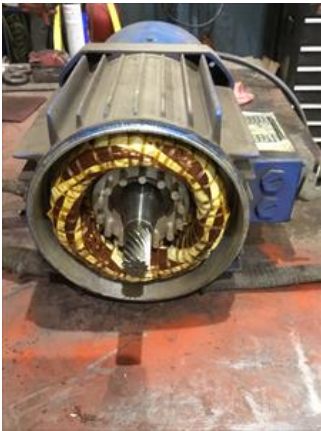
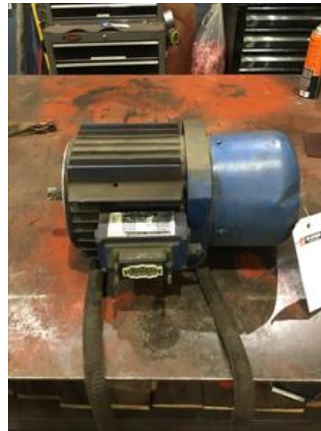
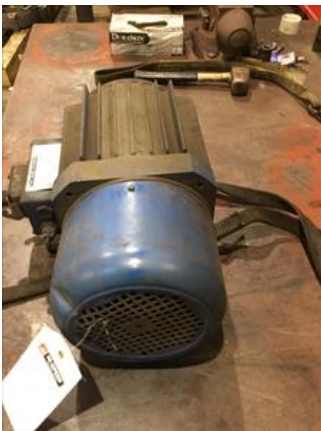
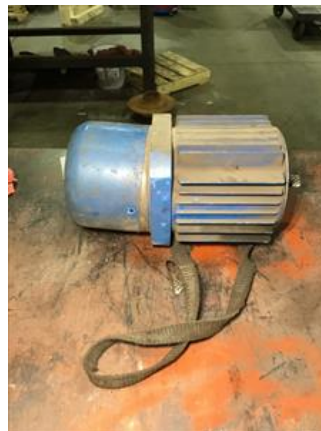
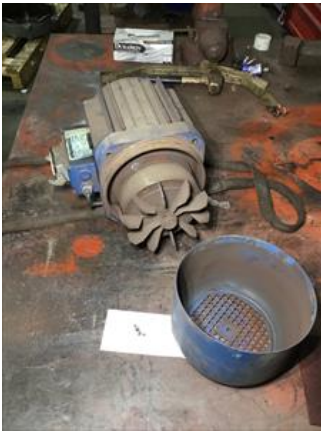
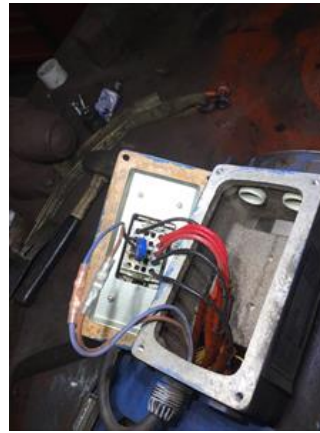
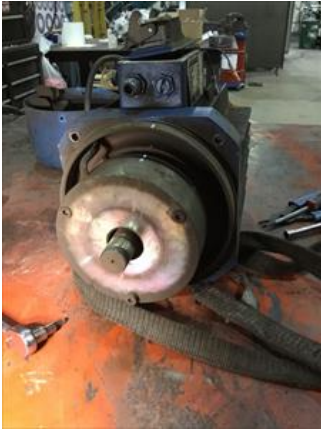
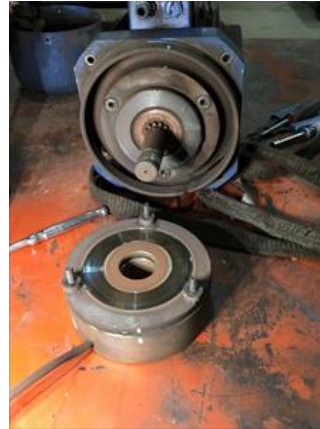
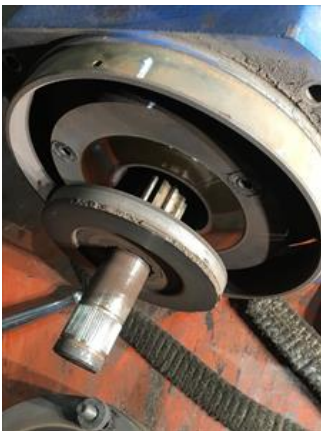
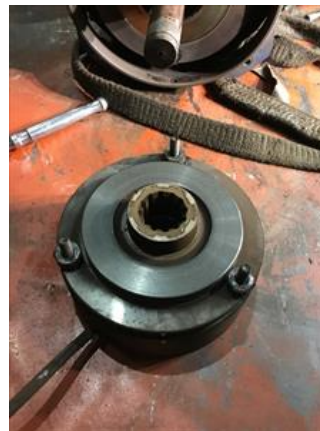
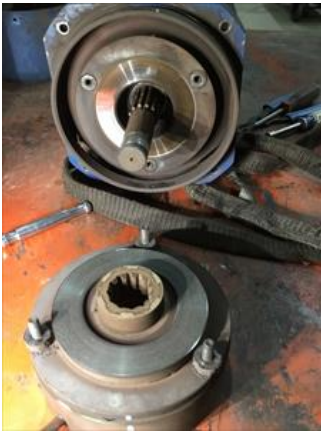
3. Photos of all six sides of the machine.

4. Describe the Overall Condition of the Equipment as Received
Serviceable, but missing DE housing.

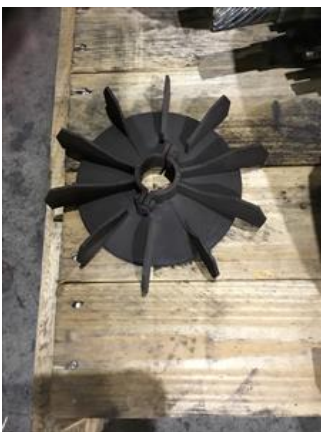
fan cover missing 2 bolts

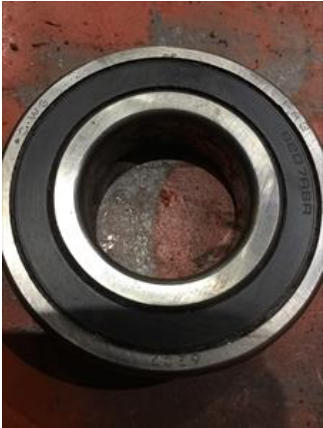
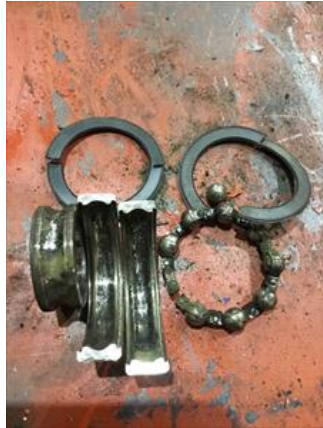
28.	Drive End Bearing Number-		
29.	Drive End Bearing Qty.		
30.	Drive End Bearing Type		
31.	Drive End Lubrication Type		
32.	Drive End Bearing Insulation or Grounding Device?		
33.	Drive End Wavy Washer/Snap-Ring Other Retention Device?	wavy washer	
34.	Drive End Bearing Condition	locked up	
35.	Opposite Drive End Bearing Brand	FAG	
36.	Opposite Drive End Bearing Number-	6207	P100

37.	Opposite Drive End Bearing Qty.	1	
38.	Opposite Drive End Bearing Type	(Ball) Ball Bearing	
39.	Opposite Drive End Lubrication Type	(Grease) Grease Lubricated	
40.	Opposite Drive End Bearing Insulation or Grounding Device?	na	
41.	Opposite Drive End Wavy Washer/Snap-Ring Other Retention Device?	wavy washer	
42.	Opposite Drive End Bearing Condition	locked up	
43.	Drive End Seal		
44.	Opposite Drive End Seal

Bearing and brake assembly

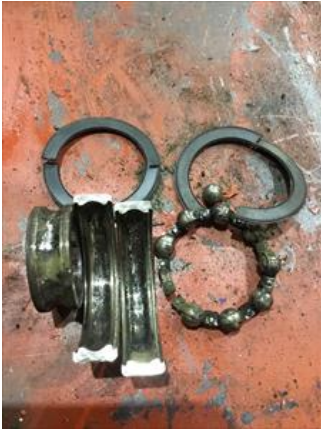
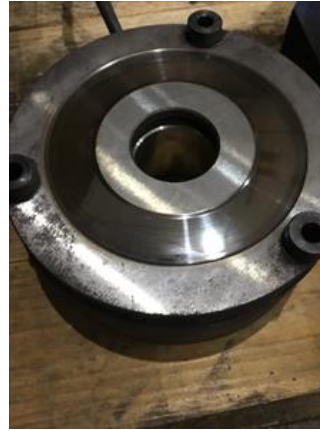
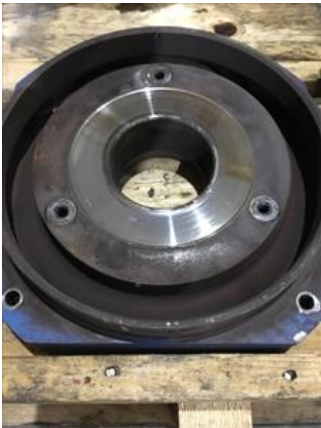
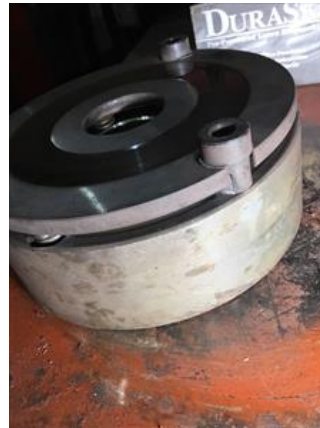
68. Failure locations

Brake assembly wear plates worn, and brake pad cracked on edges. ODE bearing completely locked up from worn out lubricants.

ODE bearing was completely locked up.
