AC Inspection as Found

DeWaffelbakkers (10743)

AC Inspection - Rev. 2

Description: 200HP RAM/TOSHIBA EVAL

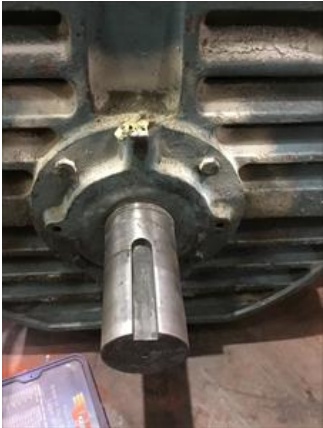
| 8. Does Shaft Have Visible Damage? | (No) No | P26 |

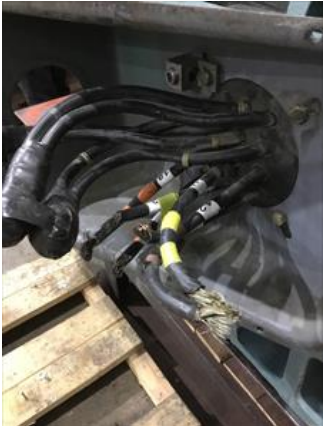
| 12. Lead Condition | (P) Pass | P69 |

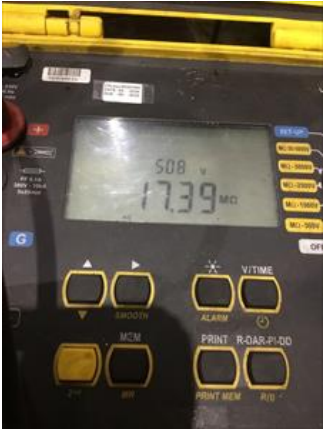
| 19. Insulation Resistance/Megger | 17.39 Megohms | P8 |

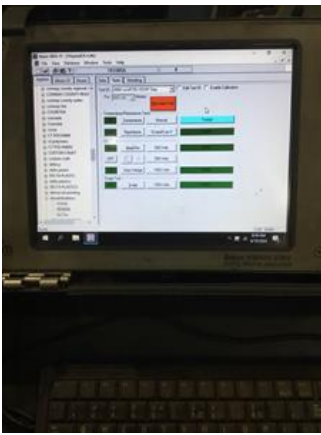
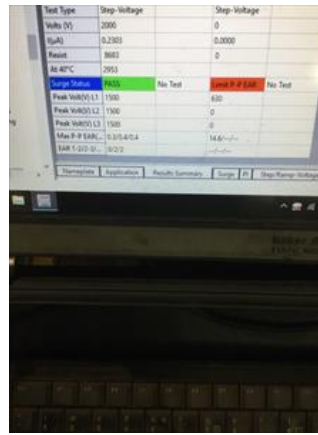
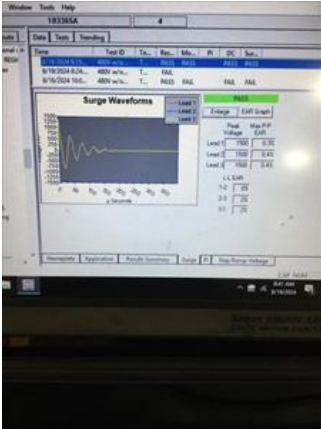
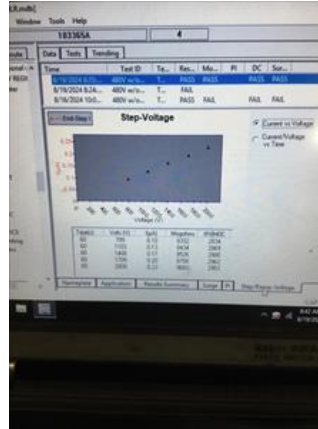
| 21. Perform Surge Test | (P) Pass | P57 |

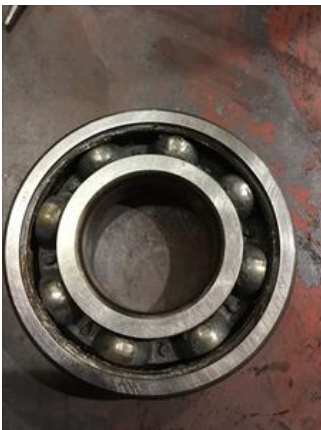
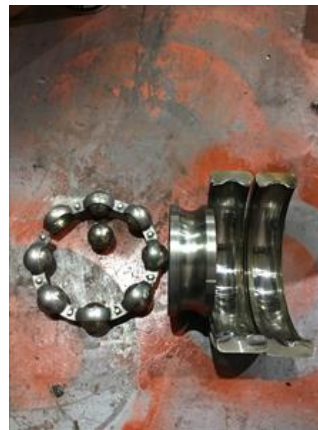
26. Drive End Bearing Brand

| 33. | Drive End Bearing Condition | replace | |

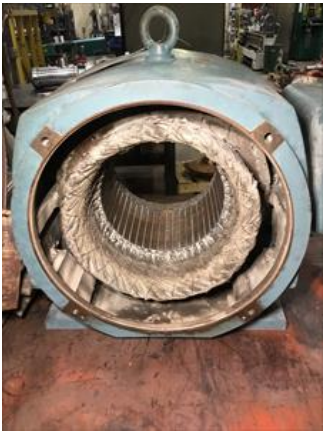
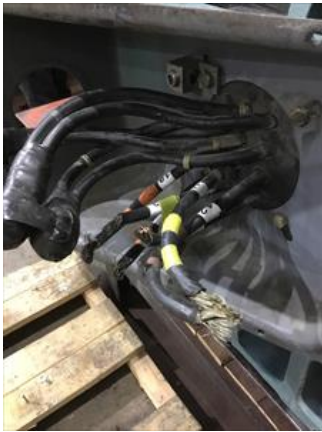
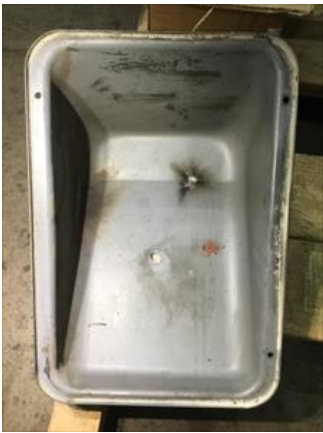
67. Failure locations

Windings were very dirty. Leads are only 5.5" long. Top connection box cover as black mark that appears to be from where the leads shorted against it.

Possible leads shorting against connection box cover.
