AC Inspection as Found
ARKANSAS INDUSTRIAL MACHINERY
3804 N. NONA ST
NORTH LITTLE ROCK, AR 72118

AC Inspection - Rev. 2

Description: 184/245 MARATHON

Hi-Speed Job Number: 103442

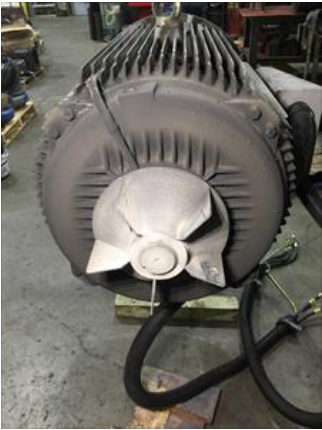
</div>			
16.	Frame Condition	pass	
●	17. Fan Condition	(P) Pass	P116

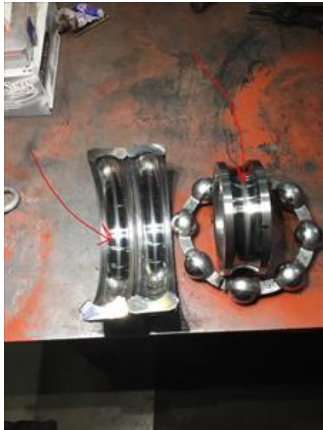
ODE housing fit.

Contaminated/hardened grease in both bearings. ODE housing fit out of tolerance. DE bearing shows signs of frosting. Recommend aegis shaft grounding ring.
