**AC Inspection as Found**  
**ARKANSAS INDUSTRIAL MACHINERY**  
3804 N. NONA ST  
NORTH LITTLE ROCK, AR 72118

**AC Inspection - Rev. 2**

Description: 184/245 MARATHON

Hi-Speed Job Number: 103442

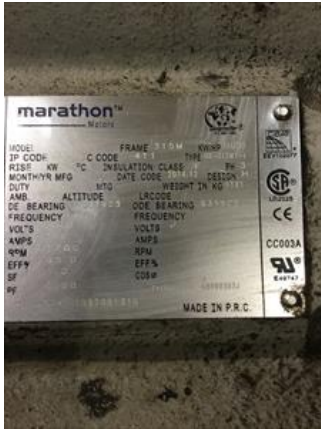
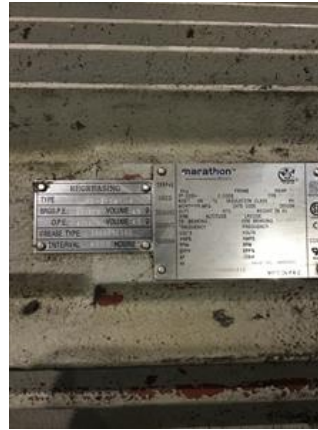
P37

## 2. Nameplate Picture

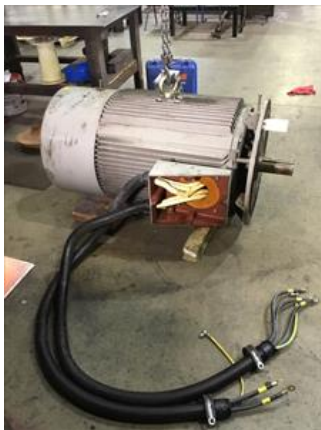
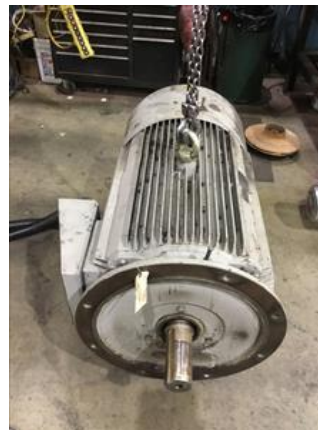
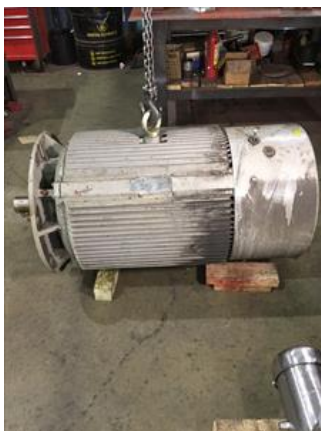
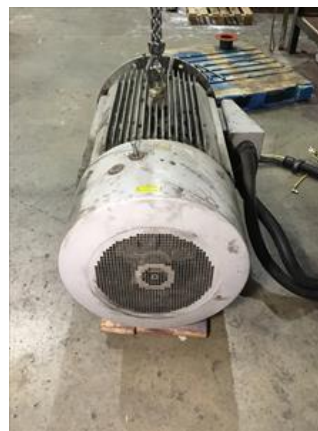
P45

3. Photos of all six sides of the machine.

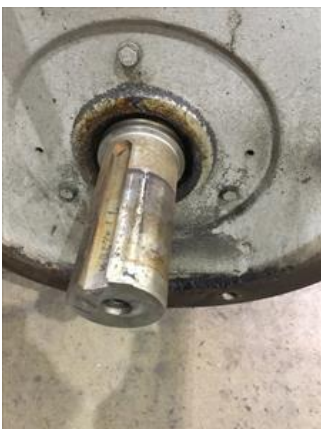
| 8. Does Shaft Have Visible Damage? | <b>(No) No</b> | P26 |

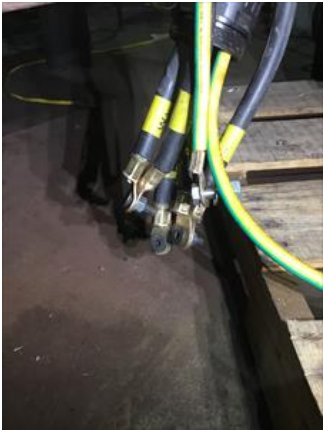
13.	Lead Length	96 Inches	
●	14. Does it have Lugs?, If so what is the Stud Size?	(Yes) Yes	P94

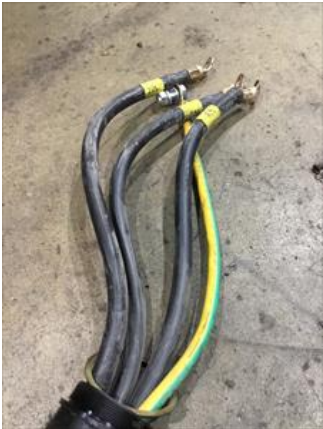
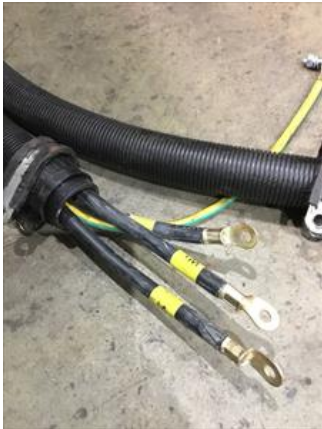
15.	Lead Numbers		P98
■	U1-V1-W1 U2-V2-W2		
<div>

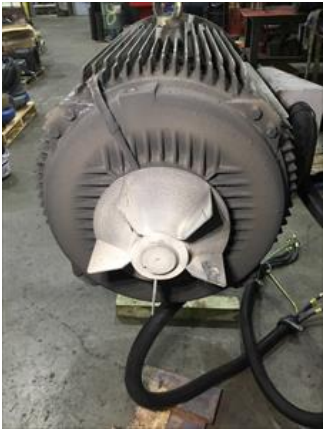
</div>			
16.	Frame Condition	pass	
●	17. Fan Condition	(P) Pass	P116

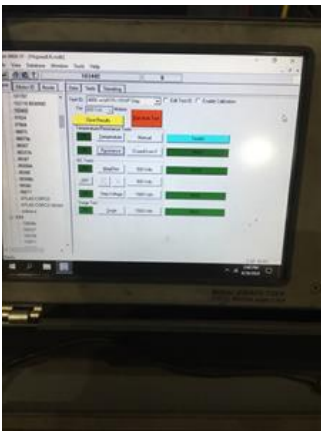
P20

## 20. Winding Resistance

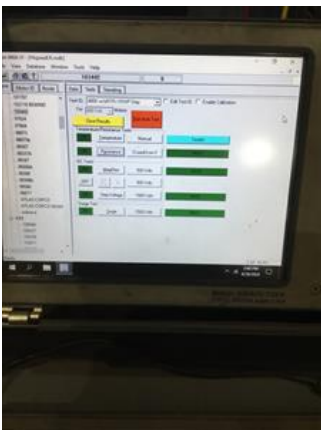
P97

21. Perform Surge Test	(P) Pass
22. Number of Stator Slots	72
23. Stator Condition	pass
24. Stator Thermistors/Ohms	
25. Stator Overloads/Ohms

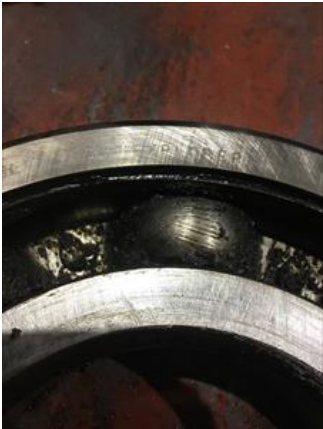
26. Drive End Bearing Brand	SKF	P12

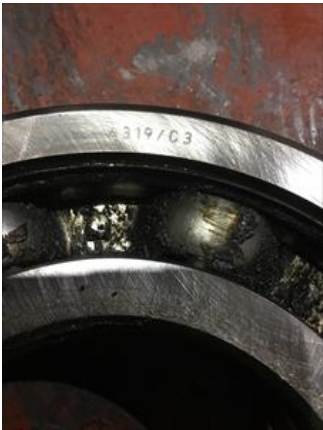
27. Drive End Bearing Number-	6319 C3	P32

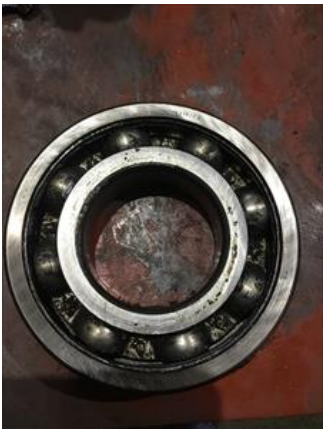
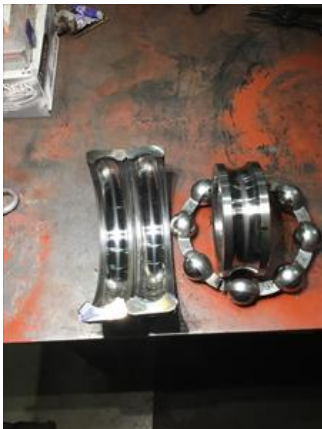
28. Drive End Bearing Qty.	1	
29. Drive End Bearing Type	(Ball) Ball Bearing	P51

30. Drive End Lubrication Type	(Grease) Grease Lubricated	
31. Drive End Bearing Insulation or Grounding Device?	none	
32. Drive End Wavy Washer/Snap-Ring Other Retention Device?	none	
33. Drive End Bearing Condition	replace	
34. Opposite Drive End Bearing Brand		P93

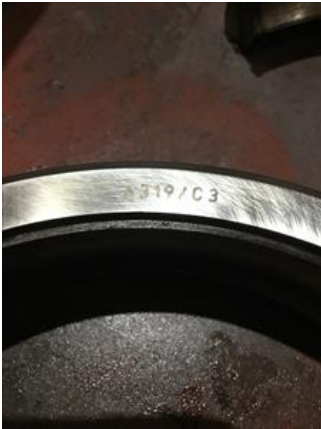
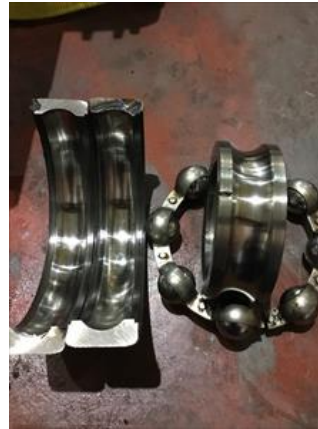
P100

35. Opposite Drive End Bearing Number-

36. Opposite Drive End Bearing Qty.	1
37. Opposite Drive End Bearing Type	(Ball) Ball Bearing
38. Opposite Drive End Lubrication Type	(Grease) Grease Lubricated
39. Opposite Drive End Bearing Insulation or Grounding Device?	none
40. Opposite Drive End Wavy Washer/Snap-Ring Other Retention Device?	snap ring
41. Opposite Drive End Bearing Condition	replace
42. Drive End Seal	
43. Opposite Drive End Seal

7.8745	7.8756	7.8752
	Verified by machinist.		
62.	Opposite Drive End - Endbell Bearing Fit Condition	(F) Fail	
	Oval shape. Verified by machinist.		
63.	Bearing Cap Condition		
	Drive End Bearing Cap	Opposite Drive End Bearing Cap	
	pass	pass

48. List the Parts needed for the Repair Below  
*Sleeve ODE housing fit*

64.	End Bell Air Seal Fits		
	Drive End Air Seal	Opposite Drive End Air Seal	
65.	List Machine Work Needed Below		
	ODE housing fit

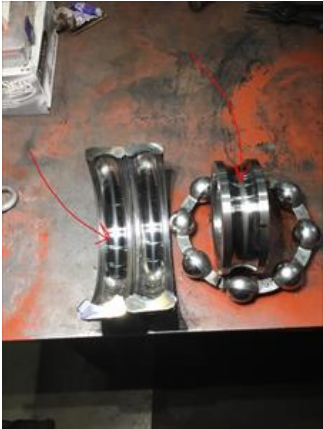
67. Failure locations  
ODE housing fit.

68. Root cause of failure P18  
Contaminated/hardened grease in both bearings. ODE housing fit out of tolerance. DE bearing shows signs of frosting. Recommend aegis shaft grounding ring.

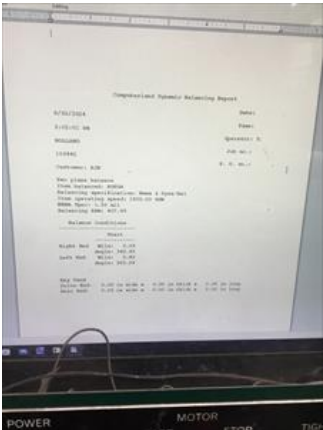
70. Initial Balance Readings P11  
Drive End                      Opposite Drive End

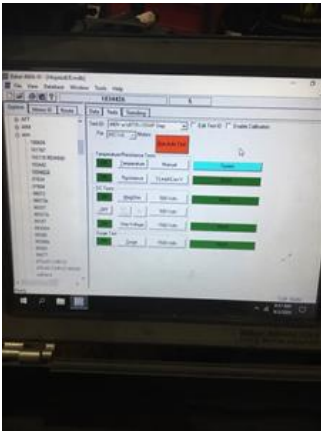
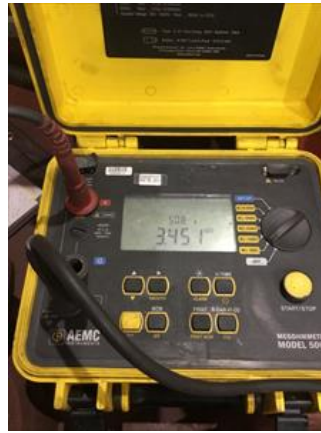
P31

80. Final Insulation Resistance Test
