AC Inspection as Found

Arauco-Malvern MDF (10298)

AC Inspection - Rev. 2

Location: LR MOTORSHOP
Serial Number: 2MA460270-G1-KY
Description: 100HP RELIANCE 1180 RPM

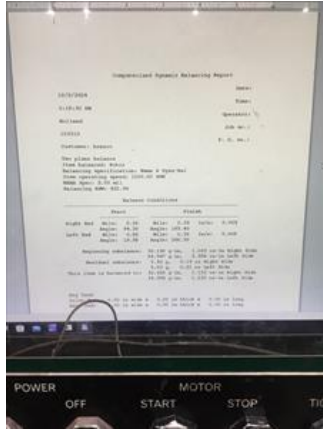
70. Initial Balance Readings

.36

.86

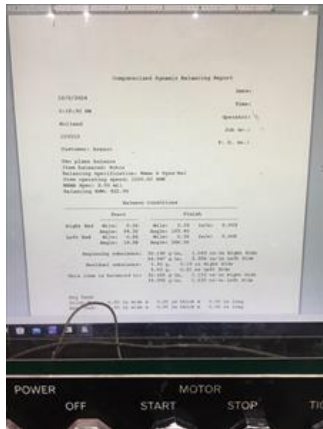
71. Final Balance Readings

.39

.36

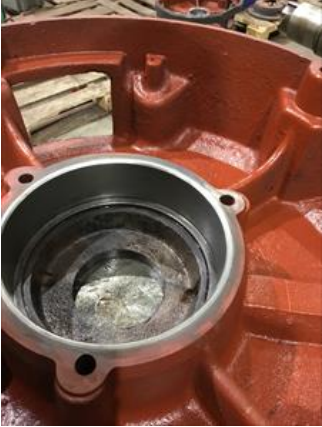
81. Drive End - Endbell Bearing Fit Post Repair			P5
0 Degrees	60 Degrees	120 Degrees	
7.4813	7.4814	7.4813

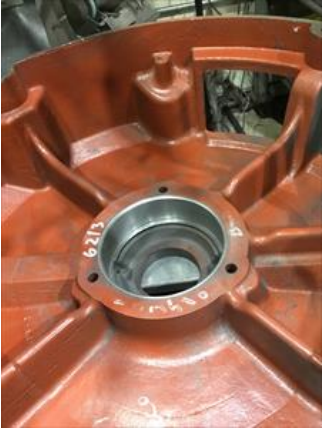
82. Opposite Drive End - Endbell Bearing Fit Post Repair			P19
0 Degrees	60 Degrees	120 Degrees	
4.7245	4.7246	4.7246

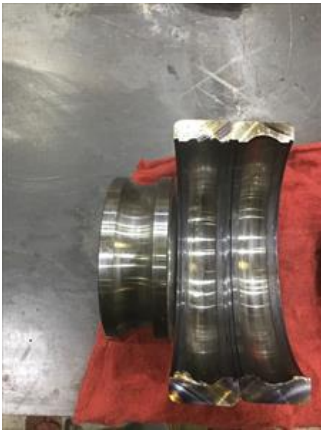
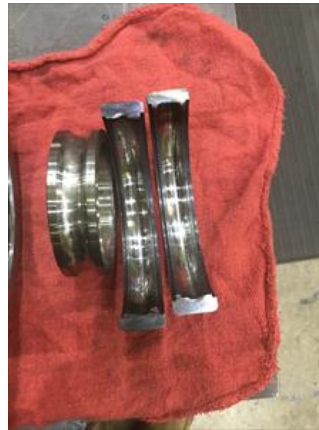
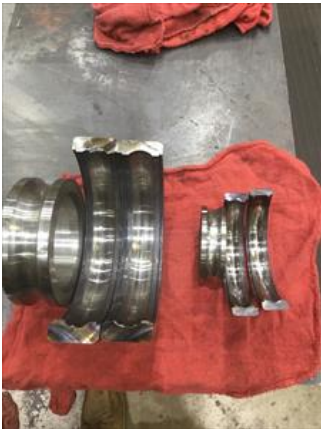
Sum frosting on idle end

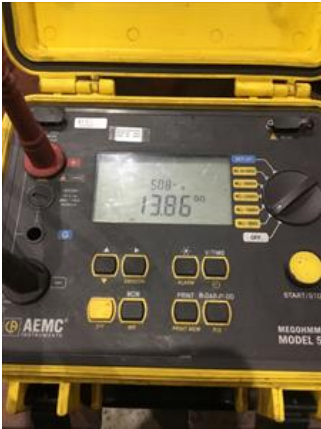
88. Final Insulation Resistance Test

13.86 Gigohms
