AC Inspection as Found

Peco Foods

AC Inspection - Rev. 2

Location: Shop
Serial Number: ZJE723C108U04
Description: 25HP TECO 1170RPM

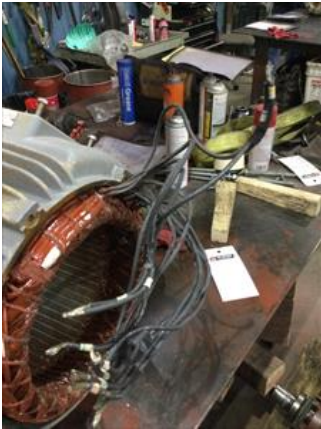
6.	Does Shaft Turn Freely?	(NA) Not Applicable	
7.	Does the shaft require T.I.R in Lathe to identify additional repairs?		
● 8.	Does Shaft Have Visible Damage?		
9.	Assembled Shaft Runout	Inches	
10.	Assembled Shaft End Play	inches	
11.	Air Gap Variation <10%		
● 12.	Lead Condition	(P) Pass	P69

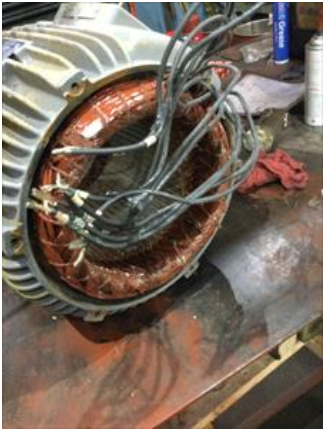
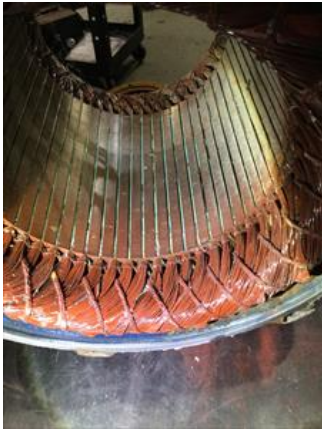
22. Number of Stator Slots	54		
23. Stator Condition	rewind

67. Failure locations
Insulation brake down shorting slot

68. Root cause of failure
Bad insulation

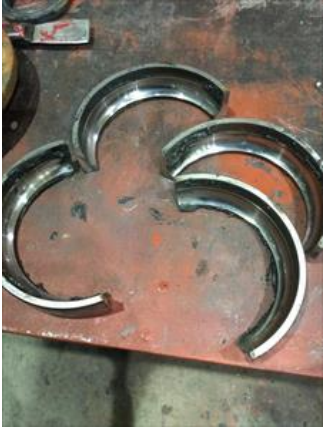
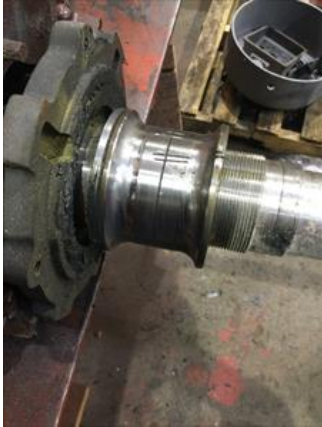
28.	Drive End Bearing Qty.	2	
29.	Drive End Bearing Type	(Thrust) Thrust	
30.	Drive End Lubrication Type	(Grease) Grease Lubricated	
31.	Drive End Bearing Insulation or Grounding Device?	na	
32.	Drive End Wavy Washer/Snap-Ring Other Retention Device?	spanner nut	
33.	Drive End Bearing Condition	normal wear	P83

2-7313 thrust bearing 1- 6212 C3

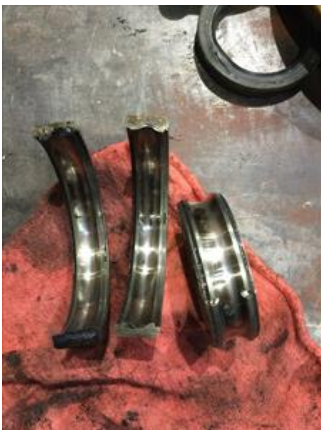
P119

41. Opposite Drive End Bearing Condition

Debris in bearing grease

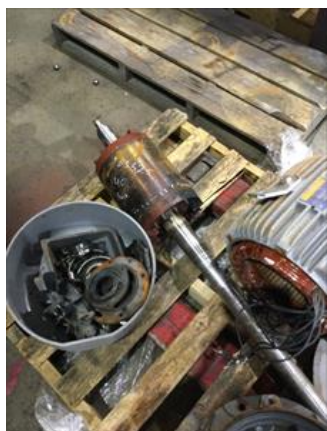
P41

47. Rotor Condition

pass

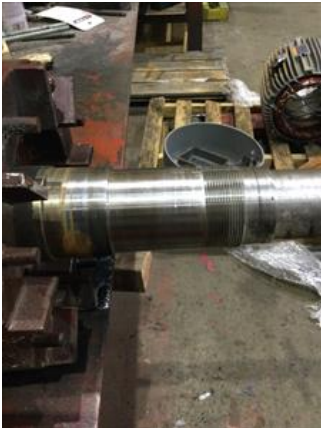
52.	Coupling Fit Closest to Bearing Housing			
	0 Degrees	90 Degrees	120 Degrees	
	Na			
53.	Coupling Fit Closest to the end of the Shaft			
	0 Degrees	60 Degrees	120 Degrees	
	Na			
54.	Drive End Bearing Shaft Fit			
	0 Degrees	60 Degrees	120 Degrees	
	2.5597	2.5597	2.5597	
55.	Drive End Bearing Shaft Fit Condition		(P) Pass	P81

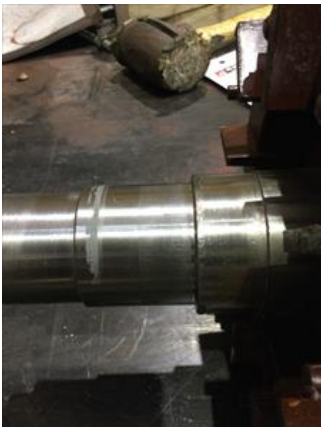
56.	Opposite Drive End Bearing Shaft Fit			
	0 Degrees	60 Degrees	120 Degrees	
	2.3627	2.3627	2.3627	
57.	Opposite Drive End Bearing Shaft Fit Condition		(P) Pass	P96
