AC Inspection as Found

Riceland Foods (11100-RLF)

AC Inspection - Rev. 2

Description: 50HP SIEMENS 1770RPM

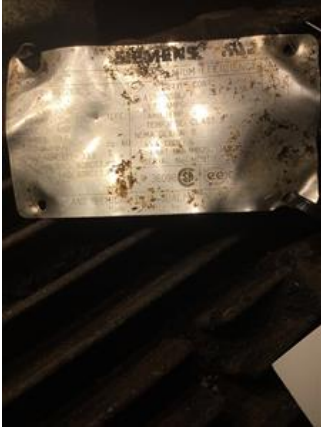
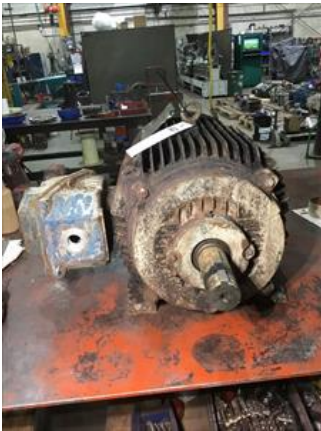
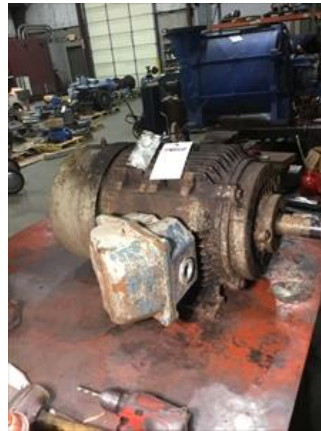
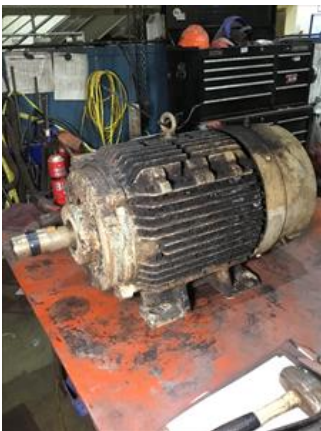
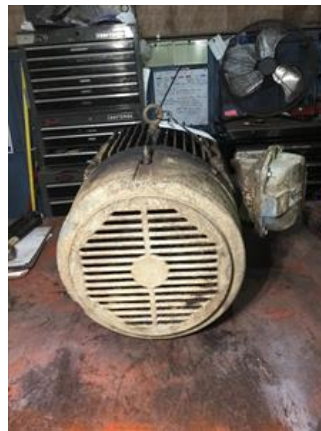
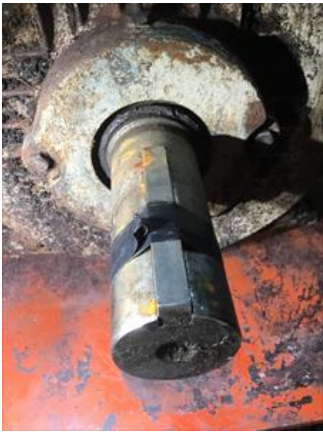
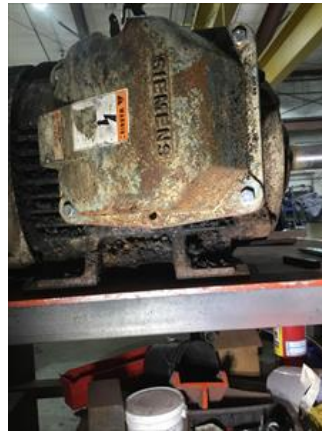
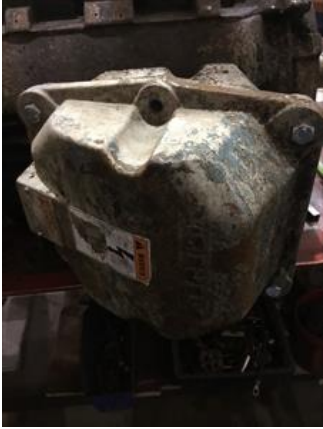
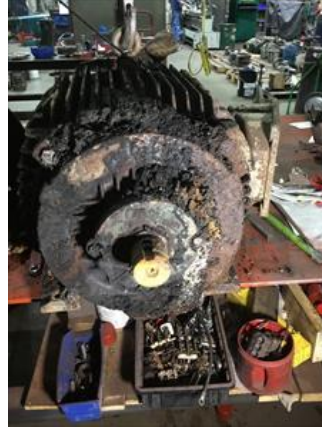
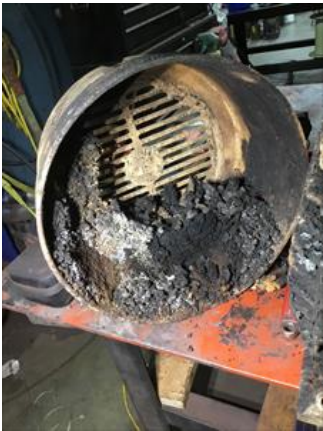
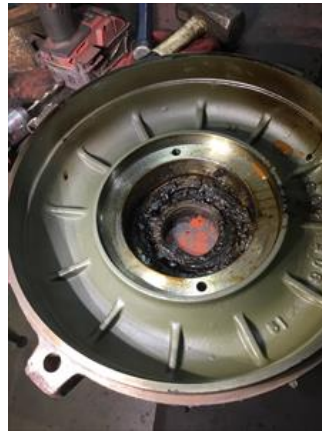
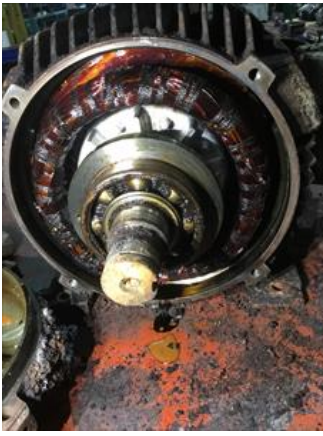
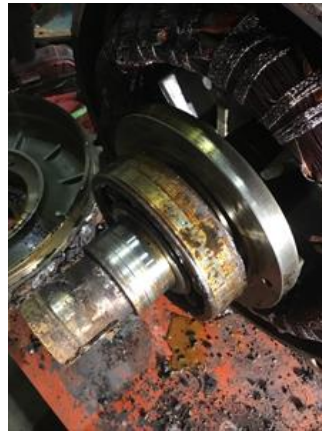
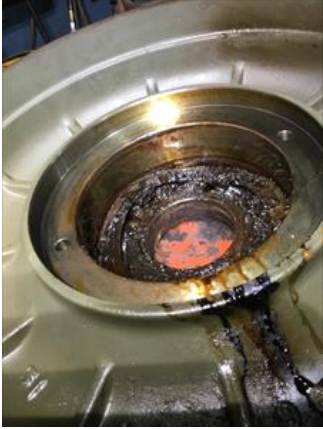
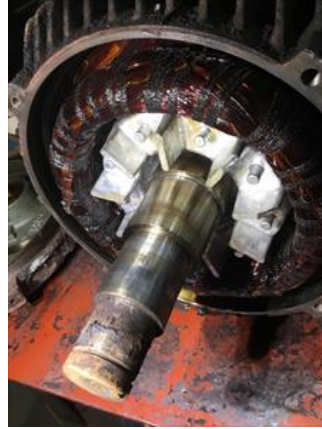
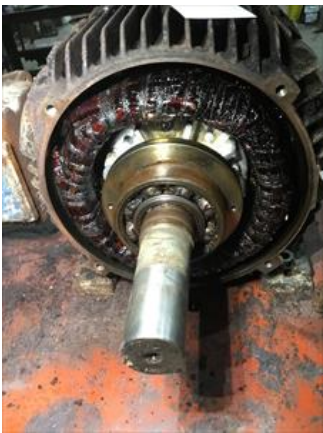
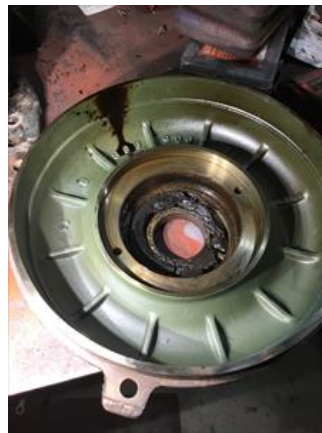
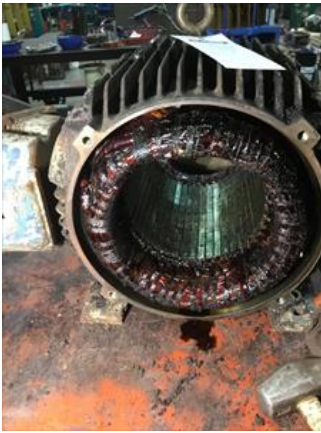
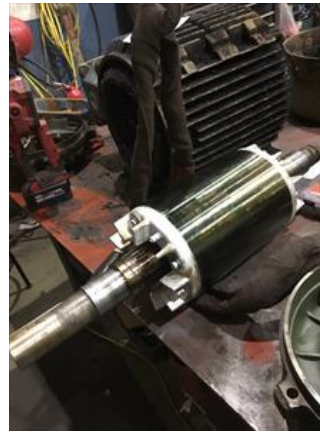
Dirty but serviceable

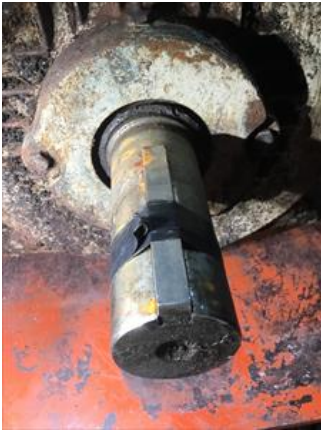
| 8. Does Shaft Have Visible Damage? | (No) No | P26 |

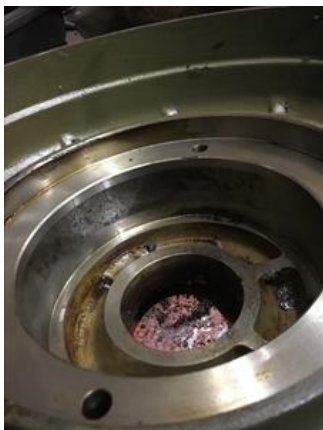
5.1192	5.119	5.1191
60.	Drive End - Endbell Bearing Fit Condition	(P) Pass	
61.	Opposite Drive End - Endbell Bearing Fit		
	0 Degrees	60 Degrees	120 Degrees
	<div>Excessive pitting</div> <div>

62.	Opposite Drive End - Endbell Bearing Fit Condition	(F) Fail

ODE housing pitted and out of tolerance.

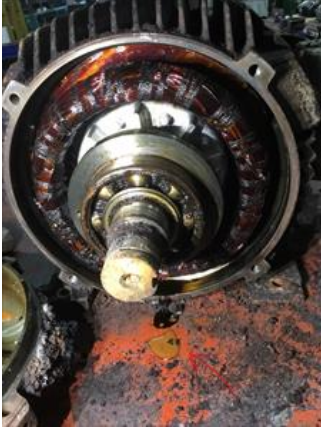
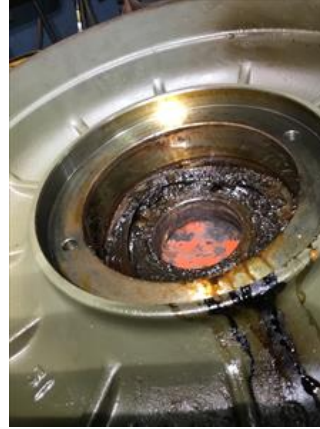
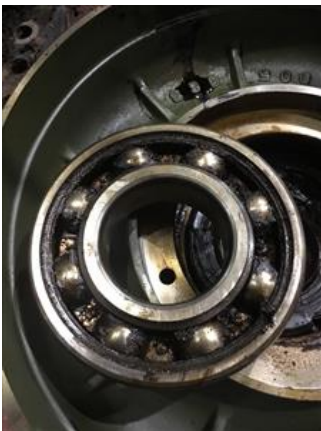
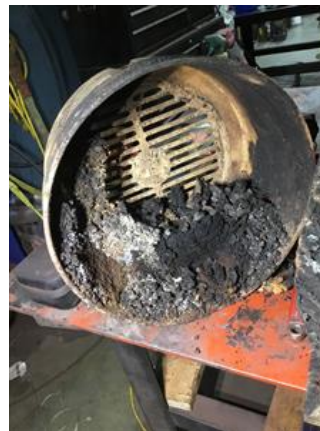
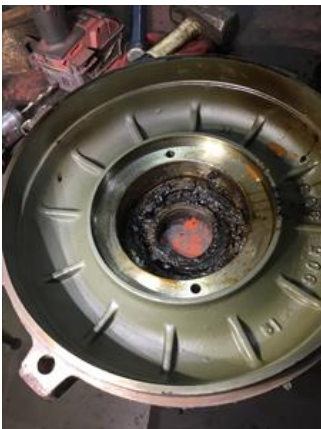
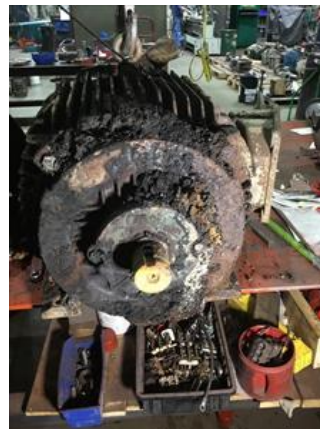
ODE housing fit.

Contaminated grease in both housings led to premature bearing failure. Also found moisture inside stator housing. Additionally there was excessive amounts of debris inside the fan cover which led to total fan destruction.
