## AC Inspection as Found

WESTERN FOODS LLC

Location: LITTLE ROCK MOTOR SHOP

Description: 40HP SIEMENS 1780RPM

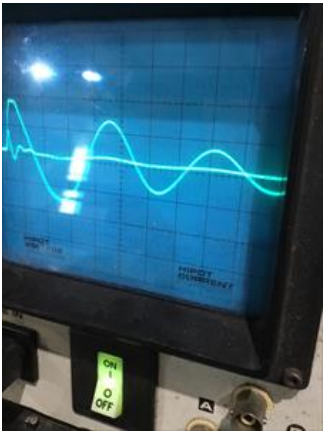
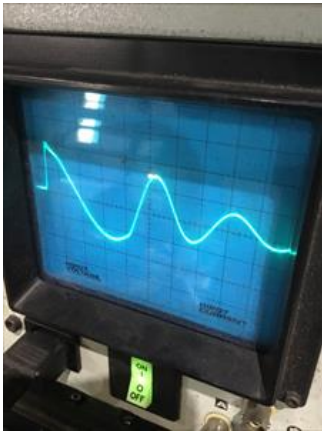
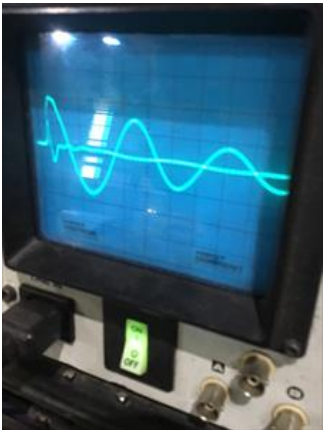
19.	Insulation Resistance/Megger	Megohms	
20.	Winding Resistance		
1-2	1-3	2-3

22. Number of Stator Slots	48		
23. Stator Condition	rewind		
24. Stator Thermistors/Ohms

*Sleeve ODE & DE housing fits.  
Rewind stator  
6210 /C3 & 6312 / C3*

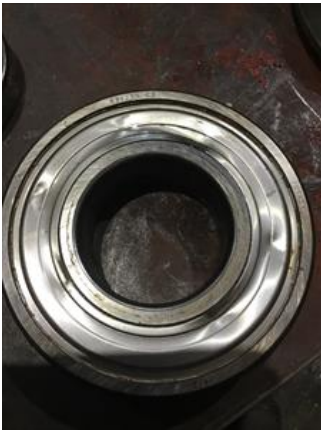
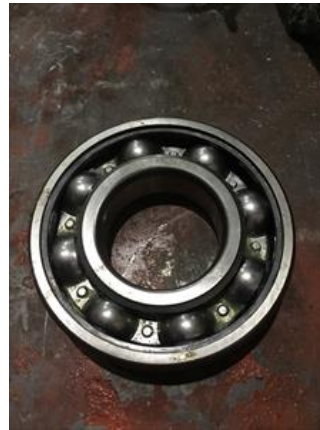
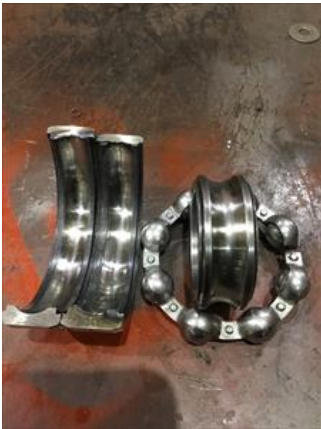
27. Drive End Bearing Number-

33. Drive End Bearing Condition

**Replace**

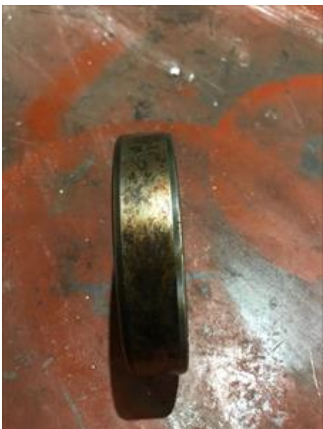
36.	Opposite Drive End Bearing Qty.	1	
37.	Opposite Drive End Bearing Type	(Ball) Ball Bearing	
38.	Opposite Drive End Lubrication Type	(Grease) Grease Lubricated	
39.	Opposite Drive End Bearing Insulation or Grounding Device?	none	
40.	Opposite Drive End Wavy Washer/Snap-Ring Other Retention Device?	wavy washer	
41.	Opposite Drive End Bearing Condition	worn	P119
	Outer race fretted.

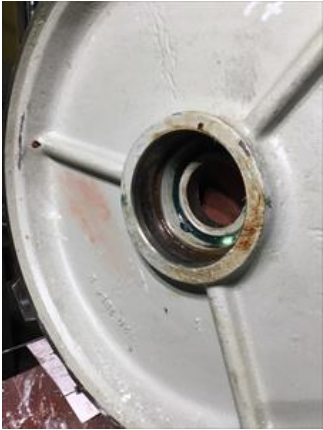
Excessive pitting

62.	Opposite Drive End - Endbell Bearing Fit Condition			(F) Fail

65. List Machine Work Needed Below  
*ODE housing fit bad.*

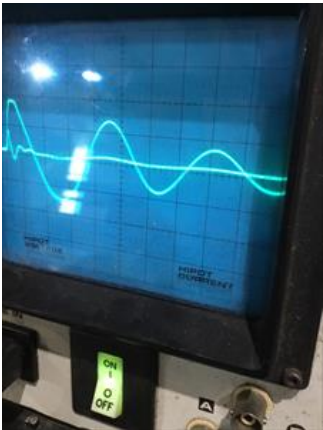
Phases 1&2

*Windings show shorted to ground on two phases. ODE housing fit requires sleeve.*

*Winding analyzer shows 2 of 3. phases shorted to ground. Cause is indeterminate. Also both housing fits are out of tolerance.*
