# AC Inspection as Found Reynolds Metals company

#### AC Inspection - Rev. 2

Hi-Speed Job Number:	103592
Manufacturer:	Reliance
Product Number:	M: 6300538
Voltage:	460
Current:	11 (Amps)
Phase:	Three
Hz:	60 (Hz)
Service Factor:	1
Enclosure:	TENV
# of Leads:	3
J-box Included:	Half
Coupling/Sheave:	None
Date Received:	10/01/2024
Bearing RTDs:	No
Stator RTDs:	No
Repair Stage:	Final
Heaters:	No
Winding Type :	Random Wound
Bearing Type:	Rolling Element

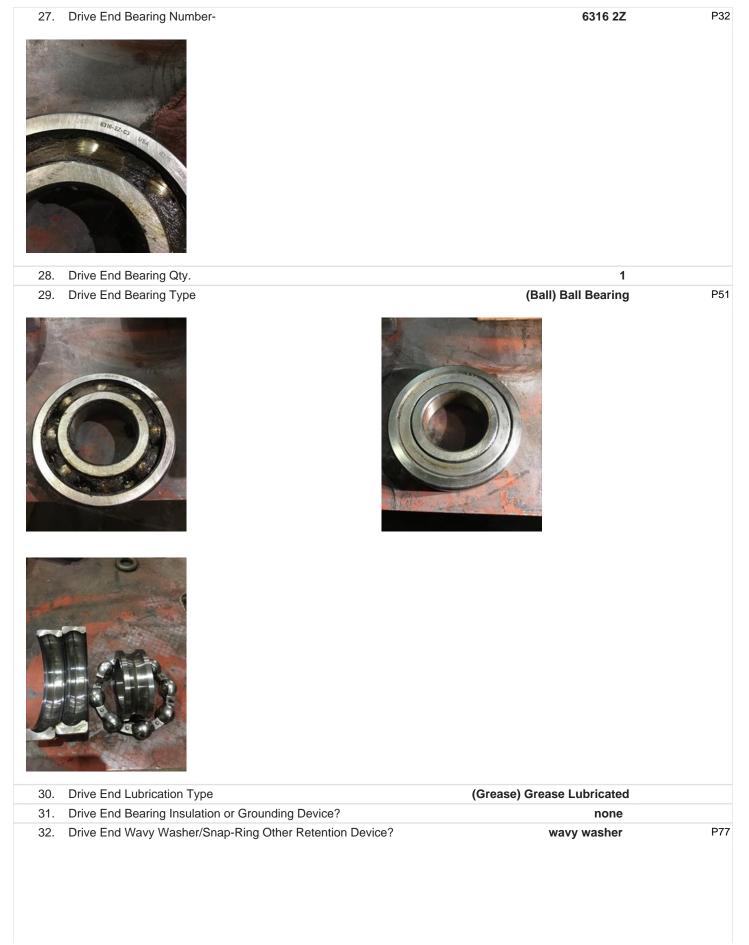
33.	Drive End Bearing Condition replace	
34.	Opposite Drive End Bearing Brand FAG	
35.	Opposite Drive End Bearing Number-	P100

61.	Opposite Drive End - Endbell E				
	0 Degrees	60 Degrees	120 Degrees		
	Lip worn in.				
62.	Opposite Drive End - Endbell E	Bearing Fit Condition	(F) Fail

0.5					
65.					
	DE shaft fit measures too small.	Both end bell housing fits wo			
66.	Technician	1 1	Terrence Holland		
	-	1 10	/		
		////			
/-					
Root C	ause of Failure		6

67.					
07.		eucine fite			
	DE shaft fit, and both end bell h	busing fits.		540	
68.	68. Root cause of failure P				
ODE bearing suffered cage failure due to lack of lubrication.					
Dynam	nic Balance Report

(2) 6316 2Z / C3 Bearings
