AC Inspection as Found

Reynolds Metals company

AC Inspection - Rev. 2

Description: Reliance

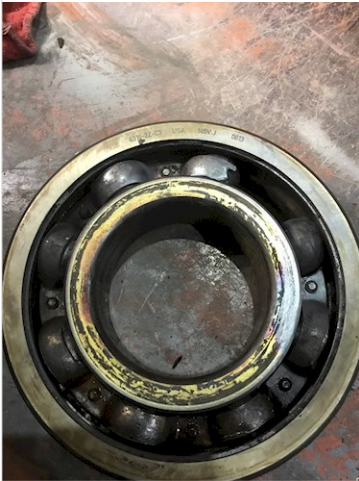
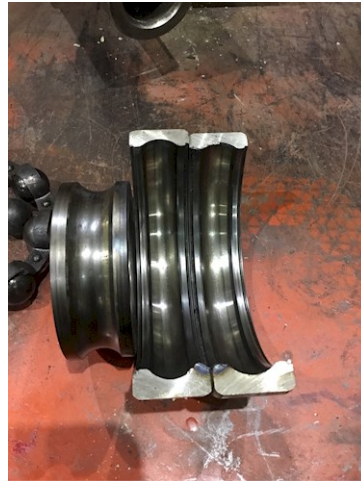
32. Drive End Bearing Condition	replace	
33. Opposite Drive End Bearing Brand	FAG	
34. Opposite Drive End Bearing Number-	6316	P100

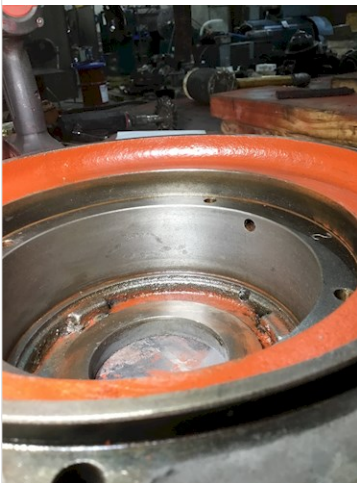
P2

*Excessive pitting*

● 59. Drive End - Endbell Bearing Fit Condition
(F) Fail

64.	List Machine Work Needed Below <i>DE shaft fit measures too small. Both end bell housing fits worn.</i>	
65.	Technician	Terrence Holland

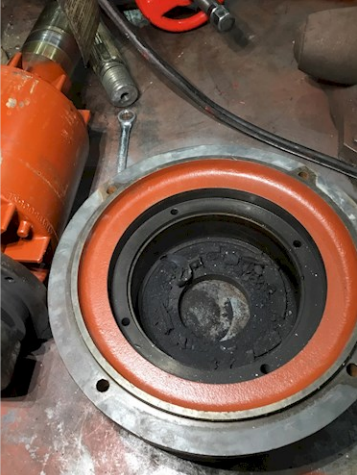
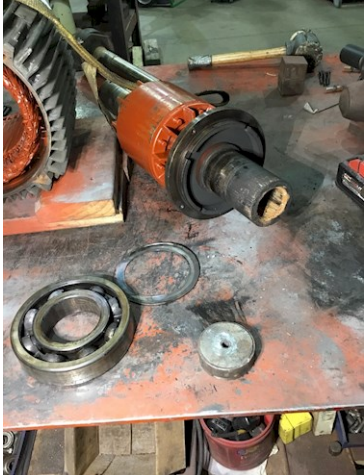
66.	Failure locations <i>DE shaft fit, and both end bell housing fits.</i>	
67.	Root cause of failure <i>ODE bearing suffered cage failure due to lack of lubrication.</i>	
<div>
