AC Inspection as Found

Welspun Tubular (11685)

AC Inspection - Rev. 2

Description: 150HP US MOTORS 1780RPM

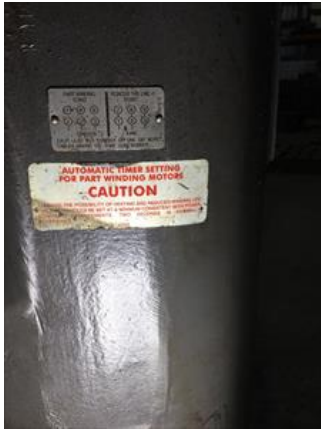
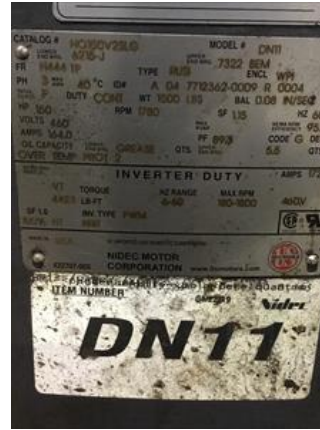
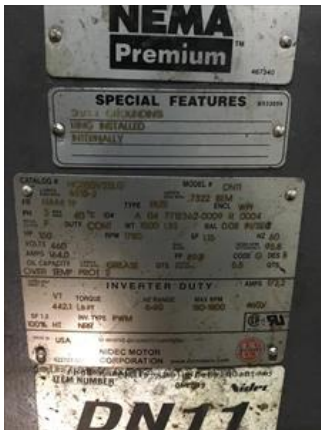
P37

2. Nameplate Picture

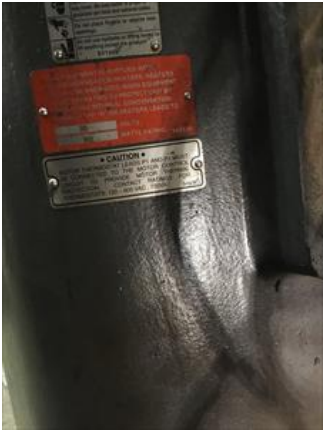
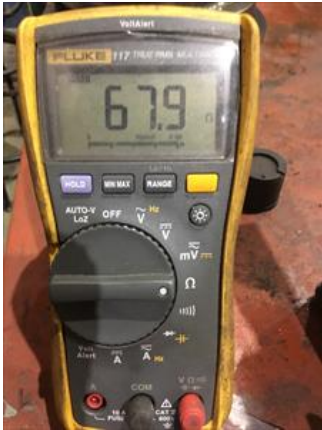
18. Heater Quantity, Ratings	P118
------------------------------	------

Quantity	Volts/Watts	Pass/Fail
1	115/192

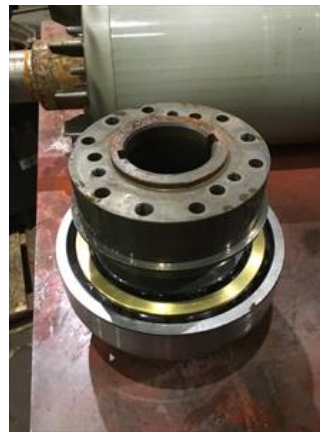
P51

34. Drive End Bearing Condition

replace
