AC Inspection as Found

Welspun Tubular (11685)

AC Inspection - Rev. 2

Description: 150HP US MOTORS 1780RPM

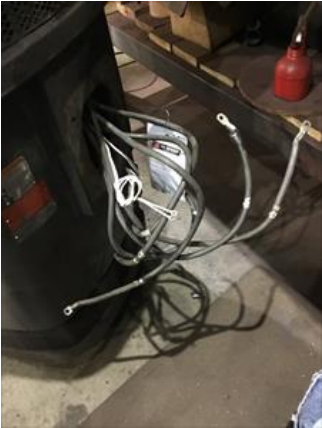
11.	Air Gap Variation <10%		
12.	Lead Condition	(P) Pass	
13.	Lead Length	22 Inches	
14.	Does it have Lugs?, If so what is the Stud Size?	(Yes) Yes	P94

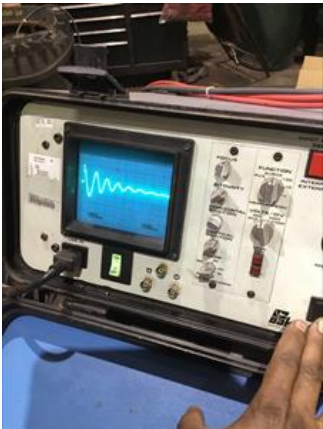
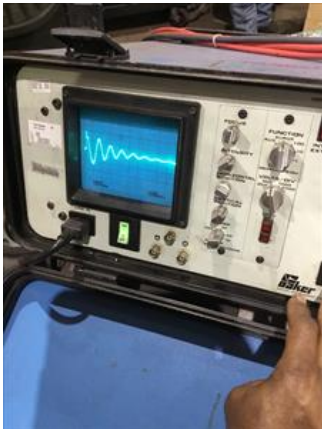
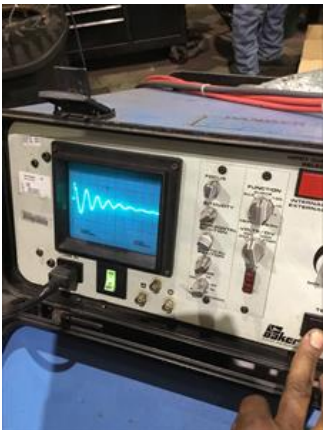
22. Perform Surge Test

(P) Pass

24. Stator Condition

rusty but passed surge & Meg

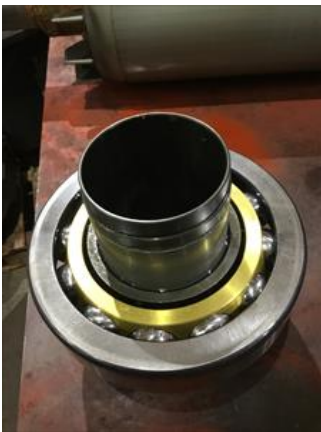
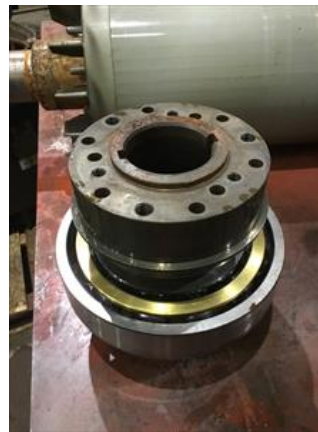
30. Drive End Bearing Type

(Thrust) Thrust

34. Drive End Bearing Condition

replace

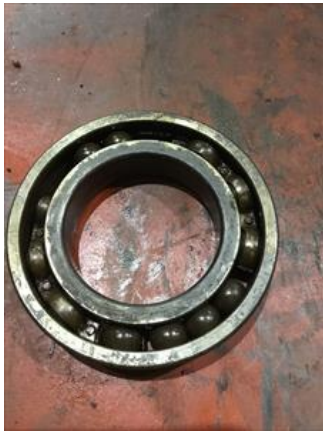
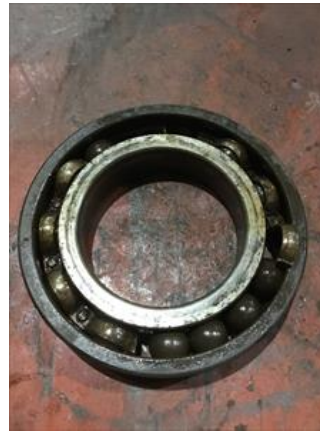
42. Opposite Drive End Bearing Condition

rusted and worn with cage
failure

Root Cause of Failure			
68.	Failure locations <i>Lower bear was rusted and grease was contaminated. Lower bearing housing has lip worn in and upper bearing shaft fit measures too small.</i>		
69.	Root cause of failure <i>Water contaminated grease in lower bearing.</i>		
Dynamic Balance Report			
70.	Rotor Weight and Balance Grade		
	Rotor Weight	Balance Grade	
71.	Initial Balance Readings		
	Drive End	Opposite Drive End

66.	List Machine Work Needed Below <i>Sleeve lower end bell housing, and repair upper and lower bearing shaft fits. Replace worn shaft grounding ring.</i>
