AC Inspection as Found
ARKANSAS INDUSTRIAL MACHINERY
3804 N. NONA ST
NORTH LITTLE ROCK, AR 72118

AC Inspection - Rev. 2

Location: Shop
Serial Number: 1PC31042AB400DV2
Description: 55KW SIEMENS

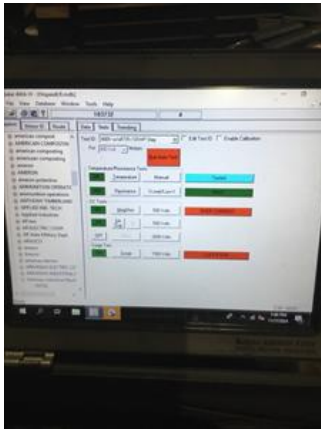
21. Perform Surge Test

(F) Fail

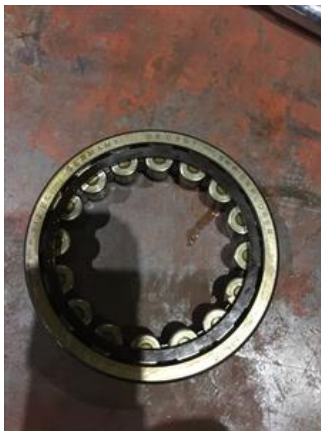
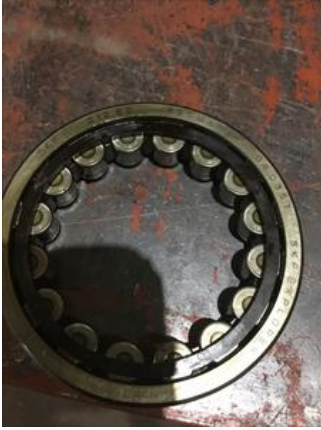
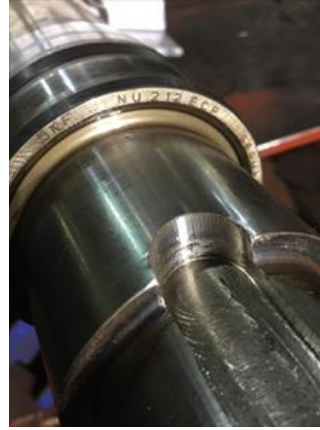
26. Drive End Bearing Brand

28. Drive End Bearing Qty.	1
29. Drive End Bearing Type	(Roller) Roller Bearing
30. Drive End Lubrication Type	(Oil) Oil Lubricated
31. Drive End Bearing Insulation or Grounding Device?	none
32. Drive End Wavy Washer/Snap-Ring Other Retention Device?	none
33. Drive End Bearing Condition	replace
34. Opposite Drive End Bearing Brand	unreadable
35. Opposite Drive End Bearing Number-	6212 2Z/C4
36. Opposite Drive End Bearing Qty.	1
37. Opposite Drive End Bearing Type	(Ball) Ball Bearing
38. Opposite Drive End Lubrication Type	(Grease) Grease Lubricated
39. Opposite Drive End Bearing Insulation or Grounding Device?	none
40. Opposite Drive End Wavy Washer/Snap-Ring Other Retention Device?	snap ring
41. Opposite Drive End Bearing Condition	catastrophic cage failure

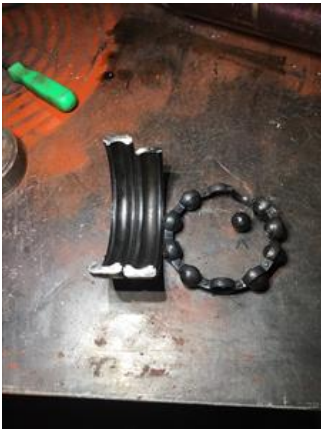
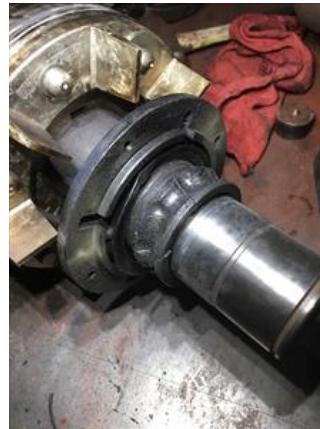
ODE bearing cage had catastrophic failure due to lack of lubrication, causing the rotor to rub on the stator iron core shorting out the windings.

*Replace snap ring, seals and bearings. Machine ODE shaft bearing cap housing fit and shaft air seal surface.
Replace broken fan.*

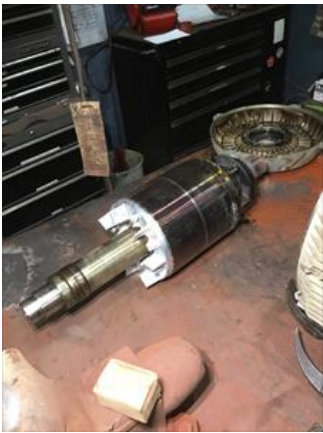
44. Rotor Type/Material

(Squirrel Aluminum) Squirrel
Cage Aluminum Die Cast

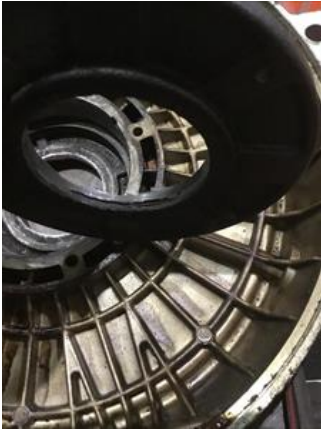
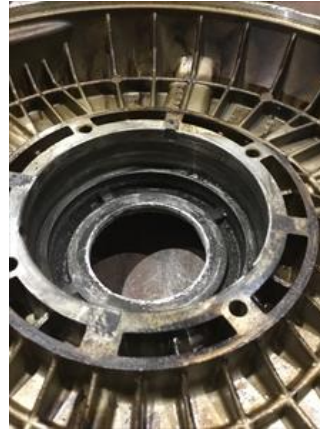
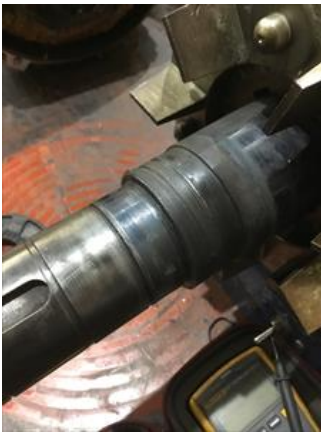
65. List Machine Work Needed Below

Excessive wear from bearing race welded to shaft

Excessive wear from catastrophic bearing cage failure.

63.	Bearing Cap Condition		
	Drive End Bearing Cap	Opposite Drive End Bearing Cap	
	na	excessive wear and cracks	
64.	End Bell Air Seal Fits		
	Drive End Air Seal	Opposite Drive End Air Seal

Sleeve ODE housing and shaft fits and repair bearing shoulder and shaft where bearing cap rides. Repair ODE bearing cap opening.
