**AC Inspection as Found**  
**Bryce Corporation (10053-BRC)**  
450 S. Benton  
Searcy, AR 72143

**AC Inspection - Rev. 2**

**Description:** 55KW SIEMENS 3570RPM W/  
FANTASTIC

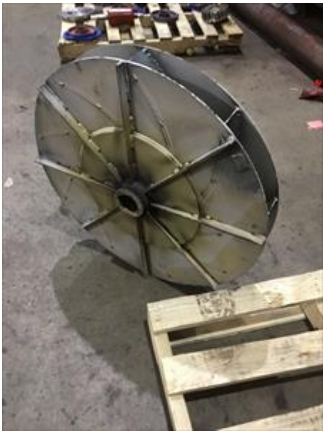
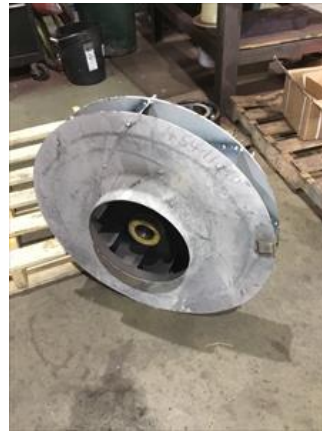
*Removed by customer*

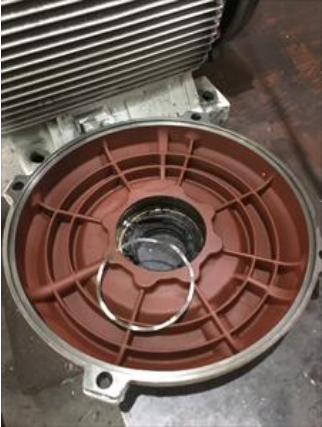
34.	Drive End Bearing Condition	replace	
35.	Opposite Drive End Bearing Brand	ORS Turkey	P92

*Both bearings show signs of excessive wear and fluting.*

*Contaminated bearing grease and fluting.*

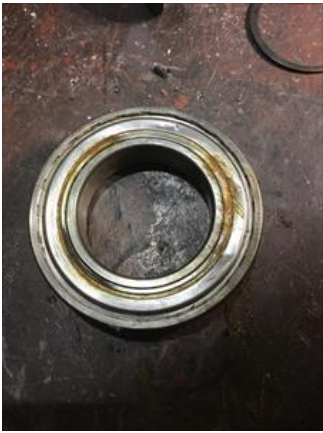
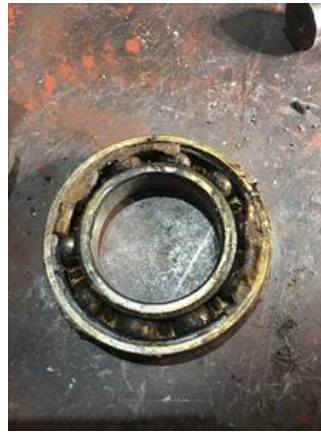
40.	Opposite Drive End Bearing Insulation or Grounding Device?	none	
41.	Opposite Drive End Wavy Washer/Snap-Ring Other Retention Device?		
	2) snap rings.		
42.	Opposite Drive End Bearing Condition	replace	
43.	Drive End Seal	dust seal	P120
