AC Inspection as Found
DELTA PLASTICS OF THE SOUTH
3104 SOUTH MAIN STREET
STUTT GART, AR 72160

AC Inspection - Rev. 2

Location: Shop
Serial Number: TGR9216632001
Description: 300HP TECO 1188RPM

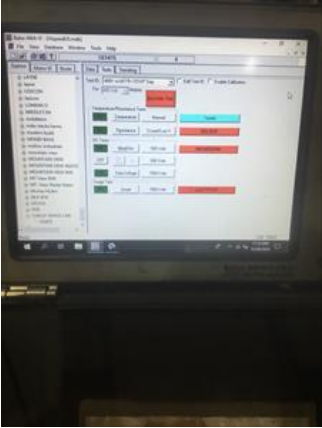
20.	Insulation Resistance/Megger	Megohms	
	<i>Unable to capture</i>		
21.	Winding Resistance		
	1-2	1-3	2-3
	<i>Unable to capture</i>		
22.	Perform Surge Test		P57
	<i>Unable to perform test. -water in housing</i>

<i>After baking</i>			
23.	Number of Stator Slots	72	
24.	Stator Condition	serviceable	
25.	Stator Thermistors/Ohms		
	<i>N/a</i>		
26.	Stator Overloads/Ohms		
Mechanical Inspection

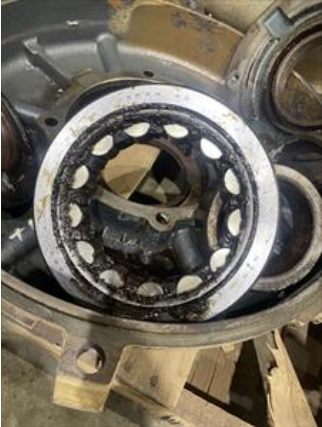
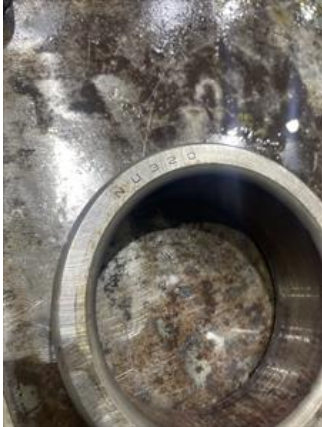
27.	Drive End Bearing Brand	ntn	
28.	Drive End Bearing Number-	NU 320	P32

32.	Drive End Bearing Insulation or Grounding Device?	none present	
33.	Drive End Wavy Washer/Snap-Ring Other Retention Device?	none present	
34.	Drive End Bearing Condition	replace	
35.	Opposite Drive End Bearing Brand	skf	
36.	Opposite Drive End Bearing Number-	6316	P99

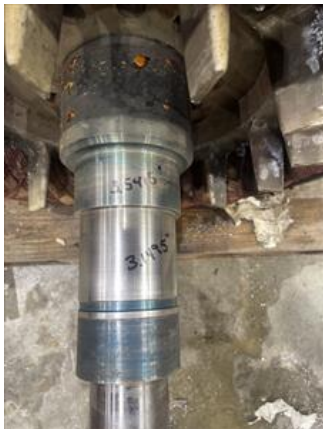
55.	Drive End Bearing Shaft Fit		
	0 Degrees	60 Degrees	120 Degrees
	3.9376	3.9378	3.9376
	3.9380"		
56.	Drive End Bearing Shaft Fit Condition		(P) Pass
57.	Opposite Drive End Bearing Shaft Fit		P89
	0 Degrees	60 Degrees	120 Degrees

3.1498	3.1499	3.15
	3.5415"-shoulder 3.1498"-shaft

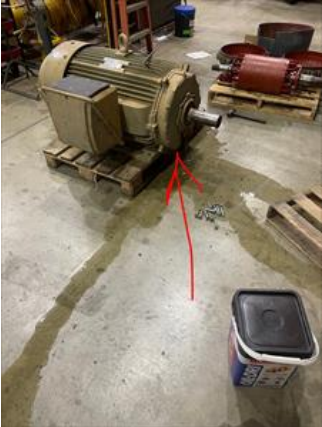
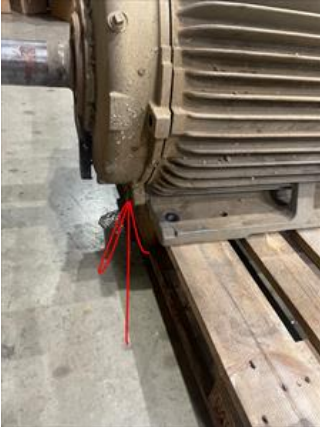
</div> <div>Co sign: TRH</div>	
Root Cause of Failure		
68.	Failure locations	
	Windings & DE housing fit bad	
69.	Root cause of failure	P18
	Water penetration	
	<div><div>
