AC Inspection as Found

Beasley Flooring (12083)

AC Inspection - Rev. 2

Description: 100HP BALDOR

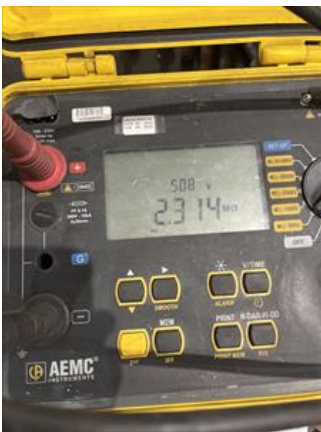
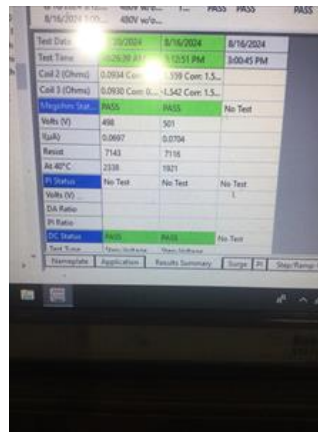
P8

18. Insulation Resistance/Megger 2.314 Megohms

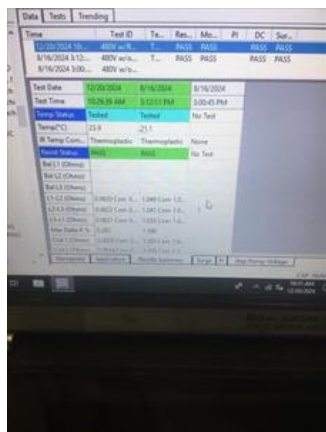
P20

19. Winding Resistance

1-2

1-3

2-3

.0620

.0622

.0621

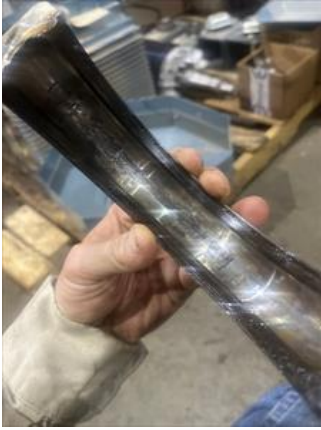
32. Drive End Bearing Condition **replace**

Metal fatigue

66. Failure locations
Bearings & bearing grease. D.E housing fit has excessive pitting.
67. Root cause of failure
Water contaminated grease caused premature bearing failure

44.	Growler Test	(Pass) Pass	
45.	Number of Rotor Bars	50	
46.	Rotor Condition	pass	
47.	List the Parts needed for the Repair Below 6316 & 6313 2Z/C3 bearings		
48.	Signature of Technician that Disassembled Motor	Cody McMillan

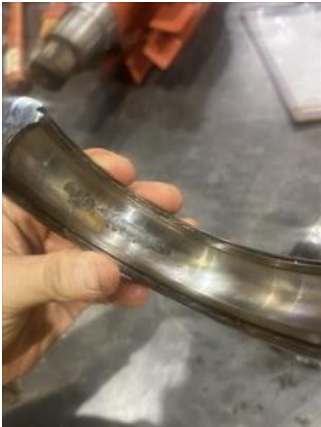
P92

40. Opposite Drive End Bearing Condition **replace**

Metal fatigue

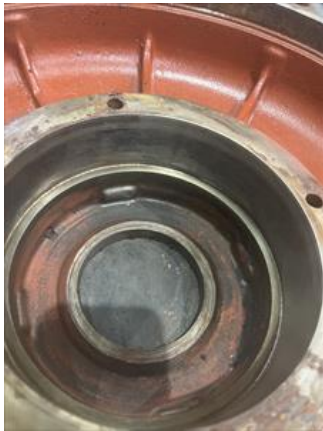
58.	Drive End - Endbell Bearing Fit	P2		
	0 Degrees	60 Degrees	120 Degrees	
	<div><div></div><div>Fail</div></div> <div>Excessive Pitting, recommend sleeving. Verified by machinist.</div> <div>

</div>			
60.	Opposite Drive End - Endbell Bearing Fit			
	0 Degrees	60 Degrees	120 Degrees	
	5.5122	5.512	5.512	
61.	Opposite Drive End - Endbell Bearing Fit Condition	(P) Pass		
62.	Bearing Cap Condition			
	Drive End Bearing Cap	Opposite Drive End Bearing Cap		
	pass	pass		
63.	End Bell Air Seal Fits			
	Drive End Air Seal	Opposite Drive End Air Seal		
64.	List Machine Work Needed Below			
	Sleeve D.E housing fit			
65.	Technician	Terrence Holland

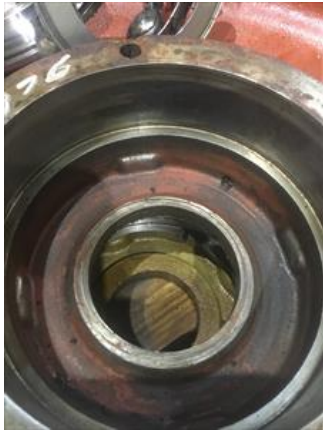
</div>			
59.	Drive End - Endbell Bearing Fit Condition	(F) Fail		P15
	<div><div></div><div>Excessive pitting. Verified by machinist.</div></div> <div>
