AC Inspection as Found

USG Interiors
850 No Broadway
Greenville, MS 38701

Location: Motorshop
Serial Number: 9VD 256TTFNA6529BA R115 R159
Description: 20 HP AC Stator

Hi-Speed Job Number:	152278
Manufacturer:	Marathon
Serial Number:	9VD 256TTFNA6529BA R115 R159
HP/kW:	20 (HP)
RPM:	1775 (RPM)
Frame:	256TC
Voltage:	230 / 460
Current:	24.1 (Amps)
Phase:	Three
Hz:	60 (Hz)
Service Factor:	1.15
Enclosure:	TEFC
# of Leads:	9
J-box Included:	Complete
Coupling/Sheave:	None
Date Received:	03/06/2024
Bearing RTDs:	No
Stator RTDs:	No
Repair Stage:	Teardown Inspection
Rewind:	No
Shaft Machined Fit Repairs Required:	No
Bearing Housing Machined Fit Repairs Required:	Yes
Heaters:	No
Winding Type :	Random Wound
Bearing Type:	Rolling Element

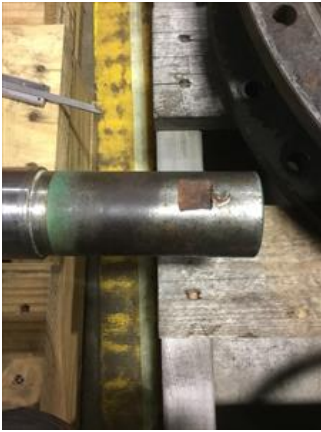
P8

7. Does Shaft Have Visible Damage?

Grove ground in shaft

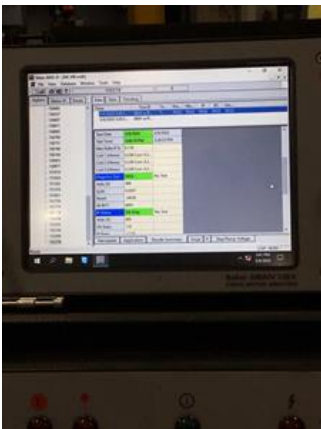
P22

18. Insulation Resistance/Megger **6493 Megohms**

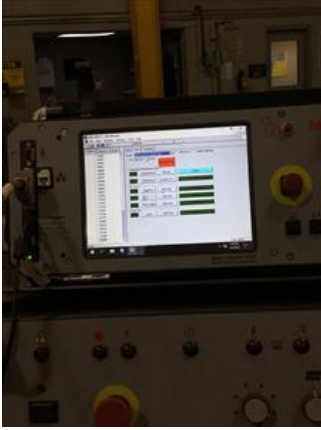
19. Winding Resistance

1-2

1-3

2-3

.476

.477

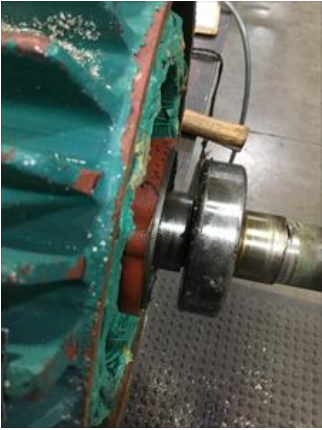
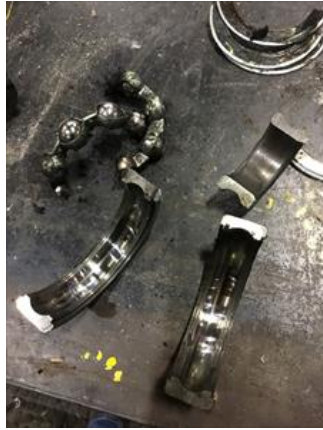
30.	Drive End Bearing Insulation or Grounding Device?	none present	
31.	Drive End Wavy Washer/Snap-Ring Other Retention Device?	none present	
32.	Drive End Bearing Condition		P36
	Off shoulder

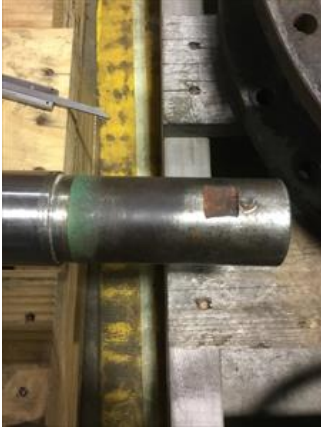
P64

52. Coupling Fit Closest to the end of the Shaft

1.625

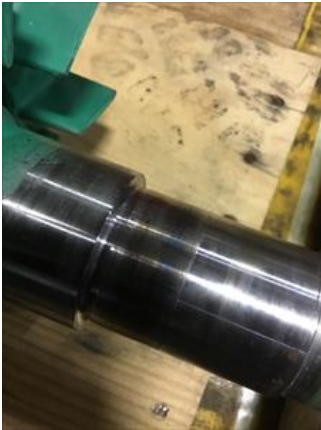
P65

53. Drive End Bearing Shaft Fit

1.7718

1.7719

*Tolerance is 1.7718-1.7722*

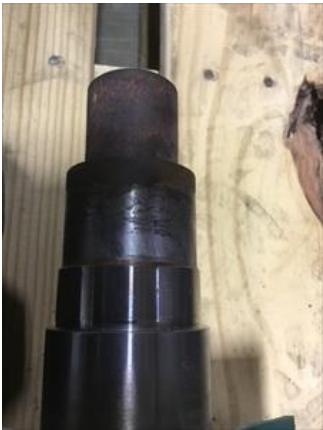
55. Opposite Drive End Bearing Shaft Fit

0 Degrees	60 Degrees	120 Degrees
1.969	1.969	1.969

Tolerance is 1.9686-1.9690

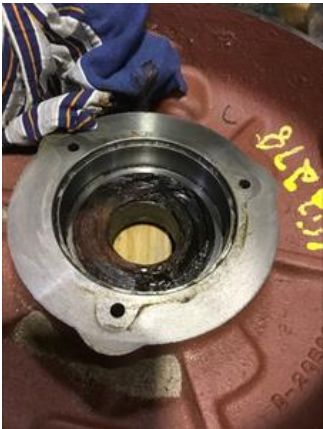
58. Drive End - Endbell Bearing Fit

0 Degrees	60 Degrees	120 Degrees
3.9381	3.9381	3.9381

Tolerance is 3.9370-3.9379

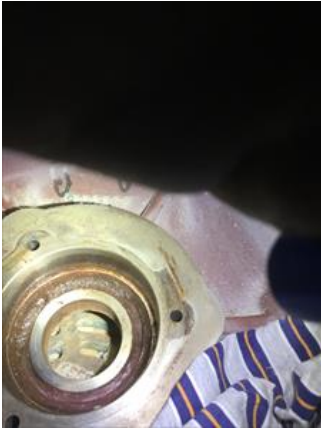
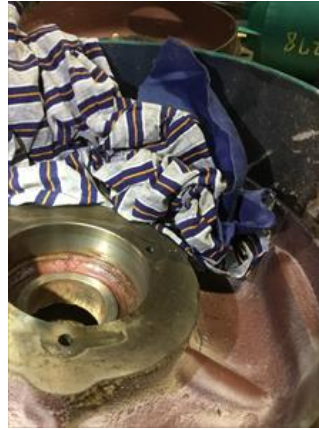
60. Opposite Drive End - Endbell Bearing Fit

3.5443

3.5445

3.6452

☐ Tolerance is 3.5433-3.5442. Out of round and requires bore and bushing.

● 61. Opposite Drive End - Endbell Bearing Fit Condition **(F) Fail**

Bore and bush ODE end bell.
