AC Inspection as Found
Almatis Inc/RCP Bauxite (10014)
4701 Alcoa Road
Bauxite, AR 72011

AC Inspection - Rev. 2

Location: LR Motor Shop
Serial Number: 1-5106-16338-1-1
Description: 60HP RELIANCE 1200 RPM

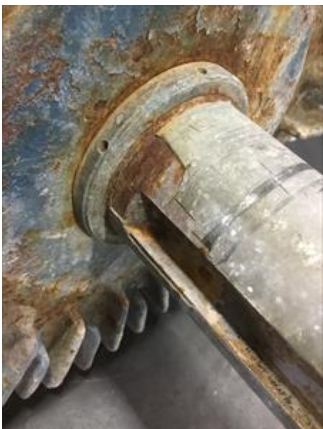
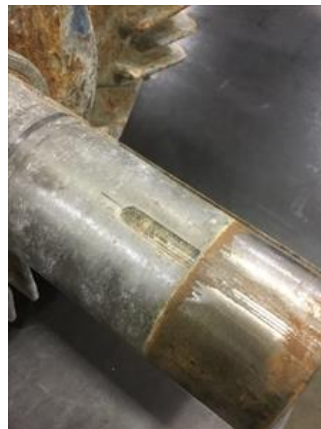
| 7. Does Shaft Have Visible Damage? | (Yes) Yes | P26 |
| <p><i>Shaft has previous been metalized. Starting to flake off.</i></p> | | |

*Bore and bush both end bell.
Braze cracks in fan shroud.
Check integrity of old metalized surface on shaft.*

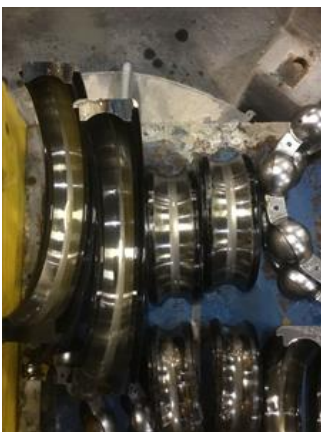
P82

32. Drive End Bearing Condition

Normal wear

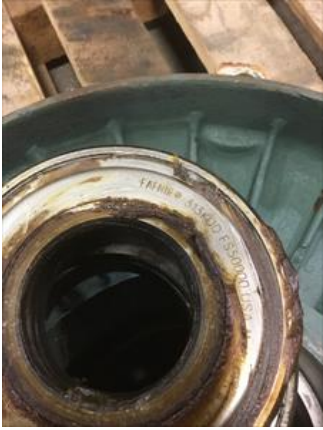
P118

34. Opposite Drive End Bearing Number-	6313 C3
35. Opposite Drive End Bearing Qty.	1
36. Opposite Drive End Bearing Type	(Ball) Ball Bearing
37. Opposite Drive End Lubrication Type	(Grease) Grease Lubricated
38. Opposite Drive End Bearing Insulation or Grounding Device?	None
39. Opposite Drive End Wavy Washer/Snap-Ring Other Retention Device?	None
40. Opposite Drive End Bearing Condition	Normal Wear

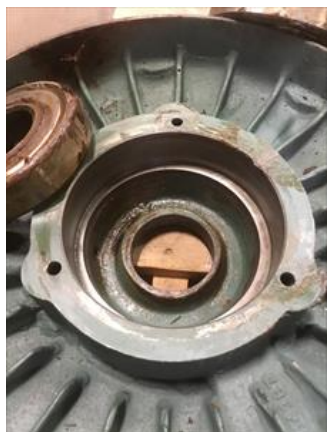
58. Drive End - Endbell Bearing Fit

0 Degrees	60 Degrees	120 Degrees
6.6958	6.6957	6.6958

☐ *Tolerance is 6.6929-6.6939. .0019 out of tolerance.*

● 59. Drive End - Endbell Bearing Fit Condition **(F) Fail**

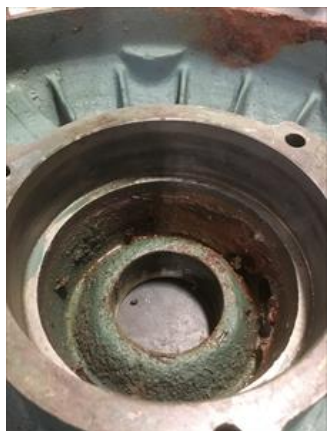
P30

60. Opposite Drive End - Endbell Bearing Fit

0 Degrees	60 Degrees	120 Degrees
5.515	5.5148	5.5147

☐ *Tolerance is 5.5118-5.5128. .002 out of tolerance.*

● 61. Opposite Drive End - Endbell Bearing Fit Condition **(F) Fail**
