AC Inspection as Found

Peco Foods (004801)

AC Inspection - Rev. 2

Hi-Speed Job Number:	154221
Manufacturer:	WEG
Product Number:	L5010/11DZ
Spec/ID #:	1026776130
HP/kW:	783 (HP)
RPM:	3575 (RPM)
Voltage:	460
Current:	842 (Amps)
Phase:	Three
Hz:	60 (Hz)
Service Factor:	1.15
Enclosure:	WPI
# of Leads:	6
J-box Included:	None
Coupling/Sheave:	None
Date Received:	11/22/2024
Bearing RTDs:	No
Stator RTDs:	Yes
Repair Stage:	Teardown Inspection
Heaters:	Yes
Winding Type :	Random Wound
Bearing Type:	Rolling Element

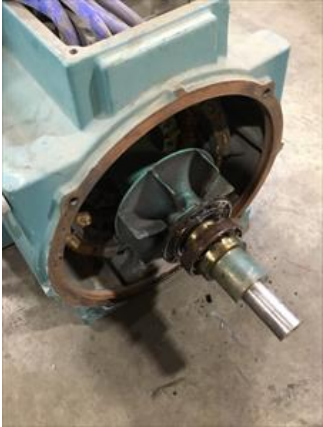
13.	Does it have Lugs?, If so what is the Stud Size?	(Yes) Yes	
	3/8"		
14.	Lead Numbers	T1-T6	
15.	Stator Temperature Detector Rating and Function		
	Quantity	Rating	Quantity Passed
	6	100	6
16.	Frame Condition	good	
17.	Fan Condition	(P) Pass	P19
	Internal on shaft

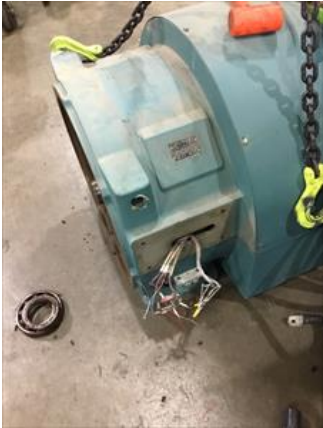
18.	Heater Quantity, Ratings		
	Quantity	Volts/Watts	Pass/Fail
	2	240/173	pass
19.	Broken or Missing Components	yes	P21
	Missing lifting eyes

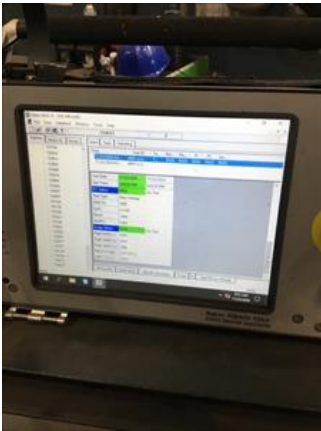
P24

22. Perform Surge Test

(P) Pass

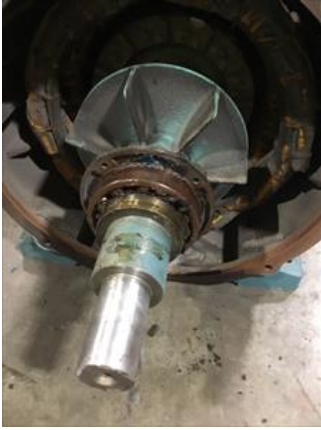
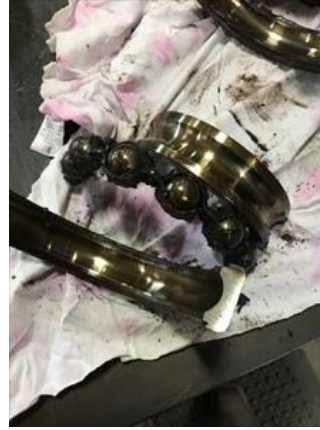
Spacer on end

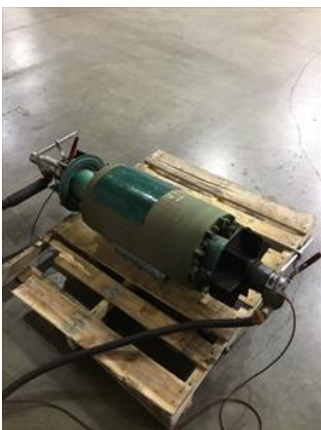
P56

46. Growler Test

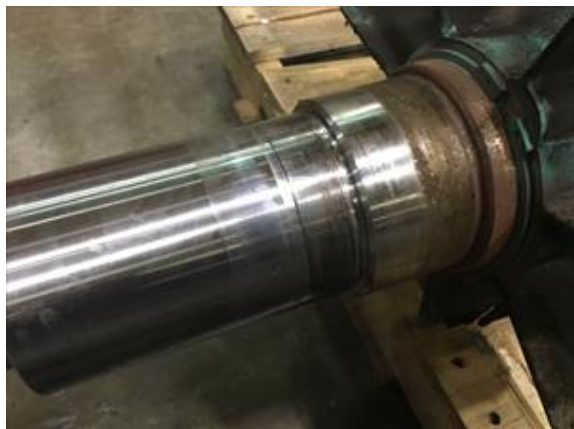
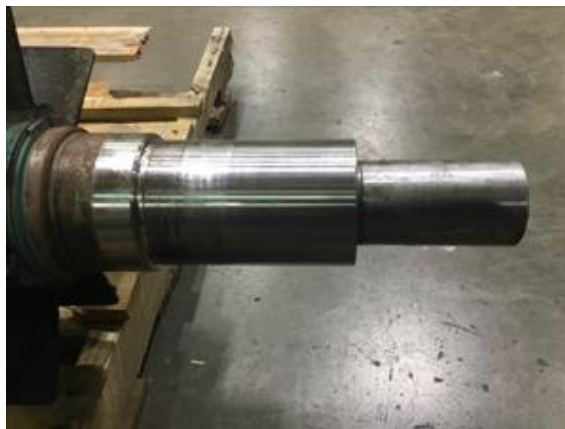
P65

55. Drive End Bearing Shaft Fit

3.5438

3.5437

90mm = 3.5433 Pressfit tolerance is from 3.5434 to 3.5440

(P) Pass

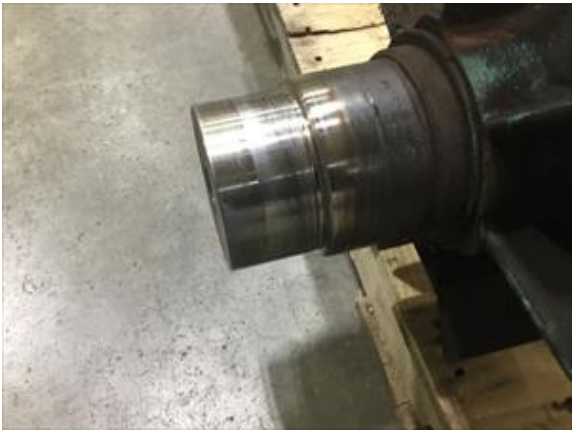
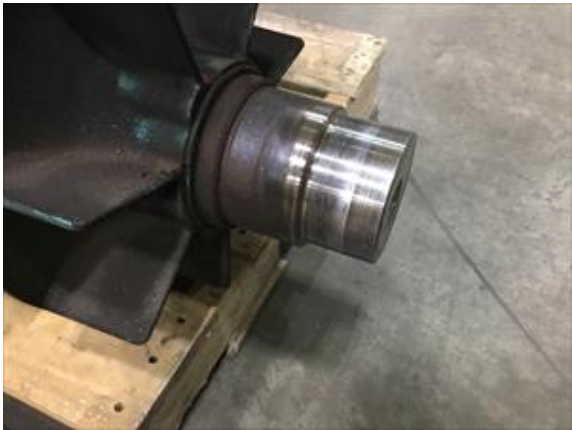
57. Opposite Drive End Bearing Shaft Fit

0 Degrees	60 Degrees	120 Degrees
3.5435	3.5435	3.5436

90mm = 3.5433 Pressfit tolerance is from 3.5434 to 3.5440

(P) Pass

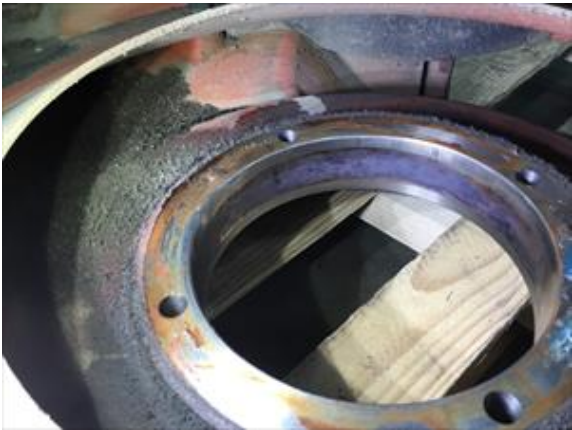
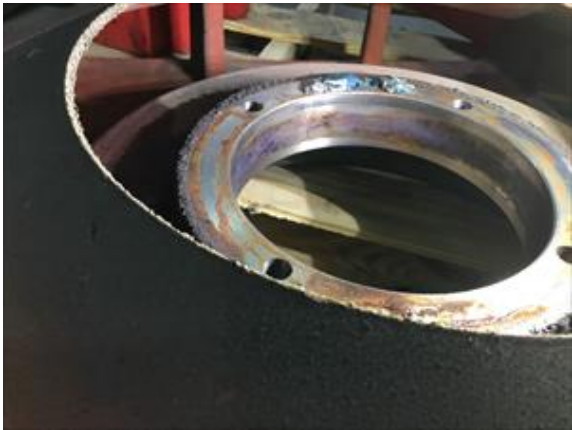
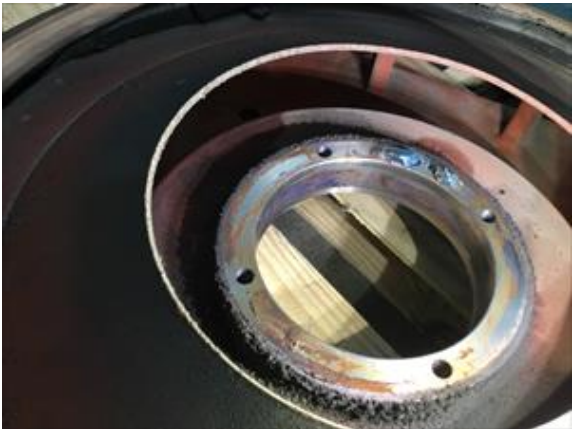
60. Drive End - Endbell Bearing Fit

0 Degrees	60 Degrees	120 Degrees
6.3002	6.3012	6.3006

160mm = 6.2992 Tolerance is from 6.2992 to 6.3002

(F) Fail

66. List Machine Work Needed Below
Both endbells need to be bored and bushed

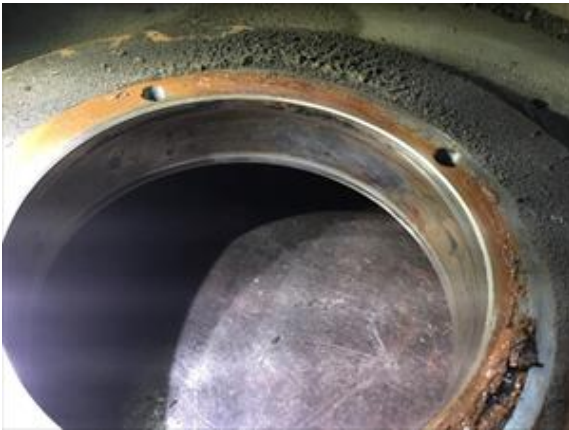
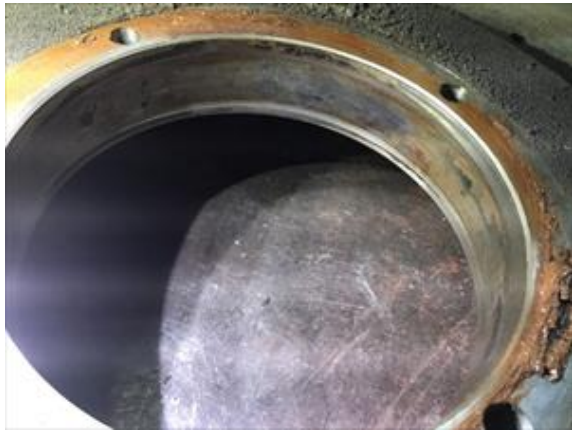
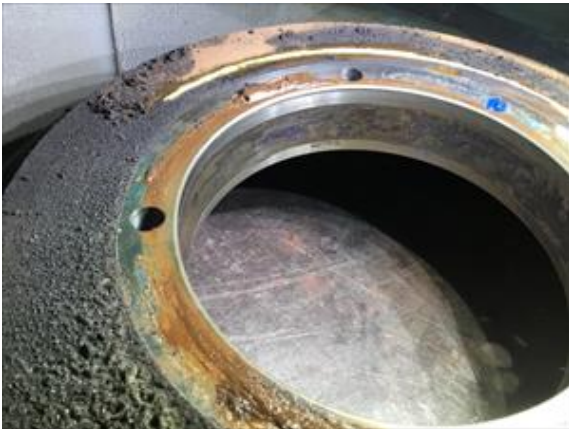
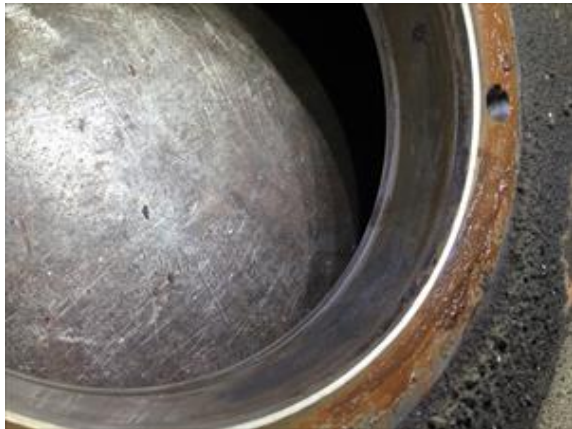
62. Opposite Drive End - Endbell Bearing Fit

0 Degrees	60 Degrees	120 Degrees
6.32	6.322	6.305

Bad the bearing has been spinning in its bore for a long time

63. Opposite Drive End - Endbell Bearing Fit Condition (F) Fail
