AC Inspection as Found

Post Foods LLC
5800 C.W. Post Rd
Jonesboro, AR 72401

AC Inspection - Rev. 2

Hi-Speed Job Number:	153874
Manufacturer:	Other
Product Number:	8P75P3C
Spec/ID #:	BJ65
Serial Number:	P 10 7382794-0010 M 0001
HP/kW:	75 (HP)
RPM:	1190 (RPM)
Frame:	405T
Voltage:	460
Current:	87 (Amps)
Phase:	Three
Hz:	60 (Hz)
Service Factor:	1.15
Enclosure:	TEFC
# of Leads:	3
J-box Included:	Complete
Coupling/Sheave:	None
Date Received:	10/09/2024
Bearing RTDs:	No
Stator RTDs:	No
Repair Stage:	Teardown Inspection
Heaters:	No
Winding Type :	Random Wound
Bearing Type:	Rolling Element

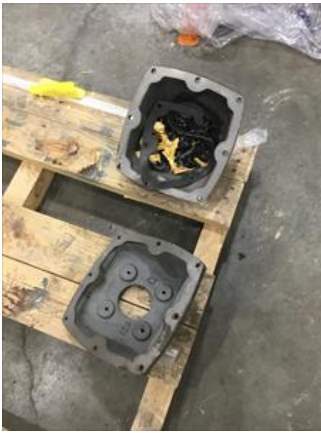
*Has machine work on the drive end
Needs new fan
Windings good*

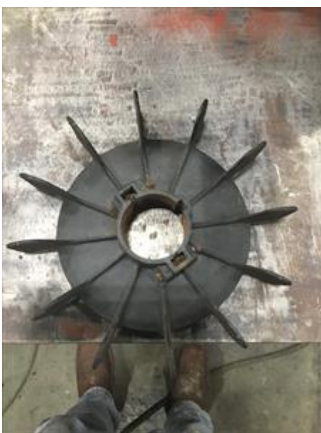
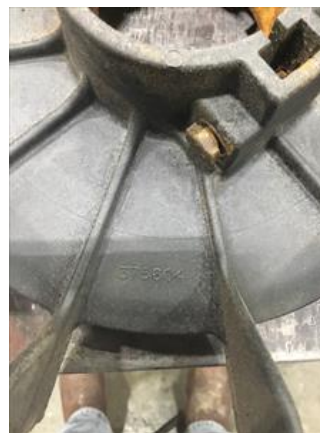
| 17. Fan Condition | (F) Fail | P20 |

| <i>Cracked over key

11" od. 12 blades. 2.365" shaft</i> | | |

18. Broken or Missing Components fan broken

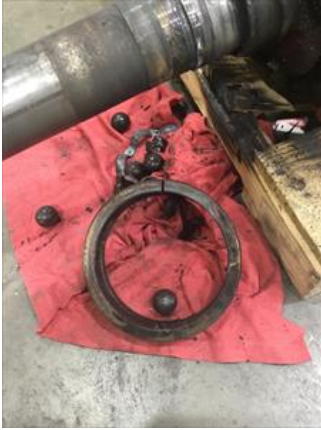
27.	Drive End Bearing Number-	6316 zz c3	
28.	Drive End Bearing Qty.	1	
29.	Drive End Bearing Type	(Ball) Ball Bearing	
30.	Drive End Lubrication Type	(Grease) Grease Lubricated	
31.	Drive End Bearing Insulation or Grounding Device?	none present	
32.	Drive End Wavy Washer/Snap-Ring Other Retention Device?	none present	
33.	Drive End Bearing Condition	failed	P37

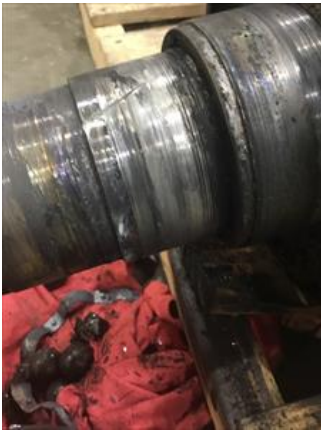
**Bearing failed**

55. Drive End Bearing Shaft Fit Condition

(F) Fail
