## AC Inspection as Found

**MARS FOOD (0001269)**

### AC Inspection - Rev. 2

Location: 5 Floor

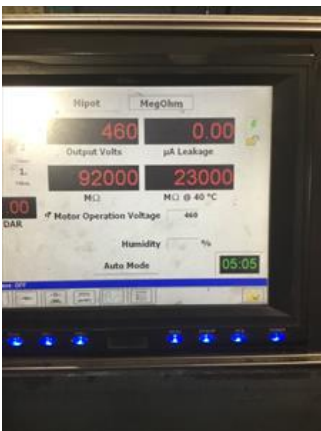
19.	Insulation Resistance/Megger	92000 Megohms	P22
-----	------------------------------	---------------	-----

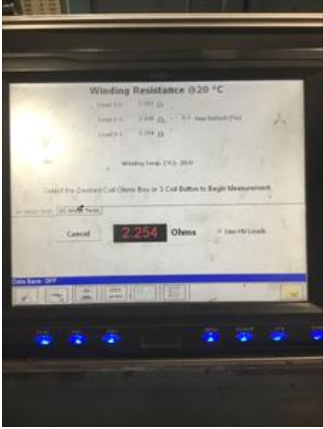
20. Winding Resistance		P23
1-2	1-3	2-3
2.257	2.258	2.54

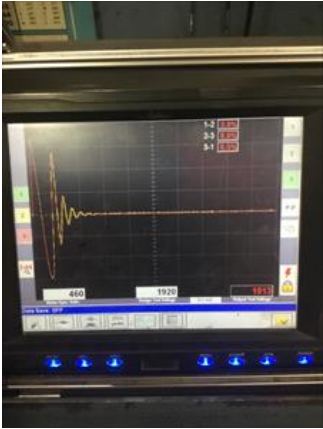
21. Perform Surge Test	(P) Pass	P24

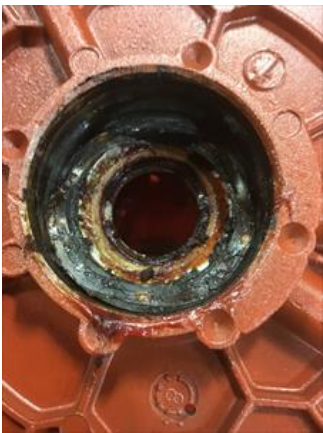
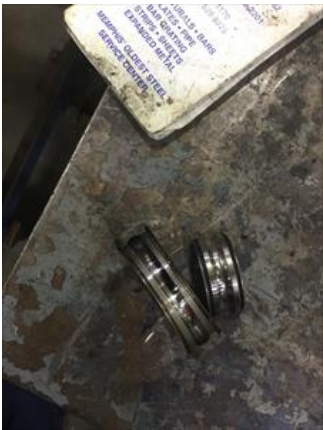
42.	Drive End Seal		
43.	Opposite Drive End Seal

34.	Opposite Drive End Bearing Brand	Skf	
35.	Opposite Drive End Bearing Number-	6205	
36.	Opposite Drive End Bearing Qty.	1	
37.	Opposite Drive End Bearing Type	(Ball) Ball Bearing	
38.	Opposite Drive End Lubrication Type	(Grease) Grease Lubricated	
39.	Opposite Drive End Bearing Insulation or Grounding Device?	no	
40.	Opposite Drive End Wavy Washer/Snap-Ring Other Retention Device?	wavy washer	P43

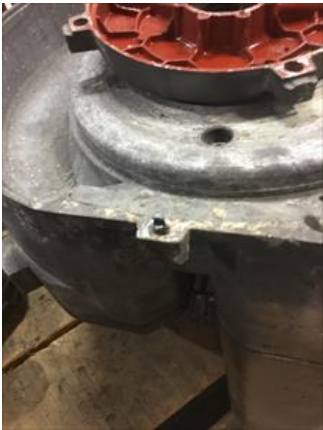
65. List Machine Work Needed Below  
*Bolts broke in housing*
