Hi-Speed Industrial Service
7030 Ryburn Dr
Millington, Tn 38053
901-873-5300

AC Inspection as Found

KTG USA
400 Mahannah
Memphis, TN 38107

Location: Default
Serial Number: C12T0329NPU 5
Description: 200 HP AC

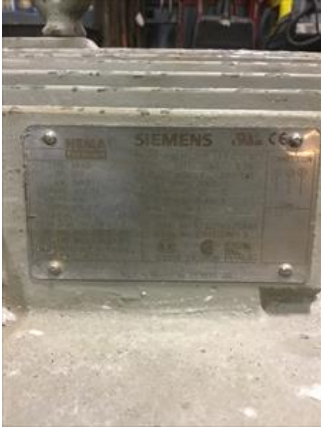
P2

2. Nameplate Picture

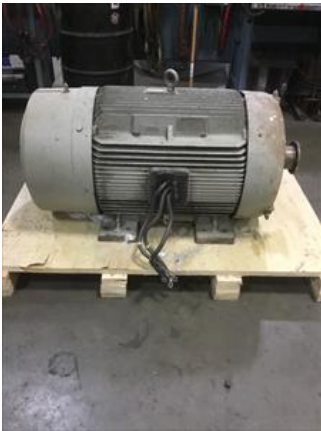
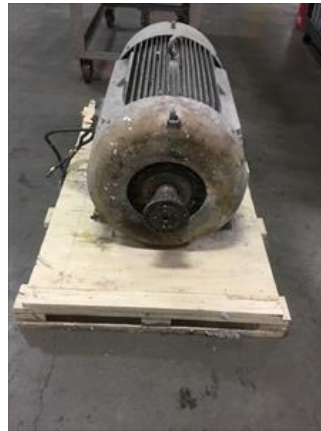
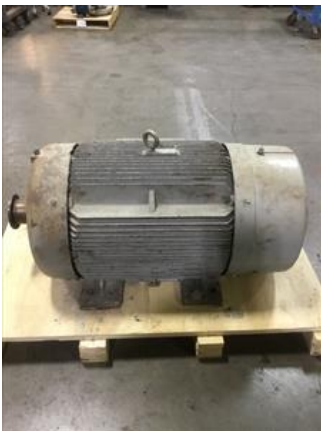
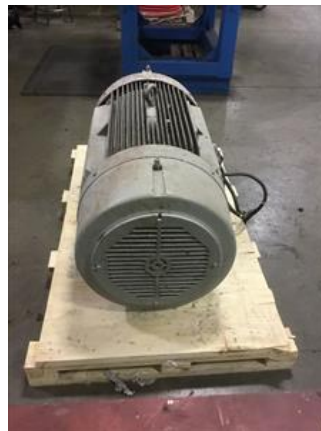
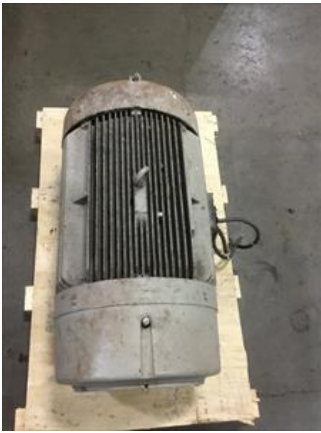
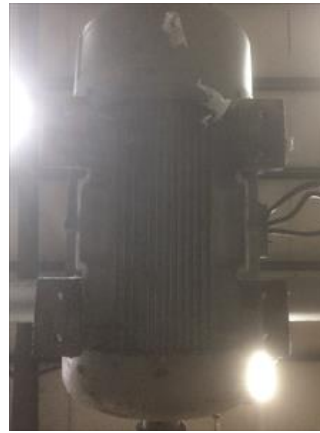
P3

3. Photos of all six sides of the machine.

4. Describe the Overall Condition of the Equipment as Received
Great condition, passed all electrical tests. Requires bore and bush both end bells to recondition.

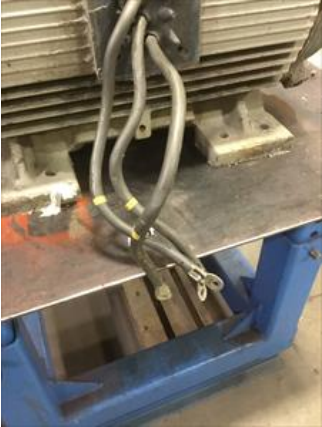
●	12. Lead Condition	(P) Pass	P12

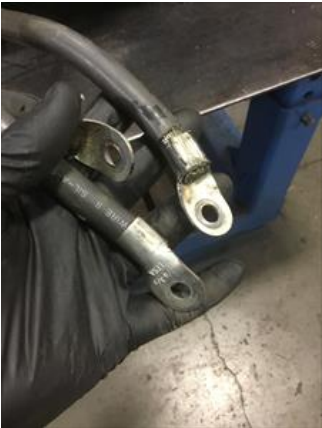
13. Lead Length	22 Inches	
●	14. Does it have Lugs?, If so what is the Stud Size?	(Yes) Yes	P14
<div data-bbox="131 646 245 667" data-label="Text"> 3/8" </div>

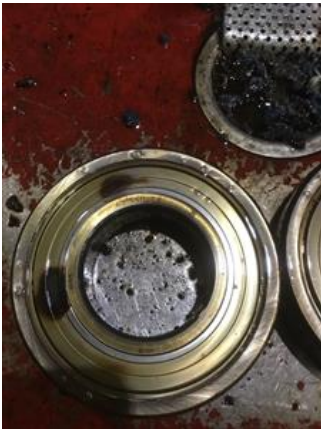
P26

26. Drive End Bearing Brand

ORD

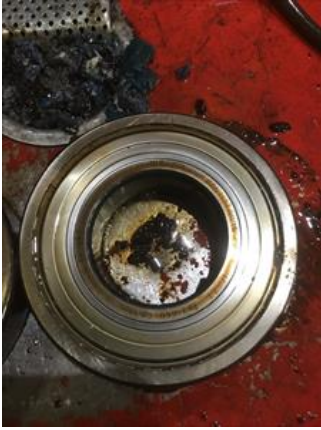
33. Drive End Bearing Condition

Normal wear

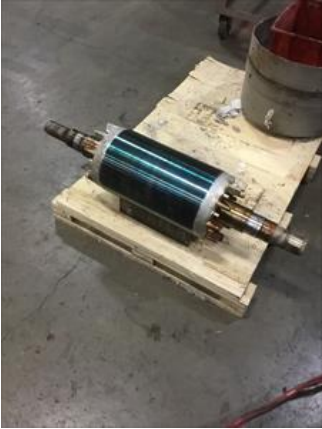
44. Rotor Type/Material	(Squirrel Aluminum) Squirrel Cage Aluminum Die Cast			
45. Growler Test	(Pass) Pass			
46. Number of Rotor Bars	27			
47. Rotor Condition	Pass			P47

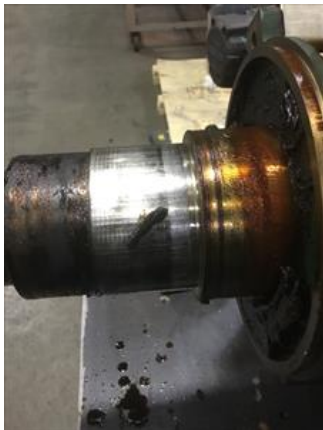
53.	Coupling Fit Closest to the end of the Shaft				
	0 Degrees	60 Degrees	120 Degrees		
	2.375	2.375	2.375		
54.	Drive End Bearing Shaft Fit			P54	
	0 Degrees	60 Degrees	120 Degrees		
	3.1502	3.1502	3.1502

Tolerance is 3.1497-3.1503

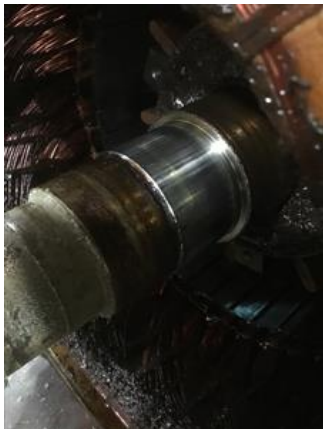
55.	Drive End Bearing Shaft Fit Condition		(P) Pass	
	56.	Opposite Drive End Bearing Shaft Fit			P56
		0 Degrees	60 Degrees	120 Degrees	
		3.1502	3.1502	3.1502

Tolerance is 3.1497-3.1503
