AC Inspection as Found

Big River Steel (004767)

AC Inspection - Rev. 2

Manufacturer: Rossi

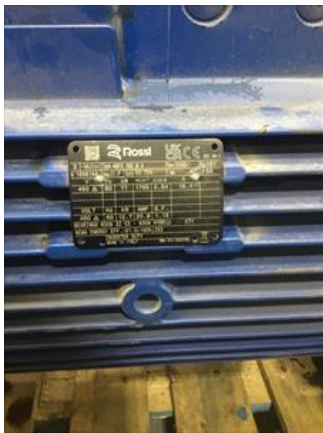
P2

2. Nameplate Picture

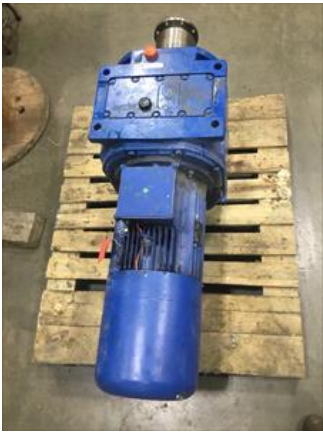
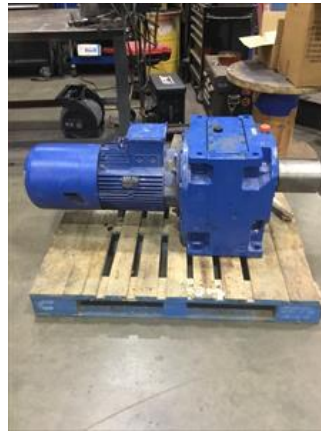
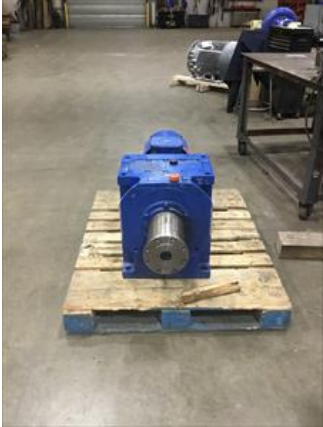
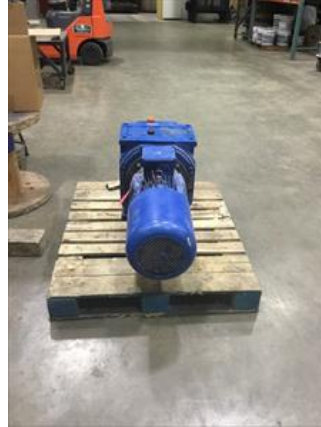
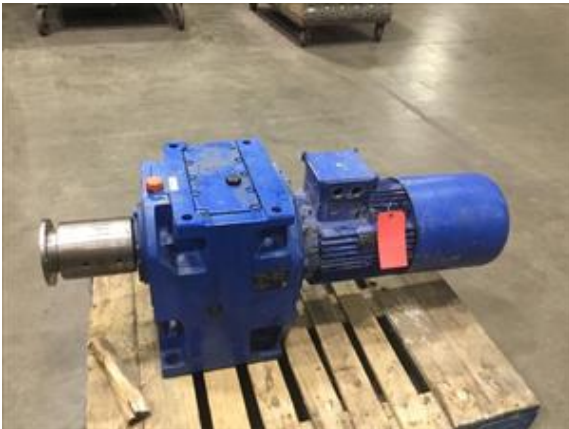
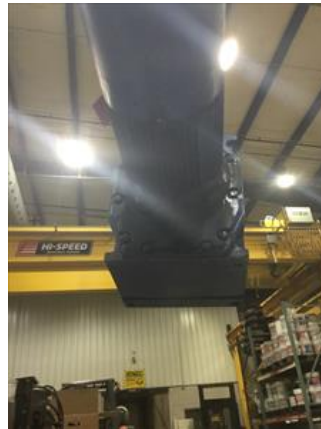
P3

4. Describe the Overall Condition of the Equipment as Received
- Gear box was about 3 gallons over full
Seal on input side of gearbox was blown out into the space between the motor and gear box causing oil to fill the motor
Fill cap replaced with bolt on gear box
Motor had about 1 gallon of oil inside*
- Motor is a rewind
No machine work
New seals and bearings*

2- 46-60-8 lip seals
2- 6309 2rs c3 bearings
1- 80-100-10 lip seal
1- 120-150-12 lip seal
All lip seals need to be viton

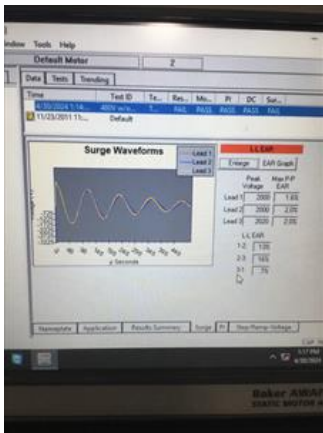
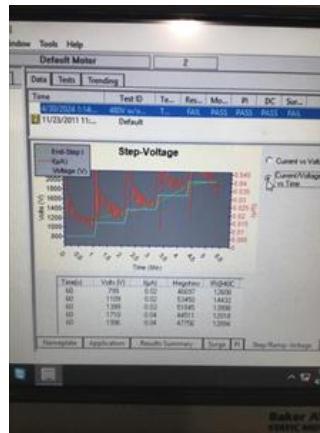
P22

22. Perform Surge Test

(F) Fail

Test Type	Step-Voltage
Volts (V)	1996
I(μA)	0.0418
Resist	47756
At 40°C	12894
Surge Status	L-L EAR No Test
Peak Volt(V) L1	2000
Peak Volt(V) L2	2000
Peak Volt(V) L3	2020
Max P-P EAR(...)	1.6/2.0/2.0
EAR 1-2/2-3/...	13/16/7
Nameplate	Application Results Sum

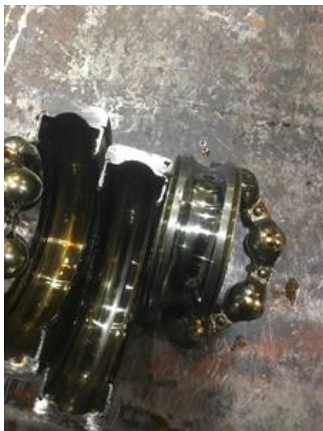
23.	Number of Stator Slots	36	
24.	Stator Condition	rewind	
25.	Stator Thermistors/Ohms		
26.	Stator Overloads/Ohms		
Mechanical Inspection			
27.	Drive End Bearing Brand	ntn	
28.	Drive End Bearing Number-	6309 2rs c3	
29.	Drive End Bearing Qty.	1	
30.	Drive End Bearing Type	(Ball) Ball Bearing	
31.	Drive End Lubrication Type	(Grease) Grease Lubricated	
32.	Drive End Bearing Insulation or Grounding Device?	none present	
33.	Drive End Wavy Washer/Snap-Ring Other Retention Device?	wavy washer	
34.	Drive End Bearing Condition	normal wear	P34
