AC Inspection as Found

ARKEMA, INC.
2571 Fite Road
Memphis, TN 38127

Description: 125 Hp Ac Motor

Hi-Speed Job Number:	152680
Manufacturer:	TECO Westinghouse
Product Number:	773B975G27
Serial Number:	8207
HP/kW:	125 (HP)
RPM:	1780 (RPM)
Frame:	444T
Voltage:	460
Current:	136 (Amps)
Phase:	Three
Hz:	60 (Hz)
Service Factor:	1.16
Enclosure:	TEFC
# of Leads:	3
J-box Included:	Half
Coupling/Sheave:	None
Date Received:	04/29/2024
Bearing RTDs:	No
Stator RTDs:	No
Repair Stage:	Teardown Inspection
Shaft Machined Fit Repairs Required:	No
Bearing Housing Machined Fit Repairs Required:	Yes
Heaters:	No
Winding Type :	Random Wound
Bearing Type:	Rolling Element

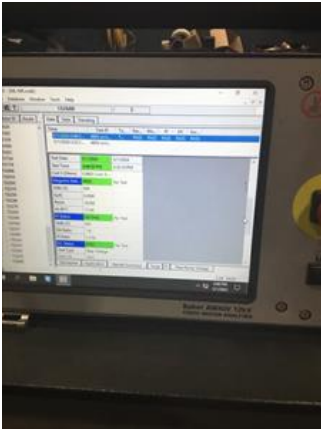
P19

19. Winding Resistance

1-2

1-3

2-3

.0407

.0408

.0404

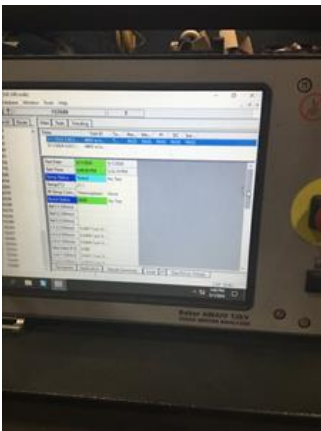
P22

22. Stator Condition

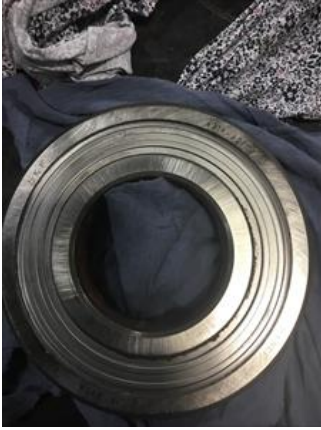
P32

27. Drive End Bearing Qty.	1
28. Drive End Bearing Type	(Ball) Ball Bearing
29. Drive End Lubrication Type	(Grease) Grease Lubricated
30. Drive End Bearing Insulation or Grounding Device?	none present
31. Drive End Wavy Washer/Snap-Ring Other Retention Device?	none
32. Drive End Bearing Condition

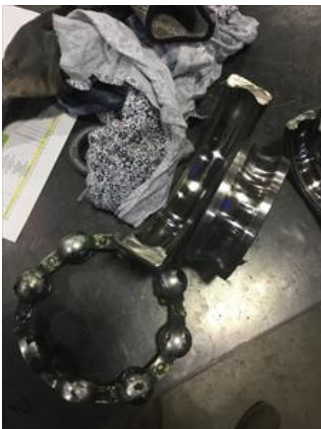
P34

33. Opposite Drive End Bearing Brand	SKF
34. Opposite Drive End Bearing Number-	6313 C3ZZ

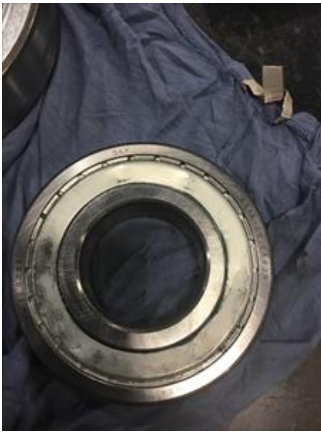
P40

35. Opposite Drive End Bearing Qty.	1
36. Opposite Drive End Bearing Type	(Ball) Ball Bearing
37. Opposite Drive End Lubrication Type	(Grease) Grease Lubricated
38. Opposite Drive End Bearing Insulation or Grounding Device?	none present
39. Opposite Drive End Wavy Washer/Snap-Ring Other Retention Device?	none present
40. Opposite Drive End Bearing Condition

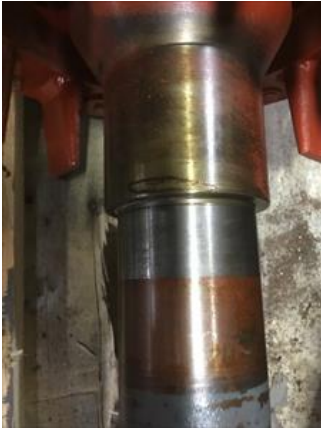
58. Drive End - Endbell Bearing Fit

0 Degrees	60 Degrees	120 Degrees
7.8771	7.8771	7.8774

Tolerance is 7.8740-7.8751

59. Drive End - Endbell Bearing Fit Condition (F) Fail

63. End Bell Air Seal Fits	
Drive End Air Seal	Opposite Drive End Air Seal
Pass	Pass
64. List Machine Work Needed Below	
<i>Bore and bush drive end.</i> <i>Drive end end bell is cracked and needs repaired</i>

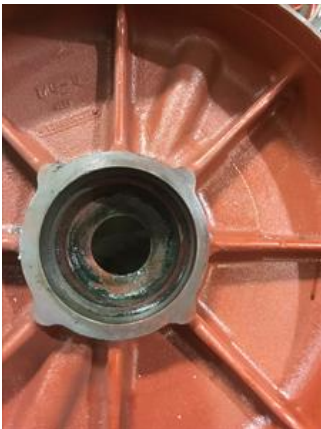
P60

60. Opposite Drive End - Endbell Bearing Fit

0 Degrees	60 Degrees	120 Degrees
5.5127	5.5127	5.5127

Tolerance is 5.5118-5.5128

61. Opposite Drive End - Endbell Bearing Fit Condition (P) Pass
