**AC Inspection as Found**  
**Arkansas Lime Company**  
600 Limedale Rd  
Batesville, AR 72501

**AC Inspection - Rev. 2**

**Location:** LITTLE ROCK MOTOR SHOP  
**Serial Number:** AF943097  
**Description:** 150 HP BALDOR 1780 RPM

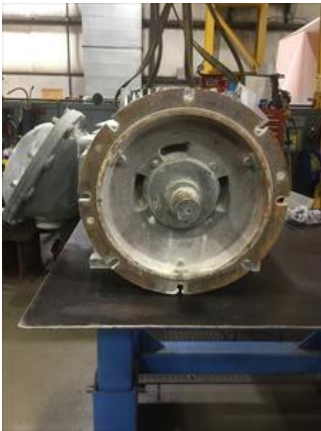
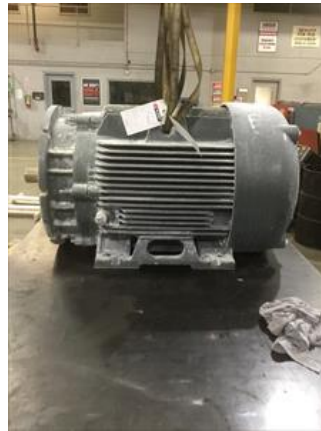
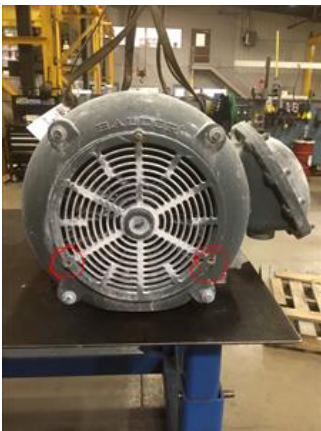
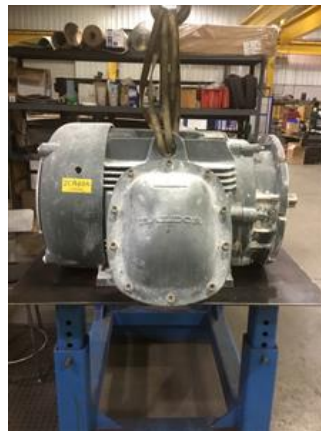
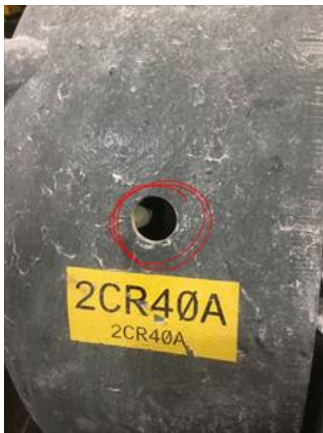
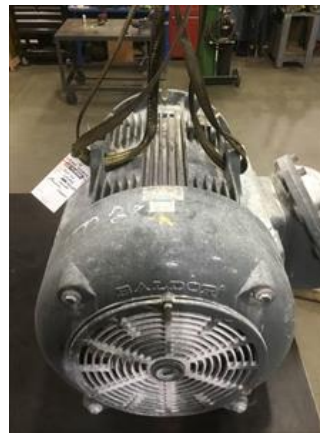
3. Photos of all six sides of the machine.

4. Describe the Overall Condition of the Equipment as Received  
*Stator windings are blown and requires rewind. Opposite drive end needs bushing installed.*

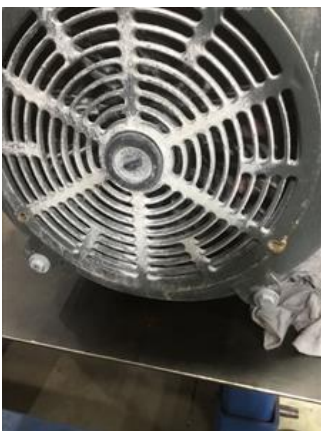
*Fan shroud bolts.*

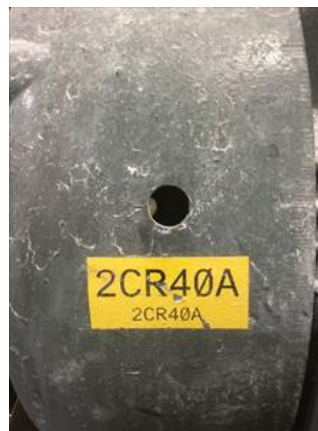
*ODE grease fitting not lined up.*

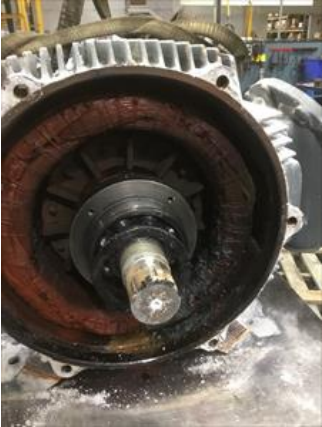
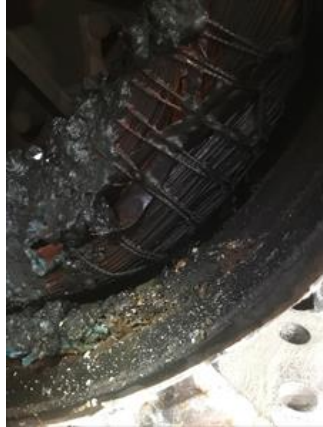
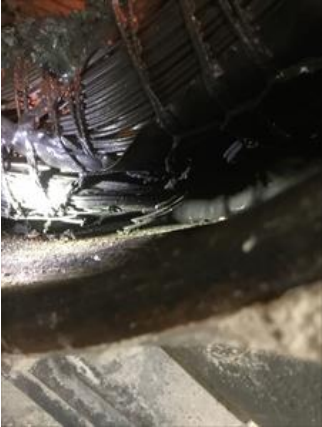
**0 Megohms**

19.	Winding Resistance		
	1-2	1-3	2-3
	0	0	0
20.	Perform Surge Test	(F) Fail	
21.	Number of Stator Slots	60	
22.	Stator Condition	Requires rewind	P84
	<div>

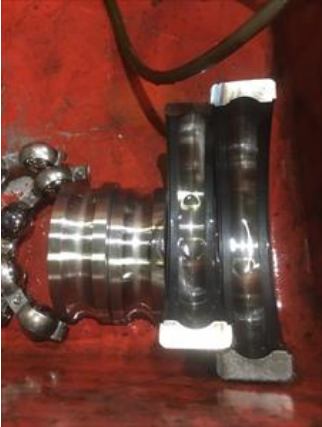
32. Drive End Bearing Condition	Normal wear	P82

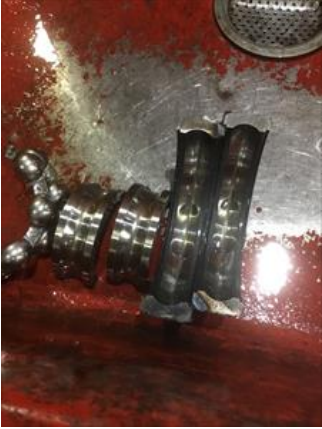
38.	Opposite Drive End Bearing Insulation or Grounding Device?	None	
39.	Opposite Drive End Wavy Washer/Snap-Ring Other Retention Device?	Wavy Washer	
40.	Opposite Drive End Bearing Condition	Normal wear	P118

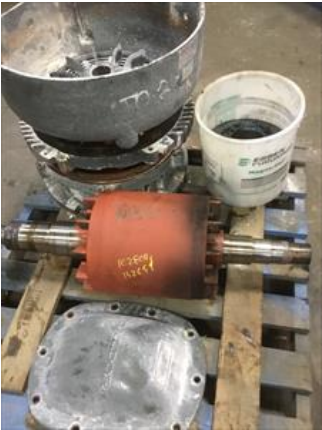
43.	Rotor Type/Material	(Squirrel Aluminum) Squirrel Cage Aluminum Die Cast	
44.	Growler Test	(Pass) Pass	
45.	Number of Rotor Bars	46	
46.	Rotor Condition	Pass	P41

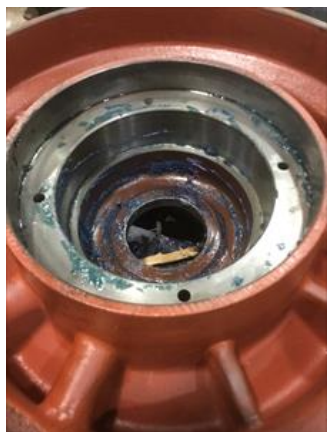
Tolerance is 7.8740-7.8751

59. Drive End - Endbell Bearing Fit Condition (P) Pass
