Hi-Speed Industrial Service
7030 Ryburn Dr
Millington, Tn 38053
901-873-5300

AC Inspection as Found
MISSISSIPPI SILICON, LLC
P.O. BOX 316
BURNSVILLE, MS 38833

AC Inspection - Rev. 2

Hi-Speed Job Number:	152629
Manufacturer:	SEW Eurodrive
Product Number:	R67 R36 DRS71S4/TF
Serial Number:	01.7188018701.0006.15
HP/kW:	.37 (kW)
RPM:	1700 (RPM)
Voltage:	460
Current:	1.83/1.06 (Amps)
Phase:	Three
Hz:	60 (Hz)
Service Factor:	1
Enclosure:	TEFC
# of Leads:	6
J-box Included:	Complete
Coupling/Sheave:	None
Date Received:	04/19/2024
Bearing RTDs:	No
Stator RTDs:	Yes
Repair Stage:	Teardown Inspection
Heaters:	No
Winding Type :	Random Wound
Bearing Type:	Rolling Element

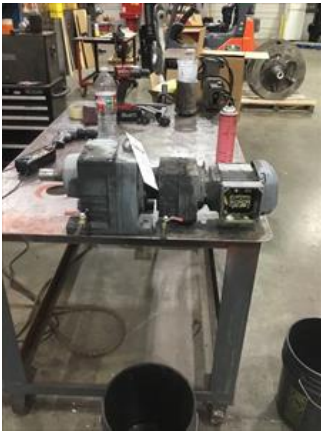
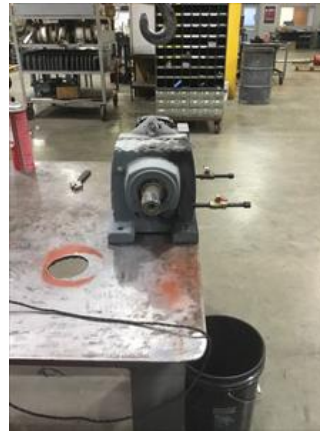
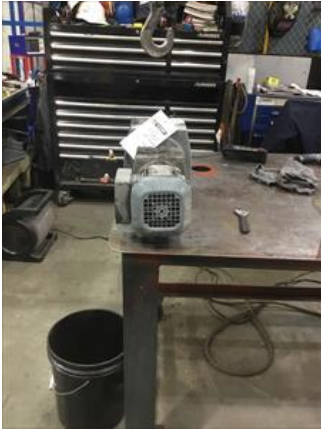
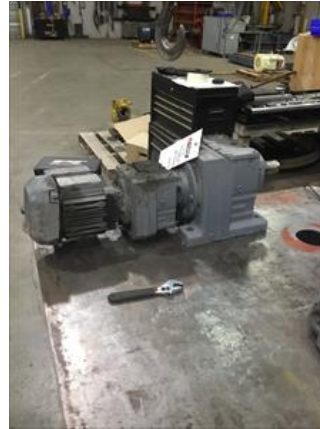
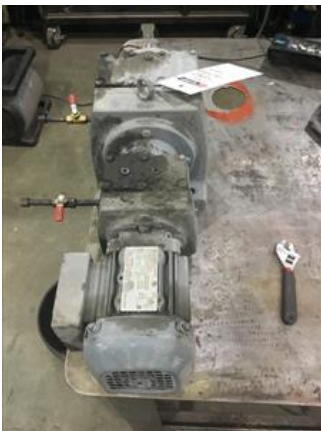
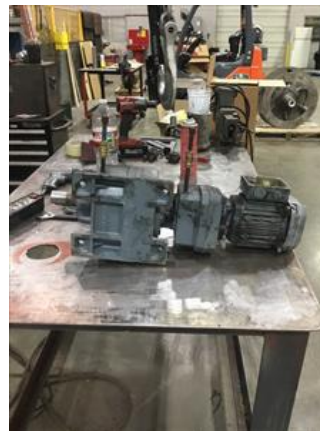
| ● 3. Photos of all six sides of the machine. | P3 |

Rewind needs new fan no machine work

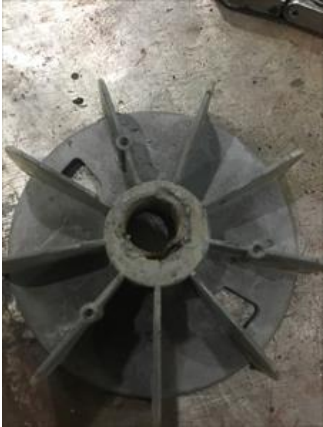
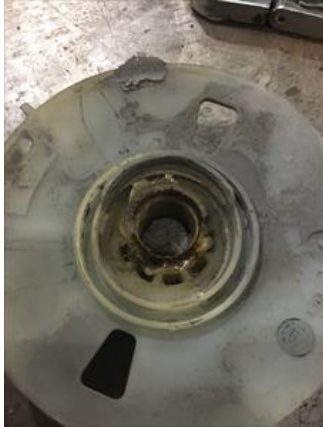
11.	Lead Condition	(P) Pass	
12.	Lead Length	6 Inches	
13.	Does it have Lugs?, If so what is the Stud Size?	(Yes) Yes	
14.	Lead Numbers	no numbers	
15.	Stator Temperature Detector Rating and Function		
	Quantity	Rating	Quantity Passed
16.	Frame Condition	good	
17.	Fan Condition	(F) Fail	P17
<div style="display: flex; justify-content: space-around;">

</div>			
18.	Broken or Missing Components	yes	
	<i>Fan melted</i>		
Initial Electrical Inspection

1- 16-28-7 lipseal
1- 17-30-7 lipseal
1- Fan
1- 6203 zz
1- 6303 zz | |

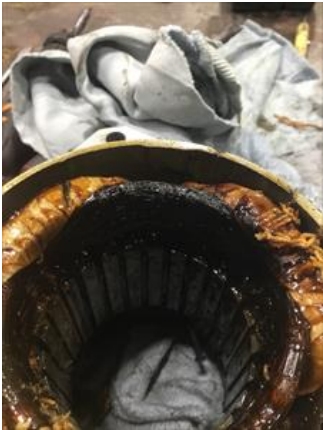
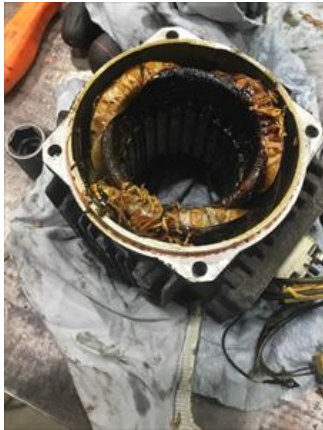
19.	Insulation Resistance/Megger	0 Megohms	P19
<div style="display: flex; justify-content: space-around;">

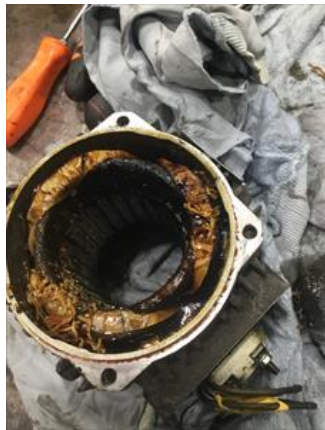
</div>			
20.	Winding Resistance		
	1-2	1-3	2-3
	0	0	0
	<i>Burnt</i>

22. Number of Stator Slots	24
23. Stator Condition	rewind
24. Stator Thermistors/Ohms	N/A
25. Stator Overloads/Ohms	N/A

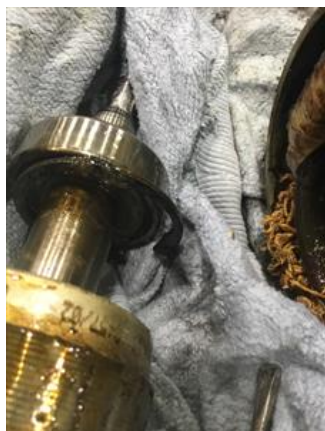
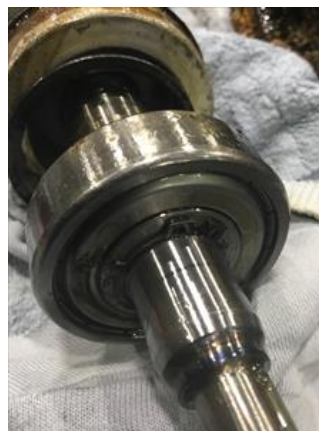
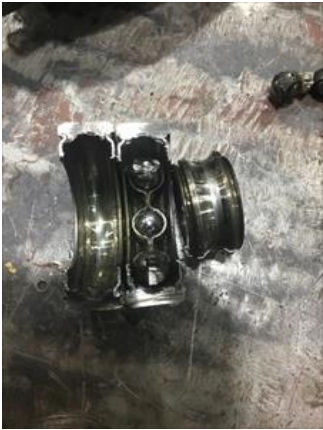
26. Drive End Bearing Brand	nsk
27. Drive End Bearing Number-	6303 zz c3
28. Drive End Bearing Qty.	1
29. Drive End Bearing Type	(Ball) Ball Bearing
30. Drive End Lubrication Type	(Grease) Grease Lubricated
31. Drive End Bearing Insulation or Grounding Device?	none present
32. Drive End Wavy Washer/Snap-Ring Other Retention Device?	snap ring

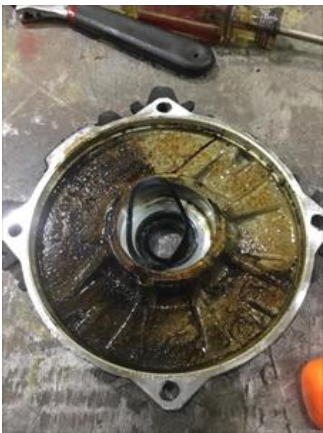
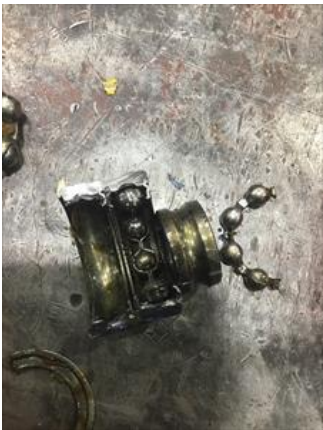
34. Opposite Drive End Bearing Brand	skf	
35. Opposite Drive End Bearing Number-	6203	
36. Opposite Drive End Bearing Qty.	1	
37. Opposite Drive End Bearing Type	(Ball) Ball Bearing	
38. Opposite Drive End Lubrication Type	(Grease) Grease Lubricated	
39. Opposite Drive End Bearing Insulation or Grounding Device?	none present	
40. Opposite Drive End Wavy Washer/Snap-Ring Other Retention Device?	wavy washer	P40

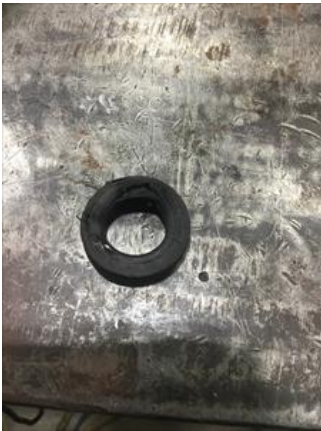
43. Opposite Drive End Seal lip seal P43
16-28-7
