AC Inspection as Found
Almatis Inc/RCP Bauxite (10014)
4701 Alcoa Road
Bauxite, AR 72011

AC Inspection - Rev. 2

Location: LR Motor Shop
Serial Number: P1022397037 KD
Description: 75HP LOUIS ALLIS

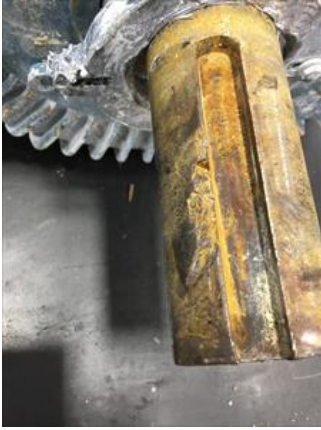
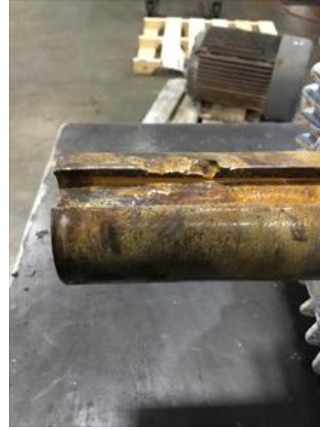
P26

7. Does Shaft Have Visible Damage?

(Yes) Yes

*Bore and bush both end bells.**Weld turn and cut new key in drive end of shaft.*

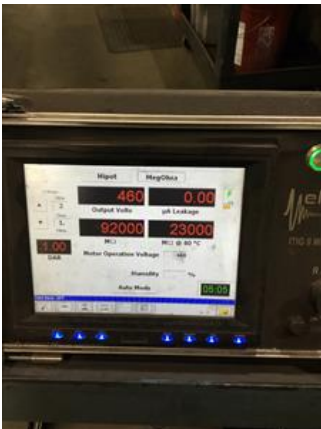
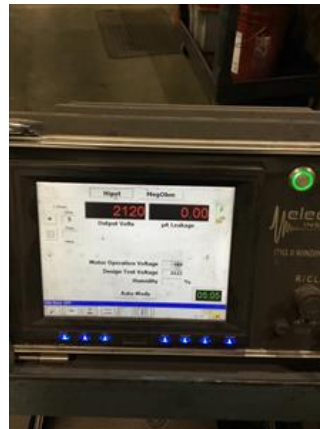
P8

18. Insulation Resistance/Megger 92000 Megohms

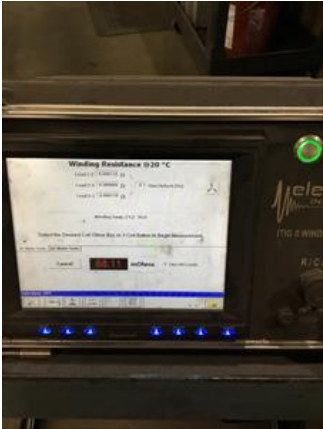
19. Winding Resistance		P20
1-2	1-3	2-3
.06811	.06811	.06806

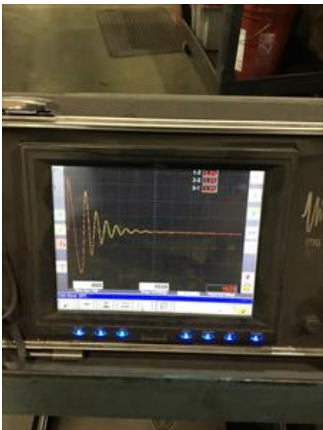
20. Perform Surge Test	(P) Pass	P57

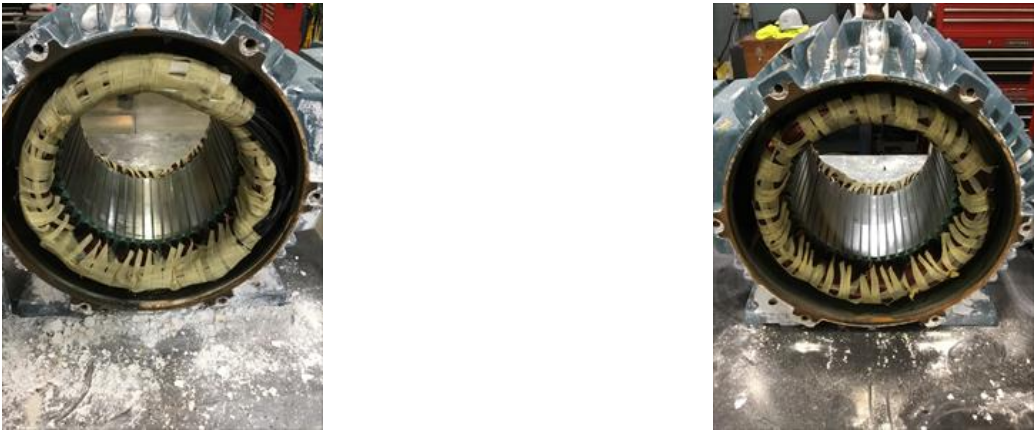
21. Number of Stator Slots	48	
22. Stator Condition		P84

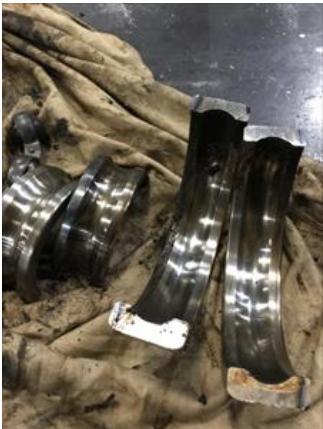
36. Opposite Drive End Bearing Type	(Ball) Ball Bearing	
37. Opposite Drive End Lubrication Type	(Grease) Grease Lubricated	
38. Opposite Drive End Bearing Insulation or Grounding Device?	None	
39. Opposite Drive End Wavy Washer/Snap-Ring Other Retention Device?	Wavy Washer	
40. Opposite Drive End Bearing Condition	Normal wear	P118

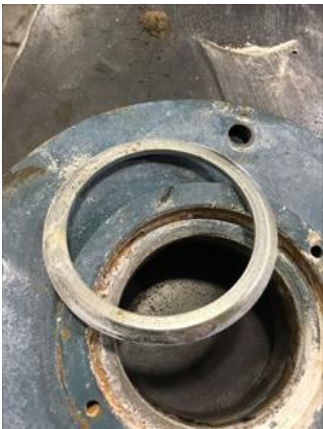
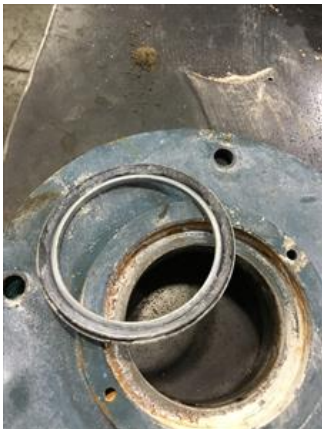
41. Drive End Seal		P120
--------------------	--	------

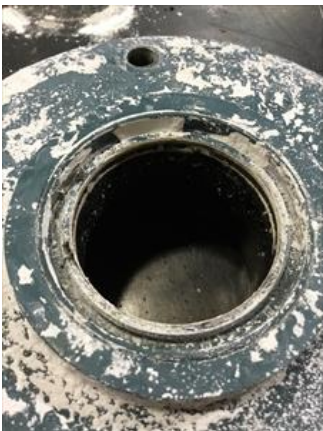
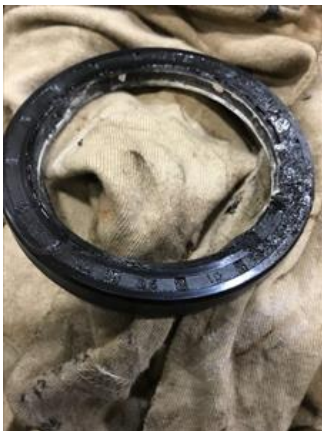
42. Opposite Drive End Seal	65 85 10	P123
-----------------------------	----------	------

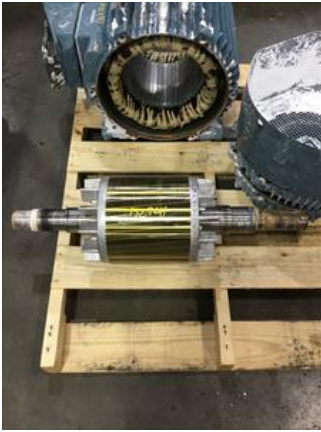
P41

46. Rotor Condition

Pass

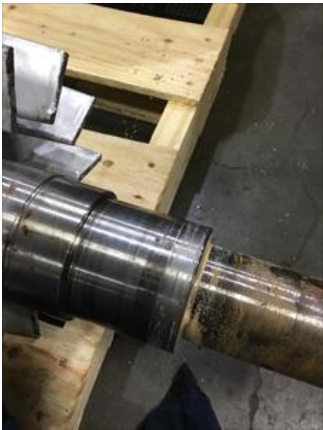
53. Drive End Bearing Shaft Fit

0 Degrees	60 Degrees	120 Degrees
3.1502	3.1502	3.1502

Tolerance is 3.1497-3.1502

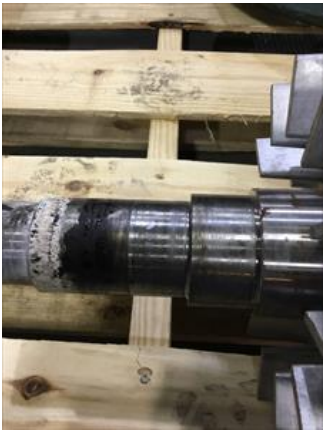
P89

0 Degrees	60 Degrees	120 Degrees
2.5598	2.5597	2.5597

Tolerance is 2.5592-2.5597

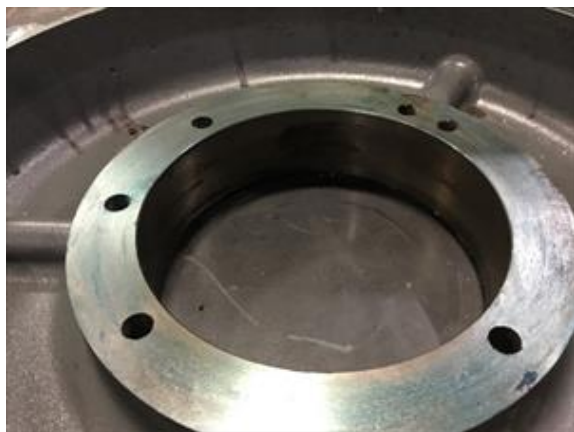
58. Drive End - Endbell Bearing Fit

☐ *Tolerance is 6.6929-6.6939. Out of tolerance and requires bore and bushing.*

● 59. Drive End - Endbell Bearing Fit Condition

(F) Fail

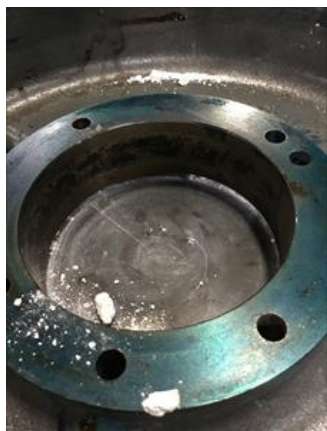
P30

5.5141

5.514

5.5139

☐ *Tolerance is 5.5118-5.5128. Out of tolerance and requires bore and bushing.*
