## AC Inspection as Found

### AC Inspection - Rev. 2

Location: Millington Motorshop

Hi-Speed Job Number:	152685
Manufacturer:	Baldor
HP/kW:	100 (HP)
RPM:	1785 (RPM)
Frame:	405T
Voltage:	230 / 460
Current:	224/112 (Amps)
Phase:	Three
Hz:	60 (Hz)
Service Factor:	1.15
Enclosure:	TEFC
# of Leads:	9
J-box Included:	Complete
Coupling/Sheave:	None
Date Received:	04/24/2024
Bearing RTDs:	No
Stator RTDs:	No
Repair Stage:	Teardown Inspection
Heaters:	No
Winding Type :	Random Wound
Bearing Type:	Rolling Element

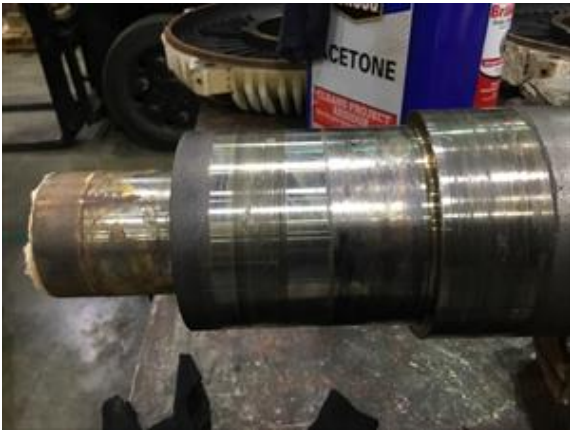
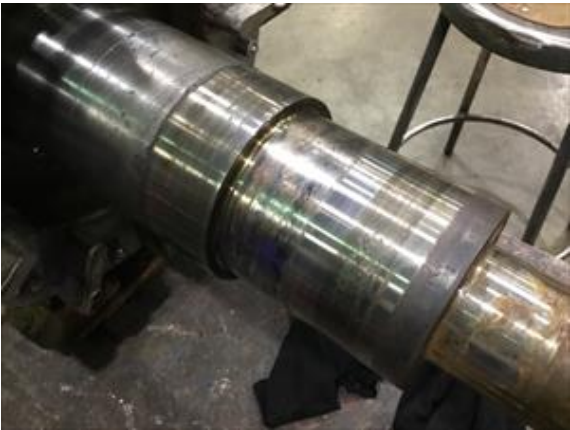
55. Opposite Drive End Bearing Shaft Fit

0 Degrees	60 Degrees	120 Degrees
3.1495	3.1495	3.1493

80mm = 3.1496 Pressfit tolerance is from 3.1497 to 3.1502

(F) Fail

I would recommend loctiting this bearing to

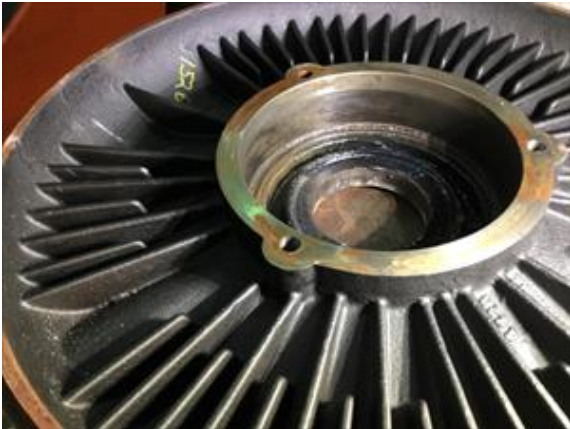
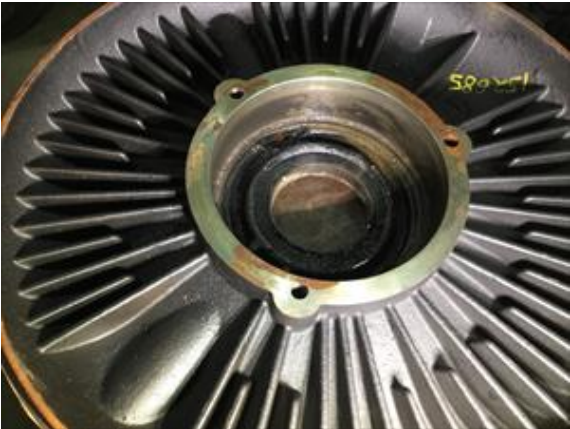
58. Drive End - Endbell Bearing Fit

0 Degrees	60 Degrees	120 Degrees
6.6948	6.6948	6.6948

170mm = 6.6929 Tolerance is from 6.6929 to 6.6939

(F) Fail

This endbell needs to be bored and bushed

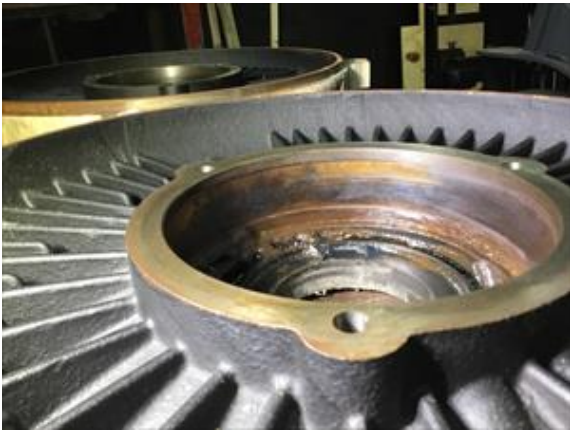
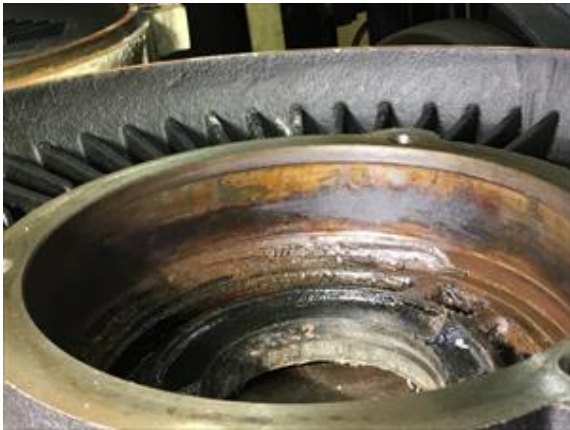
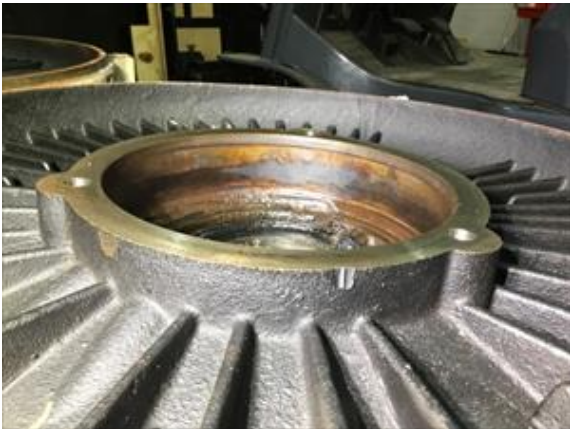
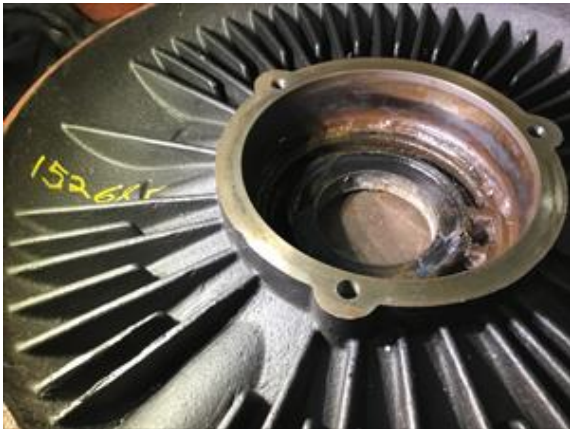
60. Opposite Drive End - Endbell Bearing Fit

0 Degrees	60 Degrees	120 Degrees
6.701	6.705	6.698

170mm = 6.6929 Tol. Is 6.6929 to 6.6939

(F) Fail

This bearing has been spinning in the endbell for a while  
This endbell has to be bored and bushed

Both endbells need to be bored and bushed
