## **AC Inspection as Found**

AC Inspection - Rev. 2

Description: 3HP W/Pump

in-opeca oob italliber.	102140
Manufacturer:	Baldor
Product Number:	VEM3561
Spec/ID #:	36J035S266G3
Serial Number:	F2002111485
HP/kW:	3 (HP)
RPM:	1760 (RPM)
Frame:	56C
Voltage:	230 / 460
Current:	8.4/4.2 (Amps)
Phase:	Three
Hz:	60 (Hz)
Service Factor:	1.15
Enclosure:	TEFC
# of Leads:	9
J-box Included:	Complete
Coupling/Sheave:	Propeller
Date Received:	05/06/2024
Bearing RTDs:	No
Stator RTDs:	No
Repair Stage:	Teardown Inspection
Rewind:	No

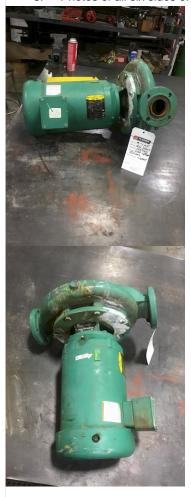
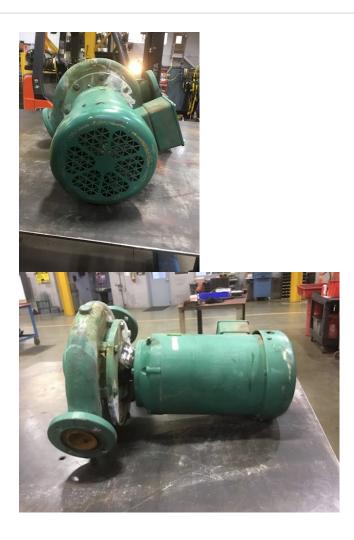
3. Photos of all six sides of the machine.

Motor and pump in great condition. Passed all tests. Needs new Mechanical seal and bearings to recondition.
