AC Inspection as Found
Almatis Inc/RCP Bauxite (10014)
4701 Alcoa Road
Bauxite, AR 72011

AC Inspection - Rev. 2

Location: LR Motor Shop
Serial Number:
Description: 60HP EMERSON EVAL

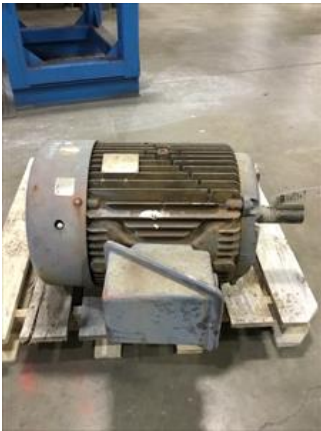
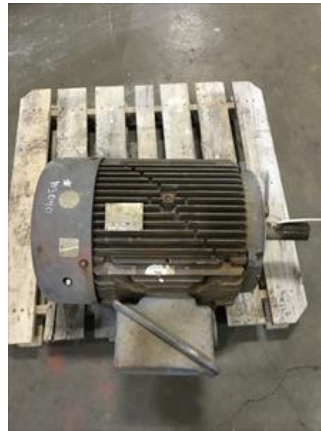
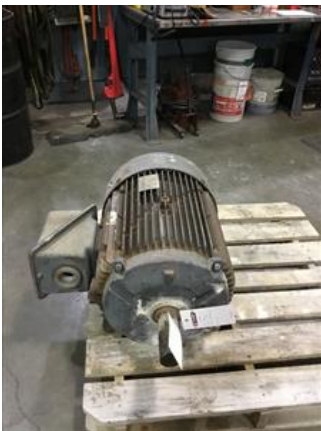
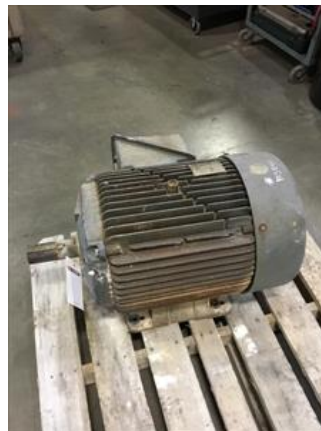
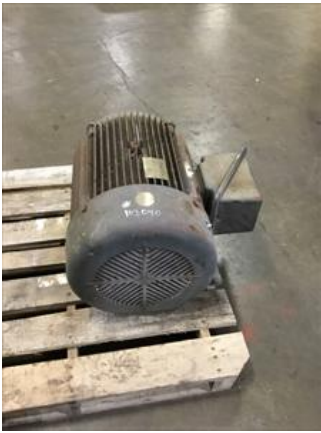
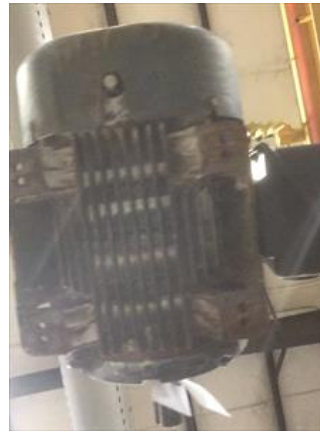
3. Photos of all six sides of the machine.

Good condition. Passed all electrical tests. Requires new bearings and fan to recondition. Bearing cap bolts from opposite drive end were missing. Bearing cap spun on shaft but didn't cause any damage to shaft. Fins on rotor were ground down but not an issue.

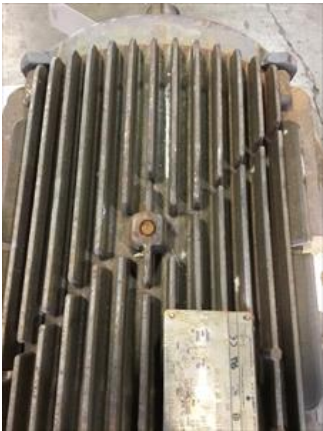
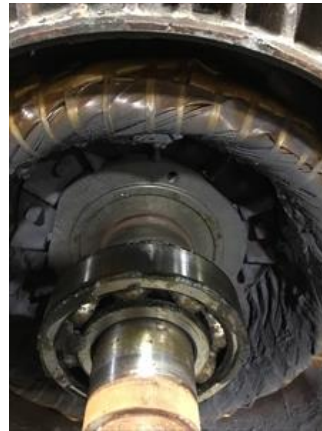
17. Broken or Missing Components

Lifting eye

Drilled and tapped.

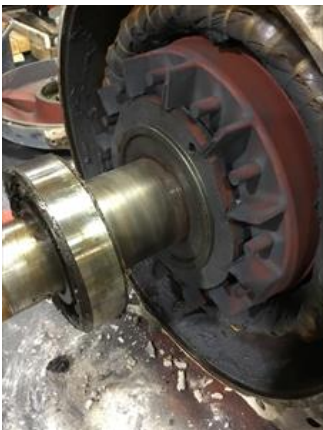
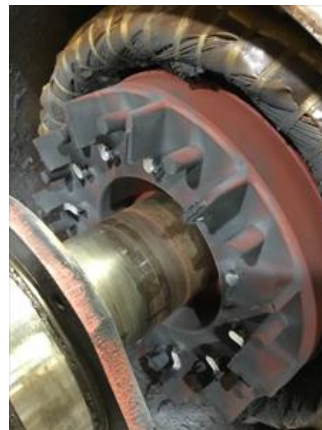
Bearing cap bolts missing on ODE.

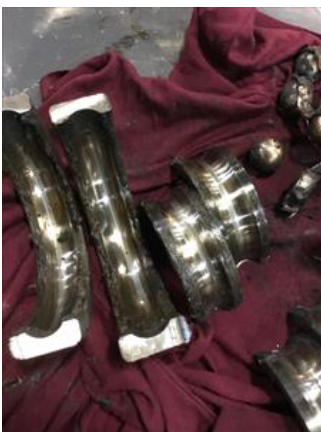
32. Drive End Bearing Condition

Normal wear

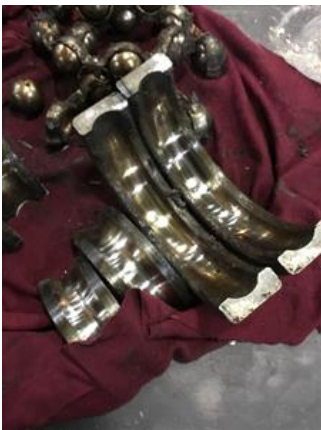
34. Opposite Drive End Bearing Number-	6313 C3
35. Opposite Drive End Bearing Qty.	1
36. Opposite Drive End Bearing Type	(Ball) Ball Bearing
37. Opposite Drive End Lubrication Type	(Grease) Grease Lubricated
38. Opposite Drive End Bearing Insulation or Grounding Device?	None
39. Opposite Drive End Wavy Washer/Snap-Ring Other Retention Device?	wavy washer
40. Opposite Drive End Bearing Condition	Normal wear

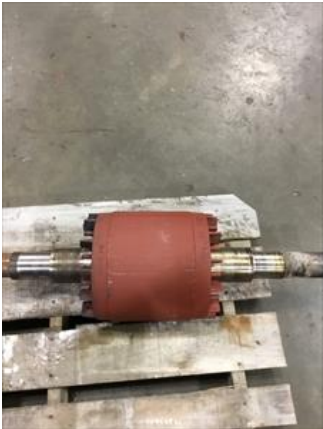
43. Rotor Type/Material	(Squirrel Aluminum) Squirrel Cage Aluminum Die Cast		
44. Growler Test	(Pass) Pass		
45. Number of Rotor Bars	56		
46. Rotor Condition			P41

47.	List the Parts needed for the Repair Below	
	6313 C3 x2 3/4 eye bolt Fan	
48.	Signature of Technician that Disassembled Motor	Brandon Woodard

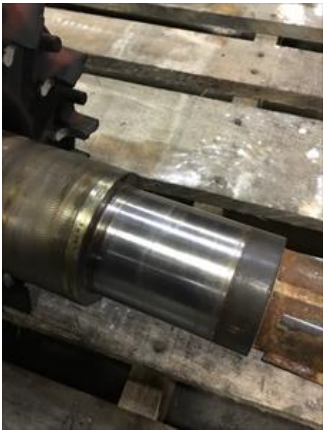
55. Opposite Drive End Bearing Shaft Fit

0 Degrees	60 Degrees	120 Degrees
2.5598	2.5598	2.5598

Tolerance is 2.5592-2.5597
