## AC Inspection as Found

Cerf Shelby LLC  
7103 OLD MILLINGTON ROAD  
MILLINGTON, TN 38053

### AC Inspection - Rev. 2

Description: 125 HP AC

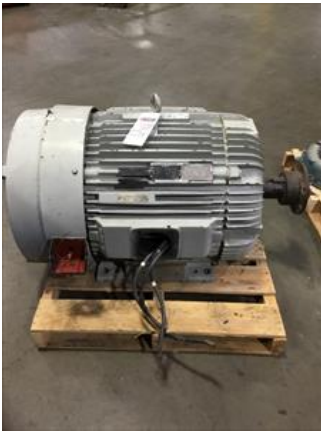
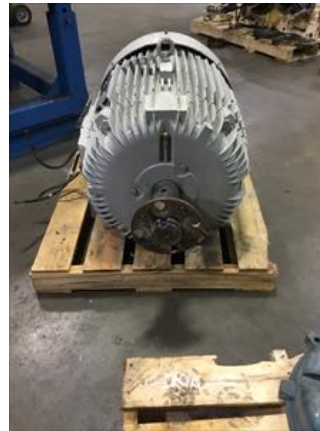
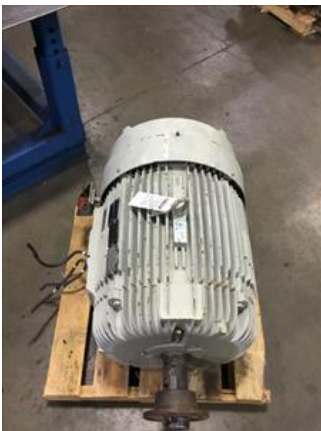
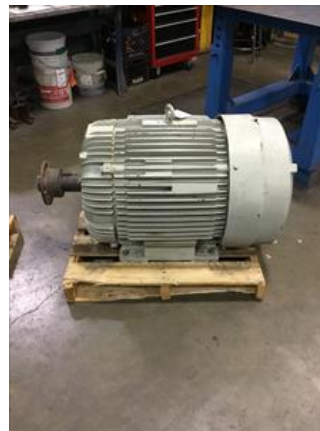
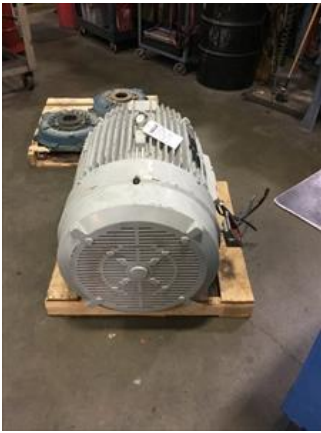
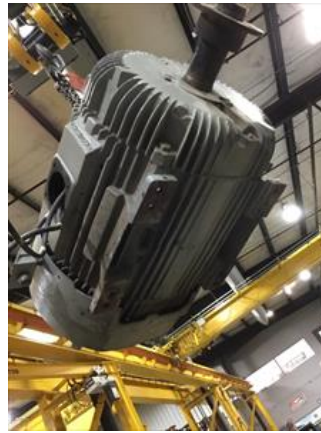
3. Photos of all six sides of the machine.

4. Describe the Overall Condition of the Equipment as Received  
*Stator will run but surge test failed. Recommend rewind. No Machine work needed.*

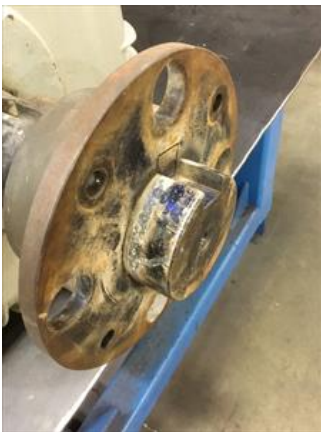
5. Distance from the end of the shaft to the Coupling/Sheave 1.275 inches P5

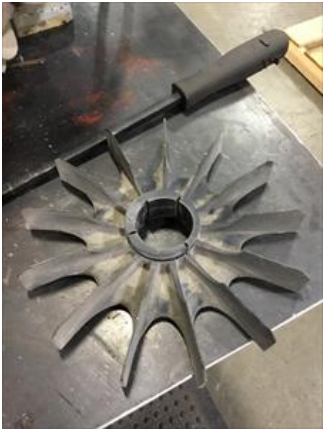
13. Lead Length	20 Inches	
14. Does it have Lugs?, If so what is the Stud Size?	(No) No	
15. Lead Numbers	1-3	
16. Frame Condition	Pass	
17. Fan Condition	(P) Pass	P17

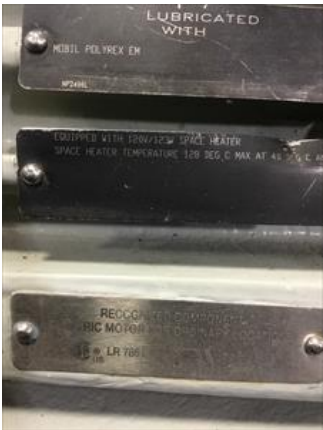
18. Heater Quantity, Ratings			P18
Quantity	Volts/Watts	Pass/Fail	
2

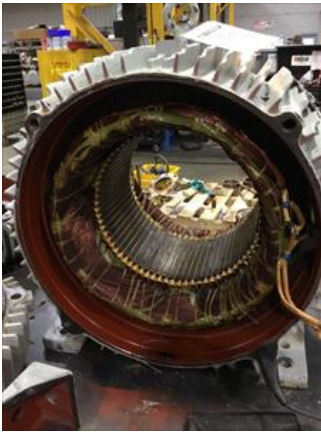
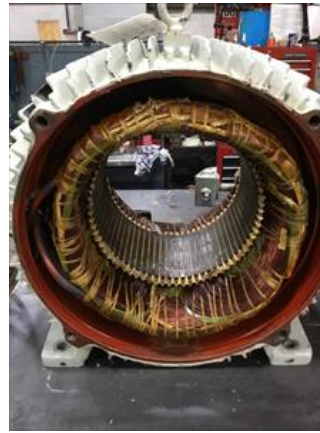
24. Stator Condition

*Stator will run but surge test failed. Recommend rewind.*

Recommend Rewind

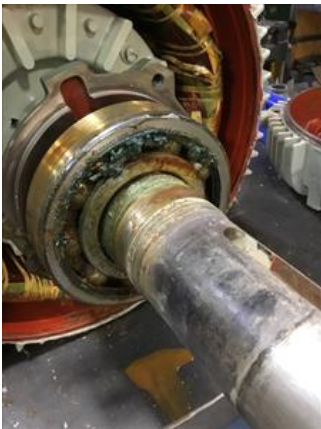
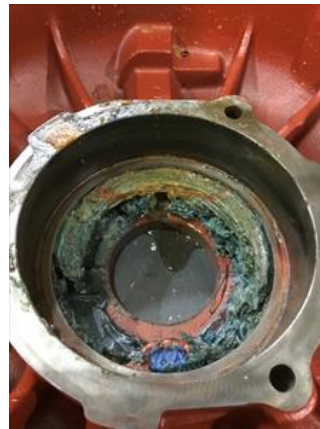
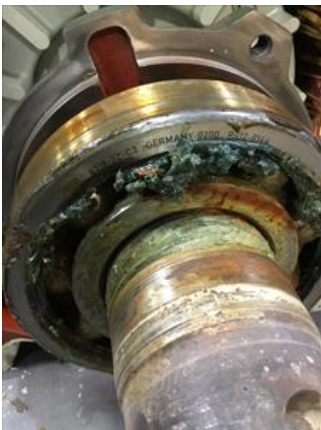
P27

33.	Drive End Wavy Washer/Snap-Ring Other Retention Device?	None	
34.	Drive End Bearing Condition	pitted	P34
	Moisture Present

*Drive end bearing*

*Water intrusion.*

| 49. List the Parts needed for the Repair Below<br>VA 90 x2<br>6318 ZZ C3 x2 | |

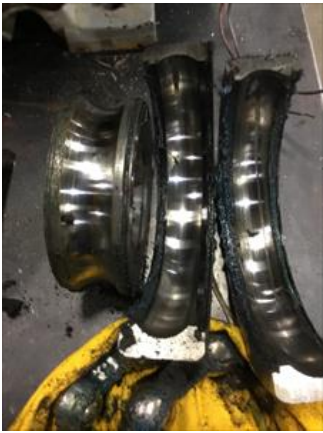
42.	Opposite Drive End Bearing Condition	Normal Wear	P42

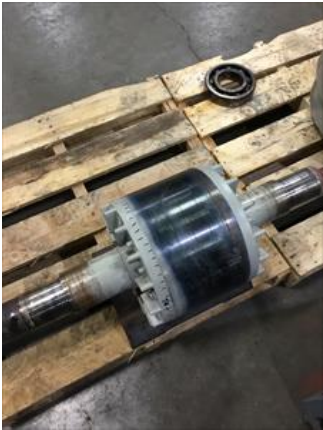
P47

| 46. Growler Test | (Pass) Pass |
| 47. Number of Rotor Bars | 58 |

| 48. Rotor Condition | Pass |

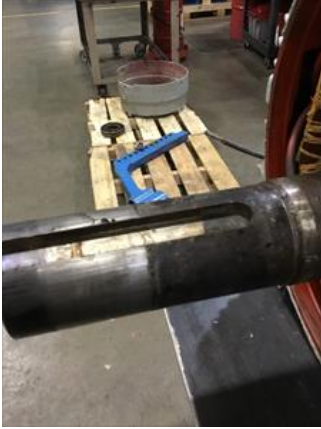
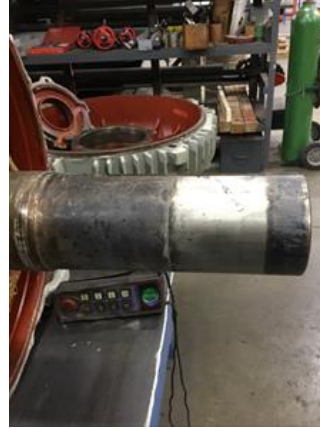
P53

## 53. Coupling Fit Closest to Bearing Housing

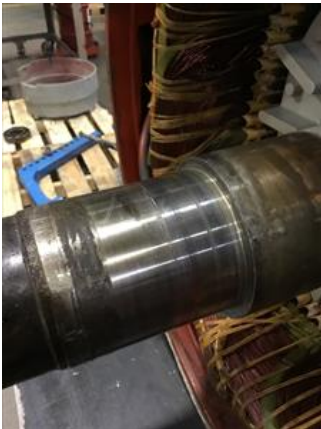
P55

## 55. Drive End Bearing Shaft Fit

*Tolerance is 3.5434-3.5440*

(P) Pass

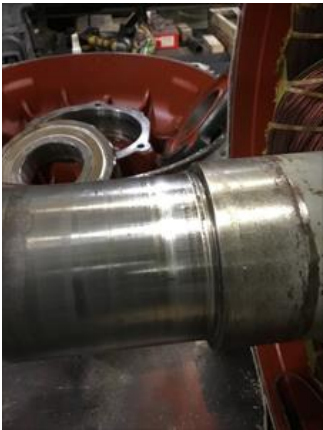
0 Degrees	60 Degrees	120 Degrees
3.5437	3.5437	3.5437

Tolerance is 3.5434-3.5440

58. Opposite Drive End Bearing Shaft Fit Condition (P) Pass

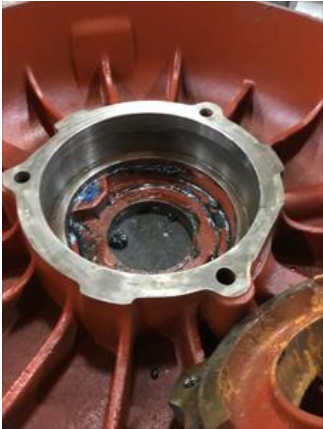
P60

0 Degrees	60 Degrees	120 Degrees
7.4814	7.4814	7.4814

Tolerance is 7.4803-7.4814

61. Drive End - Endbell Bearing Fit Condition (P) Pass

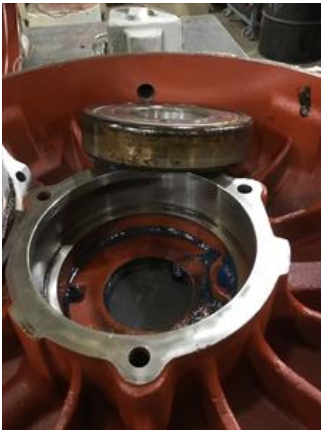
Tolerance is 7.4803-7.4814

63. Opposite Drive End - Endbell Bearing Fit Condition **(P) Pass**
