AC Inspection as Found

Process And Power

AC Inspection - Rev. 2

Hi-Speed Job Number:	15362
Manufacturer:	TECO Westinghouse
Serial Number:	RBE7164510003
HP/kW:	60 (HP)
RPM:	1775 (RPM)
Frame:	364TP
Voltage:	460
Current:	68 (Amps)
Phase:	Three
Hz:	60 (Hz)
Service Factor:	1.15
Enclosure:	TEFC
# of Leads:	12
J-box Included:	Complete
Coupling/Sheave:	None
Date Received:	09/05/2024
Bearing RTDs:	No
Stator RTDs:	No
Repair Stage:	Teardown Inspection
Rewind:	No
Shaft Machined Fit Repairs Required:	No
Bearing Housing Machined Fit Repairs Required:	No
Heaters:	No
Winding Type :	Random Wound
Bearing Type:	Rolling Element

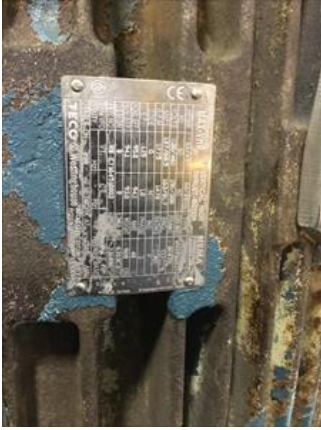
P2

2. Nameplate Picture

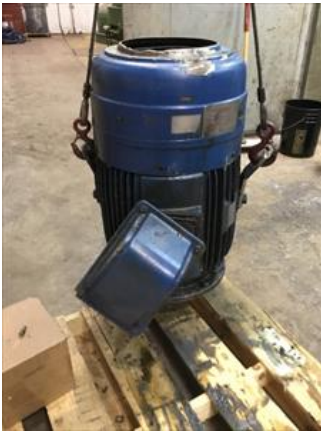
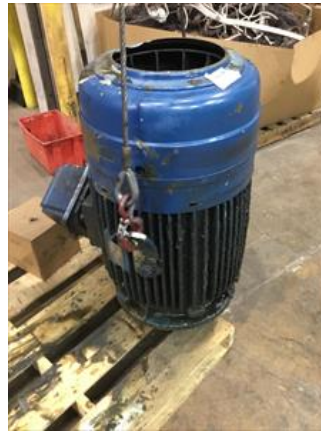
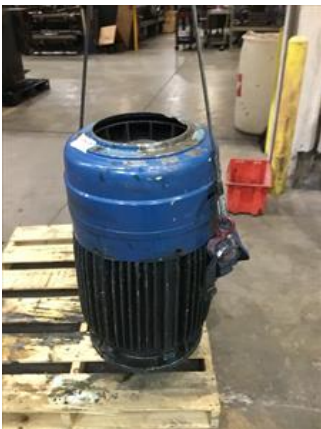
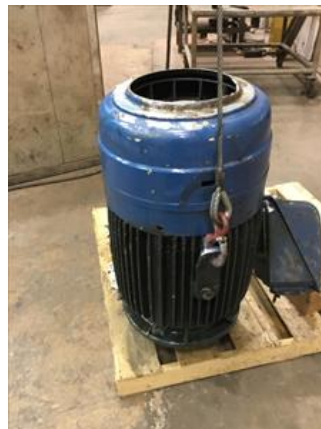
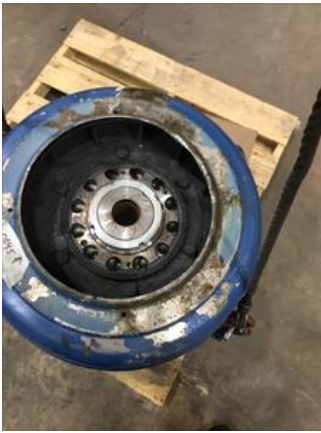
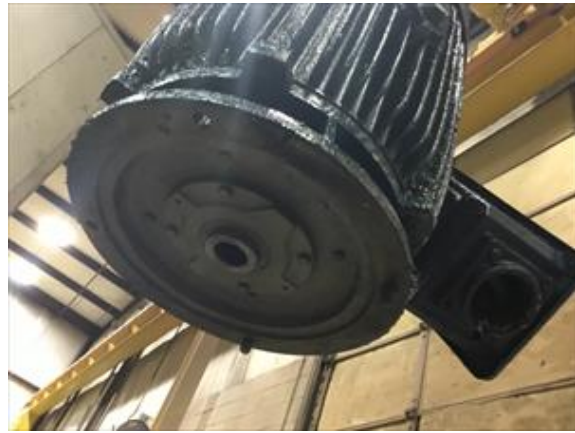
P3

3. Photos of all six sides of the machine.

Good

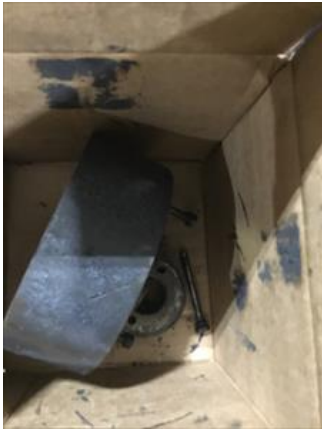
Contents of box that was shipped with motor.

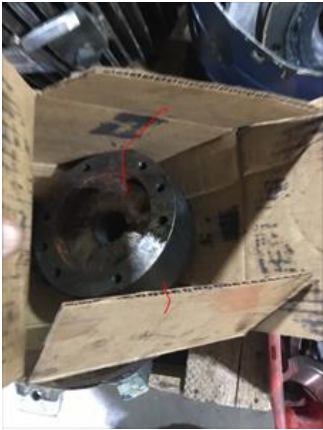
Different angle

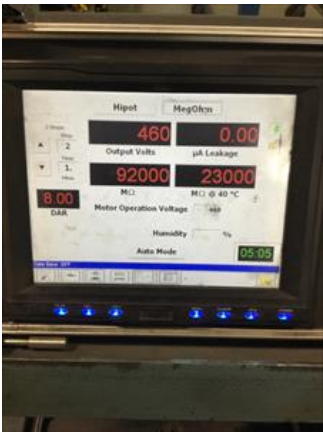
Megg

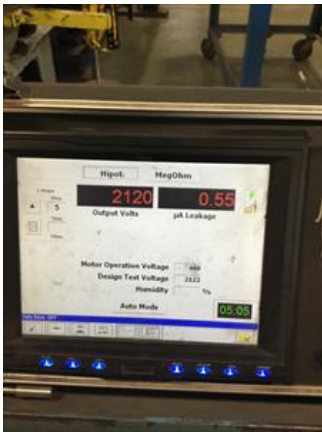
Hi pot

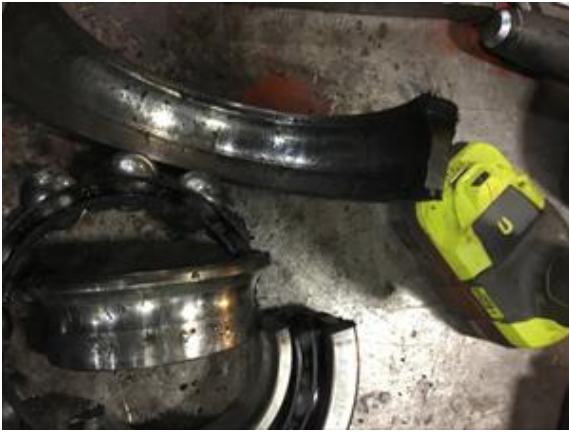
40.	Opposite Drive End Wavy Washer/Snap-Ring Other Retention Device?	none	
41.	Opposite Drive End Bearing Condition	good	P45

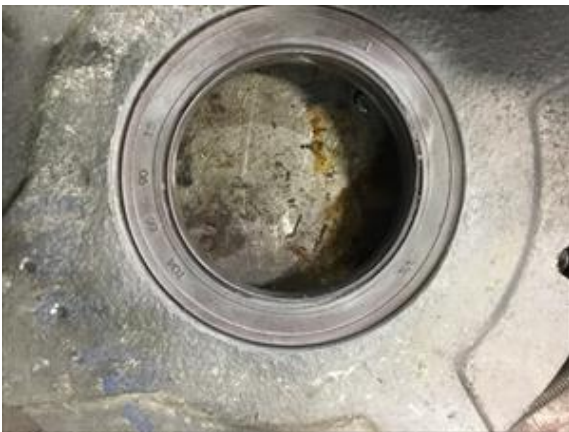
42.	Drive End Seal		P46
-----	----------------	--	-----
