AC Inspection as Found

ARKEMA, INC.
2571 Fite Road
Memphis, TN 38127

Serial Number: P36G0401B

Description: 60 HP Baldor Motor

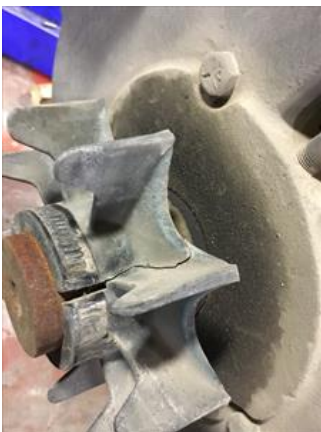
6.	Does Shaft Turn Freely?	(Y) Yes	
7.	Does the shaft require T.I.R in Lathe to identify additional repairs?	(No) No	
	<i>.001</i>		
8.	Does Shaft Have Visible Damage?	(No) No	
9.	Assembled Shaft Runout	0.001 Inches	
10.	Assembled Shaft End Play	0.003 inches	
11.	Air Gap Variation <10%		
12.	Lead Condition	(P) Pass	
13.	Lead Length	10 Inches	
14.	Does it have Lugs?, If so what is the Stud Size?	(No) No	
15.	Lead Numbers	9	
16.	Frame Condition	good	
17.	Fan Condition	(F) Fail	
	<i>Cracked</i> <i>I.D. 1.8802</i>		
18.	Broken or Missing Components	fan	P20

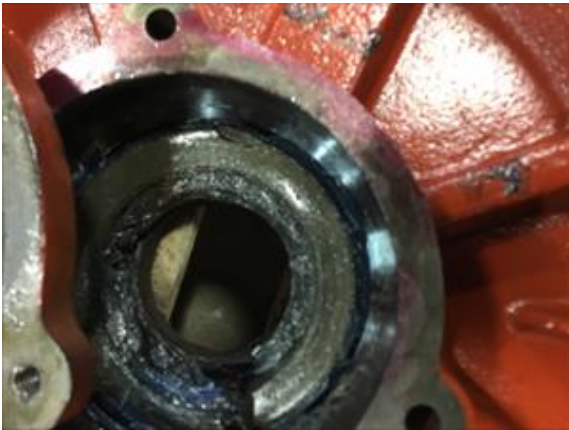
27.	Drive End Bearing Number-	6313	
28.	Drive End Bearing Qty.	1	
29.	Drive End Bearing Type	(Ball) Ball Bearing	
30.	Drive End Lubrication Type	(Grease) Grease Lubricated	
31.	Drive End Bearing Insulation or Grounding Device?	none	
32.	Drive End Wavy Washer/Snap-Ring Other Retention Device?	none	
33.	Drive End Bearing Condition	good	
34.	Opposite Drive End Bearing Brand	ntn	
35.	Opposite Drive End Bearing Number-	6313	
36.	Opposite Drive End Bearing Qty.	1	
37.	Opposite Drive End Bearing Type	(Ball) Ball Bearing	
38.	Opposite Drive End Lubrication Type	(Grease) Grease Lubricated	
39.	Opposite Drive End Bearing Insulation or Grounding Device?	none	
40.	Opposite Drive End Wavy Washer/Snap-Ring Other Retention Device?	wavy washer	P42

41.	Opposite Drive End Bearing Condition	good	
42.	Drive End Seal		
43.	Opposite Drive End Seal

48.	List the Parts needed for the Repair Below <i>2-6313 bearings</i>		
-----	--	--	--

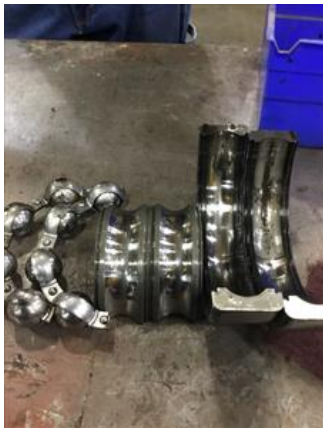
52.	Coupling Fit Closest to Bearing Housing		
	0 Degrees	90 Degrees	120 Degrees
	1.879	1.879	1.879
53.	Coupling Fit Closest to the end of the Shaft		
	0 Degrees	60 Degrees	120 Degrees
	1.874	1.874	1.874
54.	Drive End Bearing Shaft Fit		
	0 Degrees	60 Degrees	120 Degrees
	2.5595	2.5595	2.5595
	2.5603/2.5595		
55.	Drive End Bearing Shaft Fit Condition	(P) Pass	P57

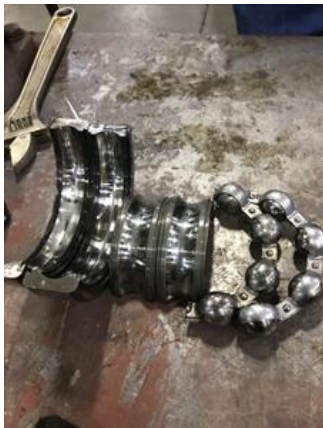
56.	Opposite Drive End Bearing Shaft Fit		
	0 Degrees	60 Degrees	120 Degrees
	2.5595	2.5595	2.5595
	2.5603/2.5595		
57.	Opposite Drive End Bearing Shaft Fit Condition	(P) Pass	P59
