## AC Inspection as Found

Big River Steel (004767)

### AC Inspection - Rev. 2

Manufacturer: Rossi

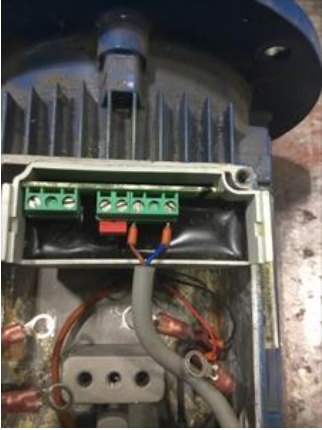
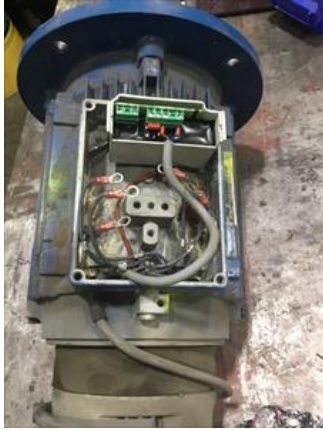
12.	Air Gap Variation <10%	no provision for measurement	
●	13. Lead Condition	(P) Pass	P13
<div>

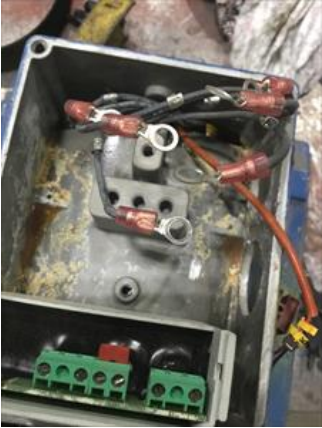
</div>			
	14. Lead Length	4 Inches	
●	15. Does it have Lugs?, If so what is the Stud Size?	(Yes) Yes	P15
<div>

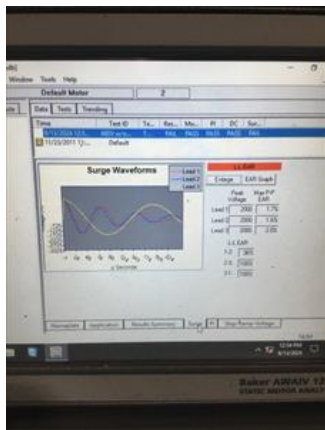
20. Insulation Resistance/Megger	4204 Megohms	
	21. Winding Resistance		
	1-2	1-3	2-3
	2.206	2.835	0.814

23.	Number of Stator Slots	36	
24.	Stator Condition	rewind	
25.	Stator Thermistors/Ohms	.590

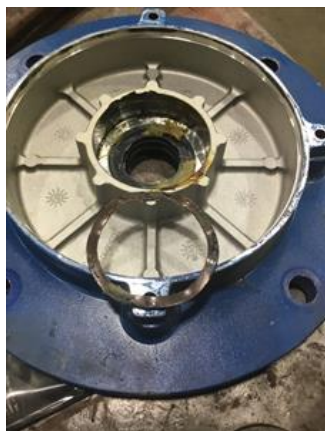
27.	Drive End Bearing Brand	nsk	
28.	Drive End Bearing Number-	6206 zz c3	
29.	Drive End Bearing Qty.	1	
30.	Drive End Bearing Type	(Ball) Ball Bearing	
31.	Drive End Lubrication Type	(Grease) Grease Lubricated	
32.	Drive End Bearing Insulation or Grounding Device?	none present	
33.	Drive End Wavy Washer/Snap-Ring Other Retention Device?	wavy washer	P33

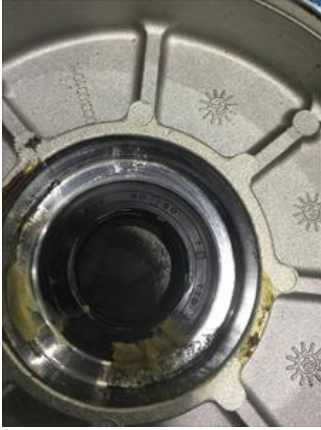
34.	Drive End Bearing Condition	
35.	Opposite Drive End Bearing Brand	<b>nsk</b>
36.	Opposite Drive End Bearing Number-	<b>6206 2rs</b>
37.	Opposite Drive End Bearing Qty.	<b>1</b>
38.	Opposite Drive End Bearing Type	<b>(Ball) Ball Bearing</b>
39.	Opposite Drive End Lubrication Type	<b>(Grease) Grease Lubricated</b>
40.	Opposite Drive End Bearing Insulation or Grounding Device?	<b>none present</b>
41.	Opposite Drive End Wavy Washer/Snap-Ring Other Retention Device?	<b>snap ring on shaft and in endbell</b>
42.	Opposite Drive End Bearing Condition
