## AC Inspection as Found

NUCOR Memphis (003974-1)

### AC Inspection - Rev. 2

Hi-Speed Job Number:	153776
Manufacturer:	Marathon
HP/kW:	40 (HP)
RPM:	1780 (RPM)
Frame:	324T
Voltage:	230 / 460
Current:	95/47.5 (Amps)
Phase:	Three
Hz:	60 (Hz)
Service Factor:	1.15
Enclosure:	TEFC
# of Leads:	9
J-box Included:	Complete
Coupling/Sheave:	Coupling
Date Received:	09/25/2024
Bearing RTDs:	No
Stator RTDs:	No
Repair Stage:	Teardown Inspection
Heaters:	No
Winding Type :	Random Wound
Bearing Type:	Rolling Element

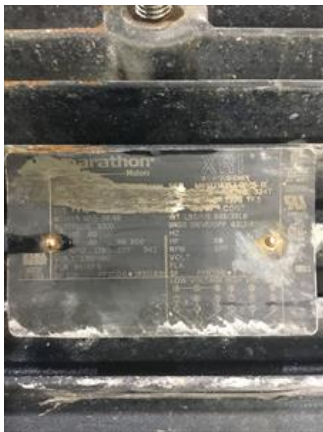
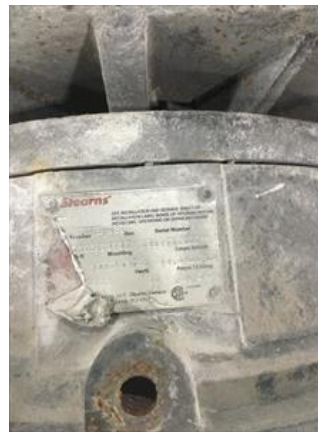
P2

2. Nameplate Picture

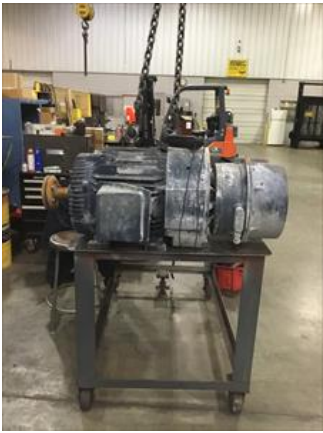
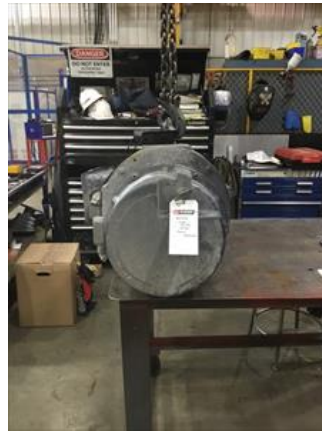
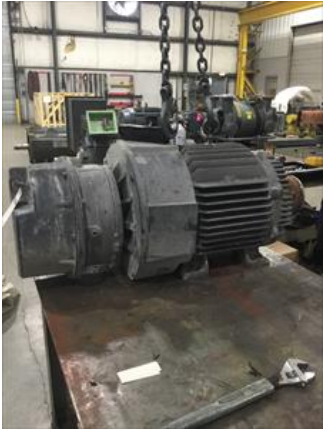
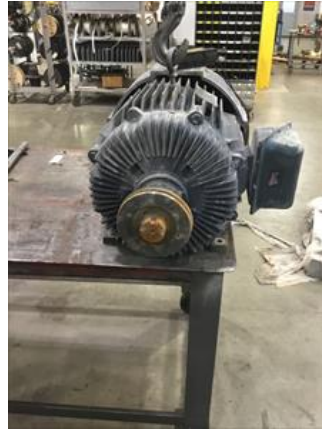
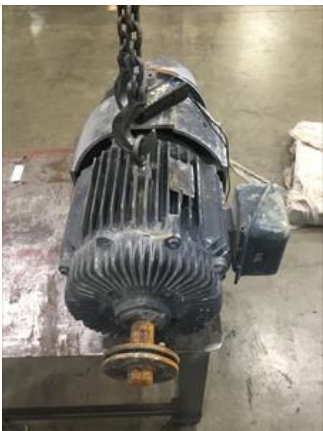
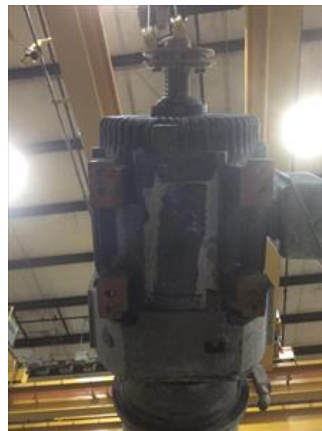
P3

3. Photos of all six sides of the machine.

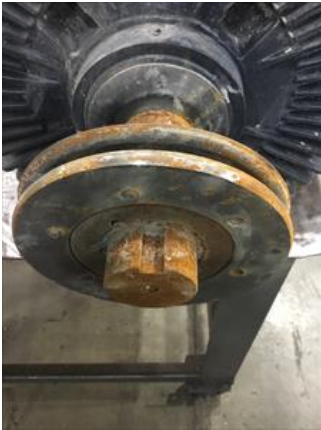
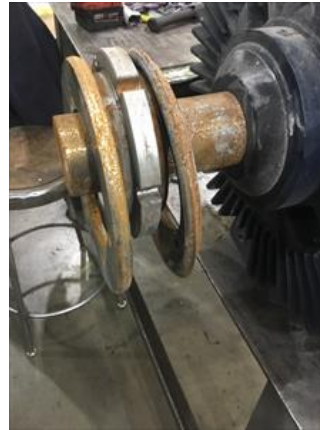
P5

5. Distance from the end of the shaft to the Coupling/Sheave

1.072 inches

*On the shaft*

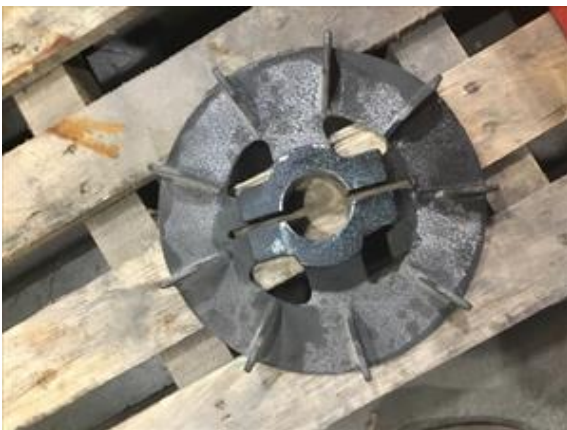
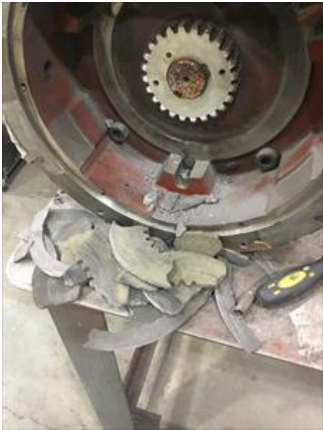
P18

| 17. Frame Condition | good |
| 18. Fan Condition | (P) Pass |
| <i>2 set screws</i> | |

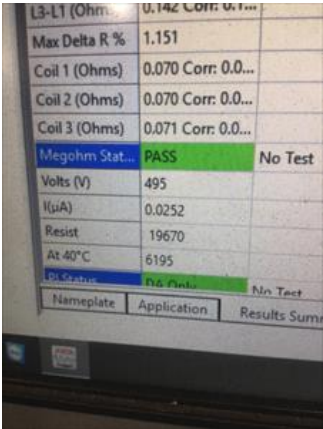
P20

20. Insulation Resistance/Megger

6195 Megohms

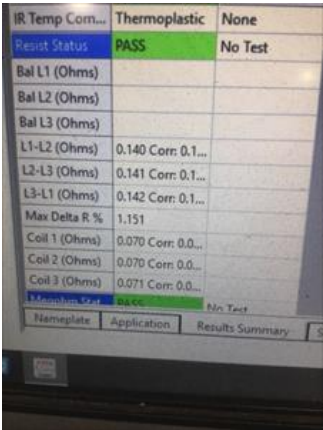
P21

21. Winding Resistance

1-2	1-3	2-3
.070	.070	.071

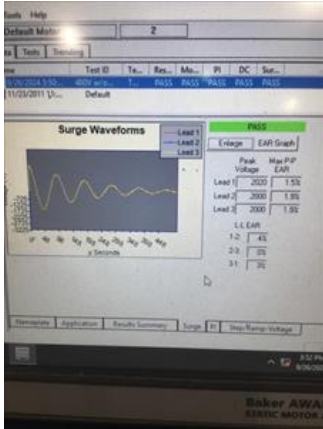
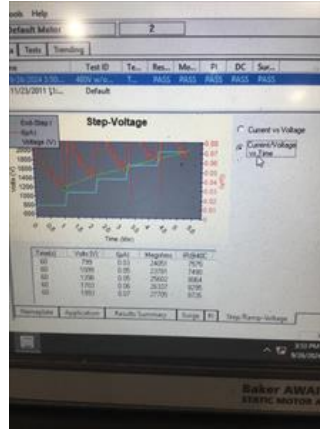
P22

22. Perform Surge Test

(P) Pass

Test Date	9/26/2024	11/23/20
Test Time	3:50:29 PM	11:30:00
PI Status	DA Only	No Test
Volts (V)	499	
DA Ratio	3.8	
PI Ratio	>2 OL	
DC Status	PASS	No Test
Test Type	Step-Voltage	
Volts (V)	1993	
I(μA)	0.0719	
Resist	27705	
At 40°C	8726	
Surge Status	PASS	No Test
Peak Volt(V) L1	2020	
Peak Volt(V) L2	2000	
Peak Volt(V) L3	2000	
Max P-P EAR...	1.5/1.9/1.9	
EAR 1-2/2-3/...	4/0/3	
Nameplate	Application	Results Summar

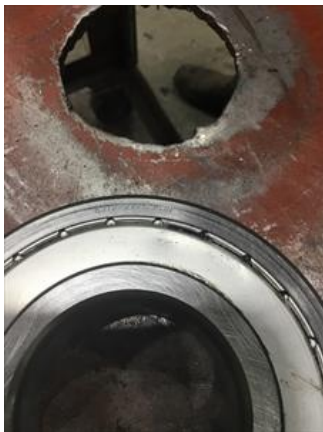
23.	Number of Stator Slots	48	
24.	Stator Condition	good	
25.	Stator Thermistors/Ohms	none present	
26.	Stator Overloads/Ohms	none present	
<b>Mechanical Inspection</b>			
27.	Drive End Bearing Brand	SKF	
28.	Drive End Bearing Number-	6312 zz c3	P28

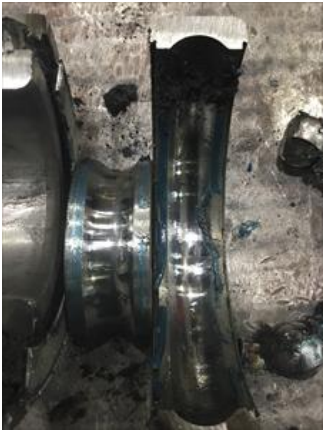
33.	Drive End Wavy Washer/Snap-Ring Other Retention Device?	<b>none present</b>	
34.	Drive End Bearing Condition	<b>normal wear</b>	P34

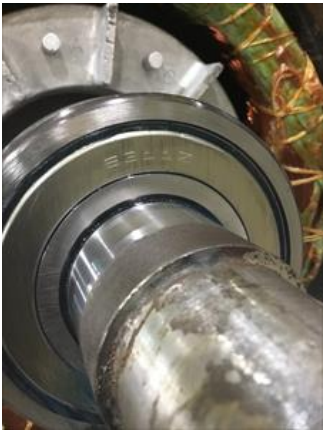
35.	Opposite Drive End Bearing Brand	<b>NTN</b>	
36.	Opposite Drive End Bearing Number-	<b>6311 zz c3</b>	P36

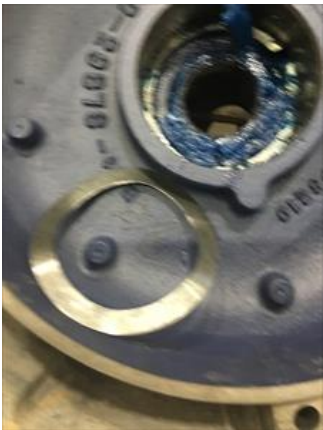
37.	Opposite Drive End Bearing Qty.	<b>1</b>	
38.	Opposite Drive End Bearing Type	<b>(Ball) Ball Bearing</b>	
39.	Opposite Drive End Lubrication Type	<b>(Grease) Grease Lubricated</b>	
40.	Opposite Drive End Bearing Insulation or Grounding Device?	<b>none present</b>	
41.	Opposite Drive End Wavy Washer/Snap-Ring Other Retention Device?	<b>wavy washer</b>	P41

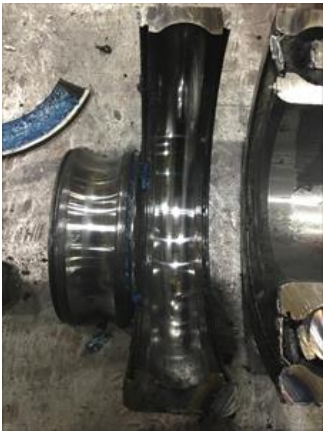
42.	Opposite Drive End Bearing Condition	<b>normal wear</b>	P42
-----	--------------------------------------	--------------------	-----

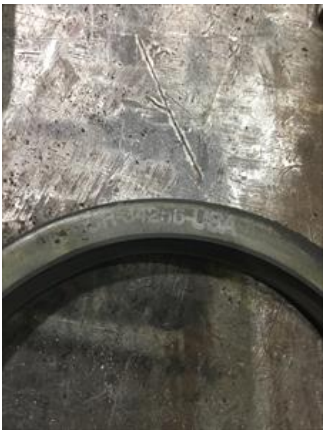
43.	Drive End Seal	slinger outside endbell
44.	Opposite Drive End Seal	none present
Rotor Inspection		
45.	Rotor Type/Material	(Aluminum Bar) Aluminum Barred Rotor
46.	Growler Test	(Pass) Pass
47.	Number of Rotor Bars	40
48.	Rotor Condition	good
49.	List the Parts needed for the Repair Below	P49
	1- CR-34256 lipseal	
	1- 6312 2RS C3 bearing	
	1- 6311 2RS C3 bearing
