AC Inspection as Found

Peco Foods (004801)

Serial Number: 12W793Y49761

Description: 20 Hp Motor

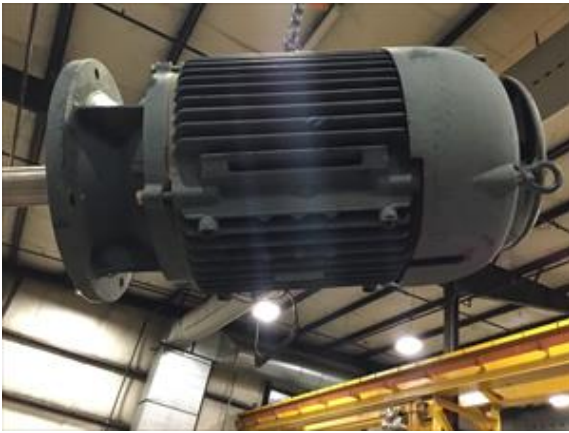
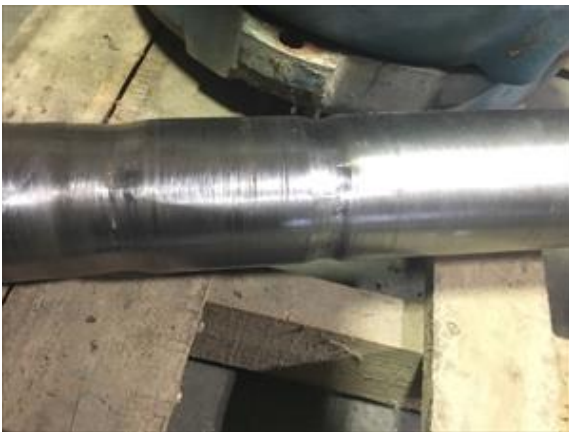
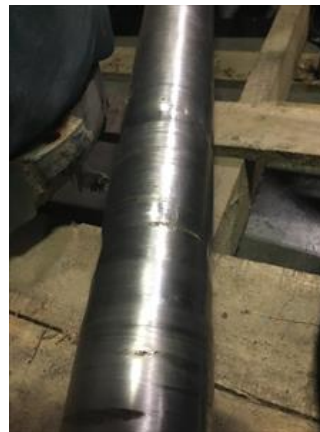
P4

4. Describe the Overall Condition of the Equipment as Received

Shaft damage

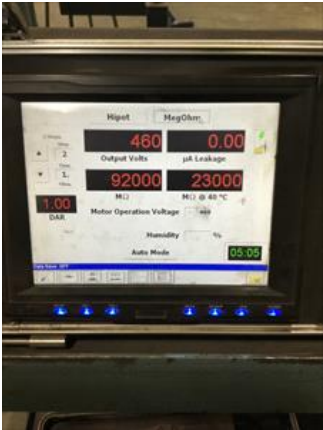
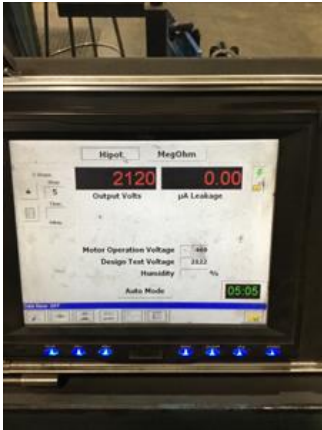
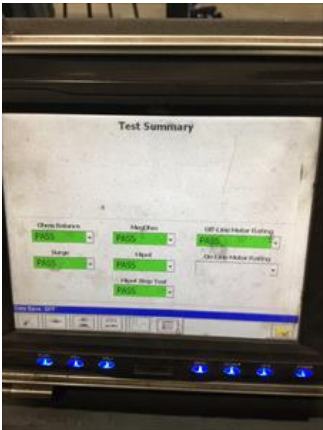
P20

20. Insulation Resistance/Megger

92000 Megohms

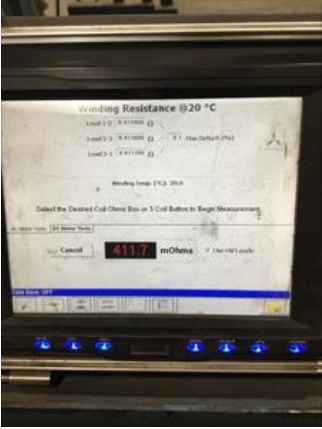
21. Winding Resistance		P21
1-2	1-3	2-3

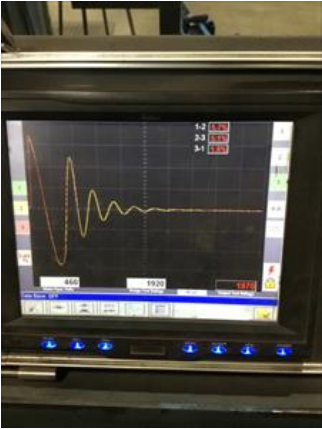
22. Perform Surge Test	(P) Pass	P22

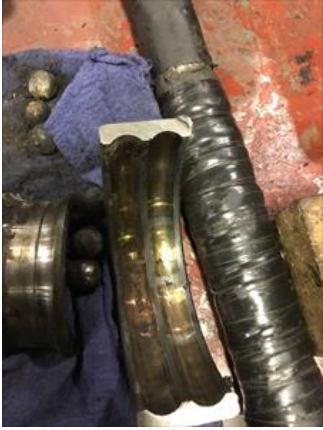
P34

34. Drive End Bearing Condition

good

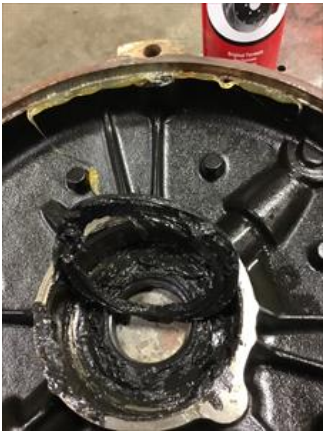
P41

none
41. Opposite Drive End Wavy Washer/Snap-Ring Other Retention Device?

wavy washer

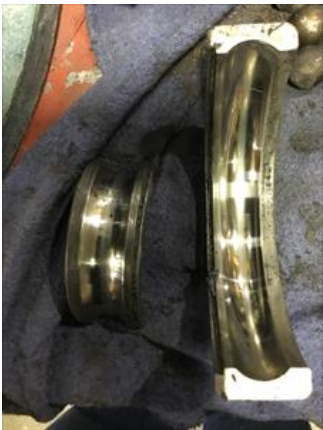
P42

42. Opposite Drive End Bearing Condition

good

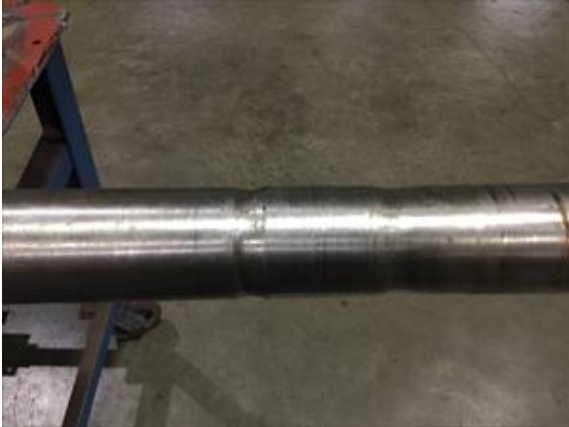
48. Rotor Condition damage to seal surface P48

Shaft size is 3.9840 at largest diameter. And 58 inches long.

49. List the Parts needed for the Repair Below
1-3215 a c3 bearing
1-6311 c3 bearing
1- shaft replacement see measurements in rotor condition section

65.	End Bell Air Seal Fits		
	Drive End Air Seal	Opposite Drive End Air Seal	
	N/a		
66.	List Machine Work Needed Below Shaft press out, cut, and press in.
