AC Inspection as Found

Blue Scope
1836 Dock St
Memphis, TN 38113

AC Inspection - Rev. 2

Description: 10 Hp

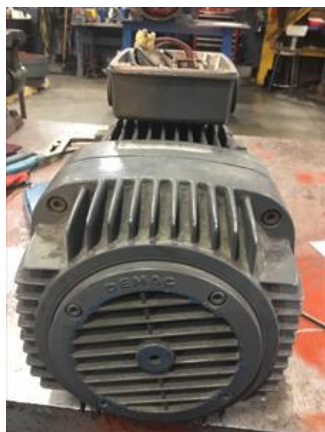
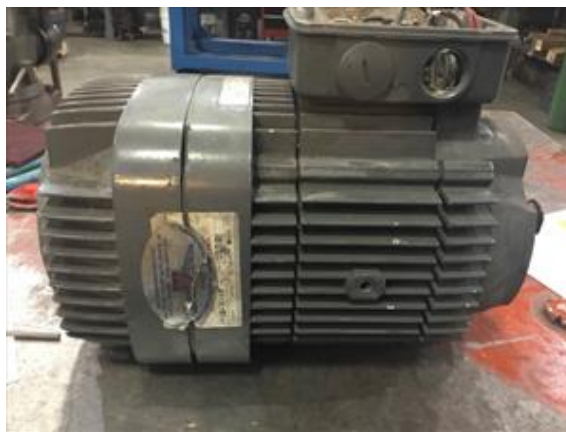
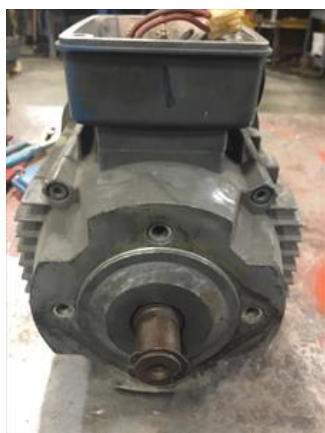
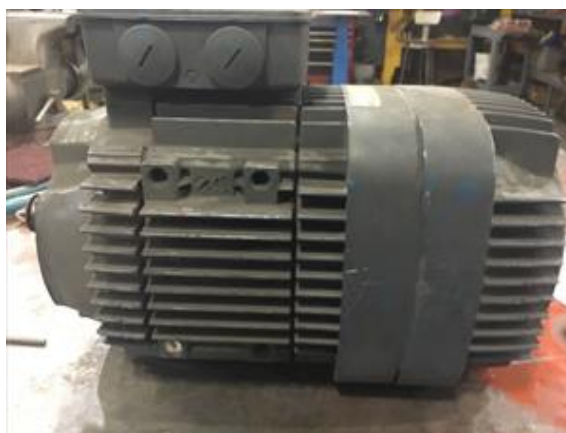
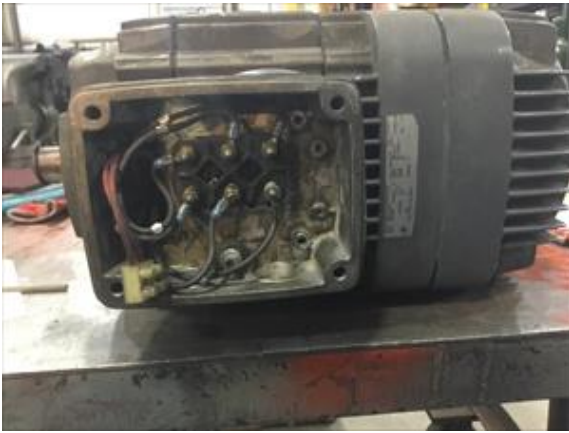
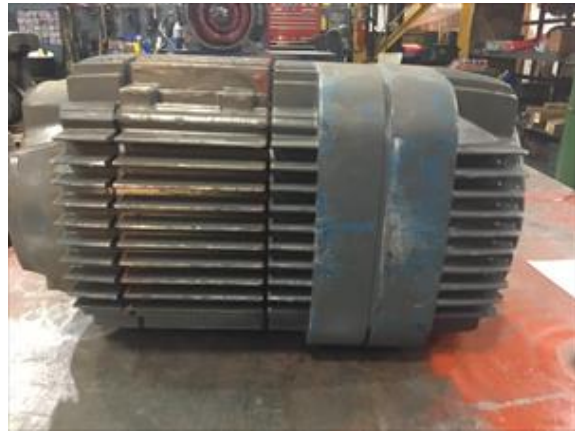
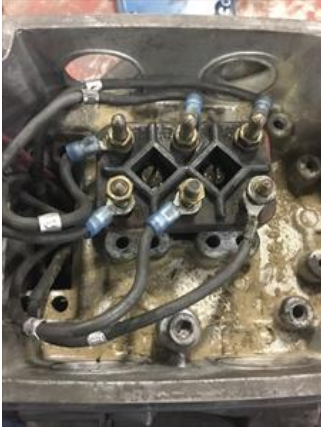
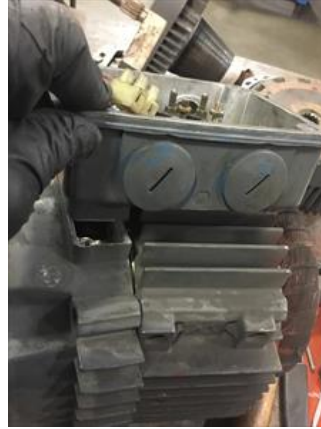
3. Photos of all six sides of the machine.

4.	Describe the Overall Condition of the Equipment as Received	
	<i>Good</i>	
5.	Report Date [COPY]	
Initial Mechanical/Electrical		
6.	Does Shaft Turn Freely?	(Y) Yes
7.	Does the shaft require T.I.R in Lathe to identify additional repairs?	(No) No
8.	Does Shaft Have Visible Damage?	(No) No
9.	Assembled Shaft Runout	0.002 Inches
10.	Assembled Shaft End Play	0.111 inches
11.	Air Gap Variation <10%	
12.	Lead Condition	(P) Pass
13.	Lead Length	3 Inches
14.	Does it have Lugs?, If so what is the Stud Size?	(Yes) Yes
	1/8	
15.	Lead Numbers	1-6
16.	Frame Condition	good
17.	Fan Condition	(N) NA
18.	Broken or Missing Components	none
Initial Electrical Inspection

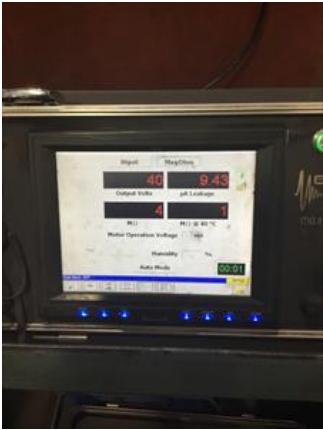
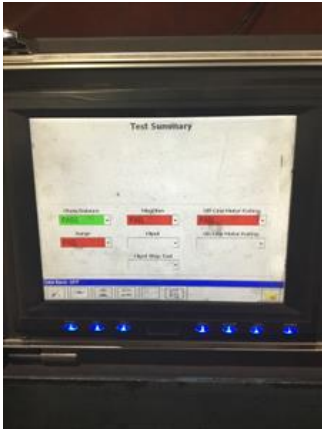
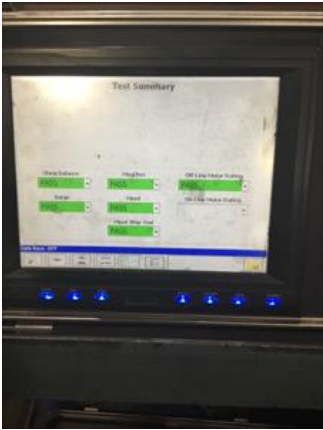
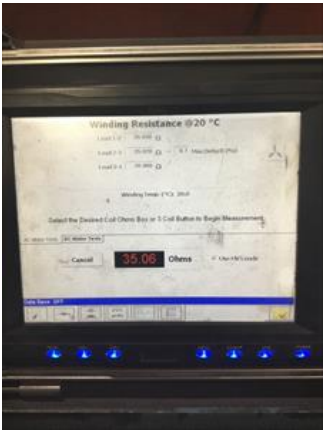
Hi speed

1-2

1-3

2-3
