AC Inspection as Found

MARS FOOD (0001269)

AC Inspection - Rev. 2

Hi-Speed Job Number:	153906
Manufacturer:	Other
Product Number:	NRD132M2
Serial Number:	EN60034-1
HP/kW:	20 (HP)
RPM:	6250 (RPM)
Frame:	IP54
Voltage:	460
Current:	32 (Amps)
Phase:	Three
Hz:	105 (Hz)
Service Factor:	1.15
Enclosure:	TEFC
# of Leads:	3
J-box Included:	Complete
Coupling/Sheave:	None
Date Received:	10/16/2024
Bearing RTDs:	No
Stator RTDs:	No
Repair Stage:	Teardown Inspection
Rewind:	No
Shaft Machined Fit Repairs Required:	No
Bearing Housing Machined Fit Repairs Required:	No
Heaters:	No
Winding Type :	Random Wound
Bearing Type:	Rolling Element

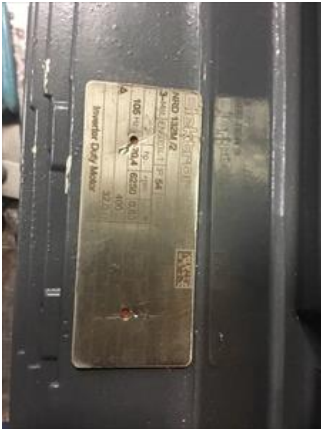
P2

2. Nameplate Picture

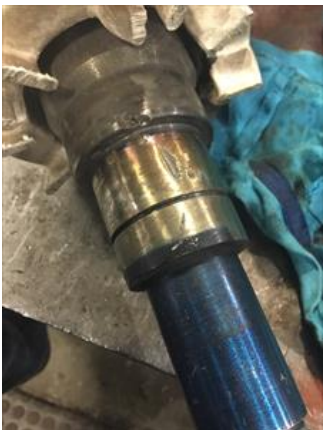
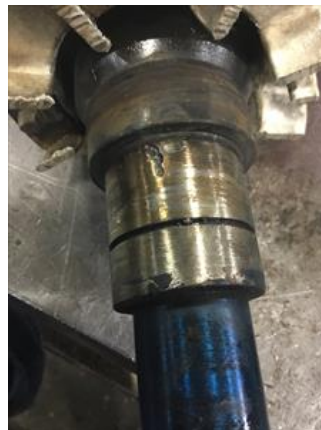
P8

| <input checked="" type="radio"/> | 8. Does Shaft Have Visible Damage? | (Yes) Yes |

Damage is on drive end. 180 degrees out.

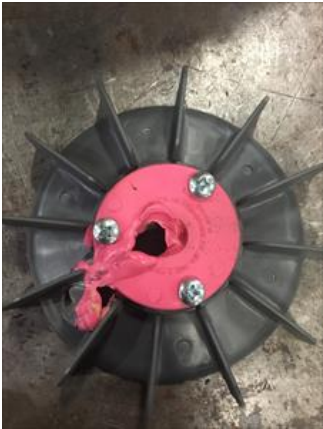
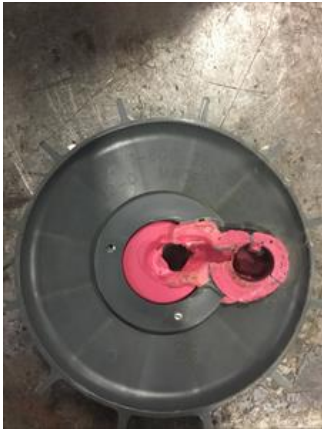
<div><div></div></div>	13. Lead Length	10 Inches	
	14. Does it have Lugs?, If so what is the Stud Size?		
<div><div></div></div>	15. Lead Numbers	1-3	
<div><div></div></div>	16. Frame Condition	good	
<div><div></div></div>	17. Fan Condition	(F) Fail	P17

48.	List the Parts needed for the Repair Below 2-3608 bearings 1-rewind 1-fan		
49.	Signature of Technician that Disassembled Motor		James Valentine

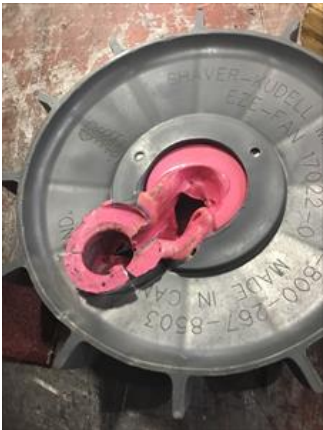
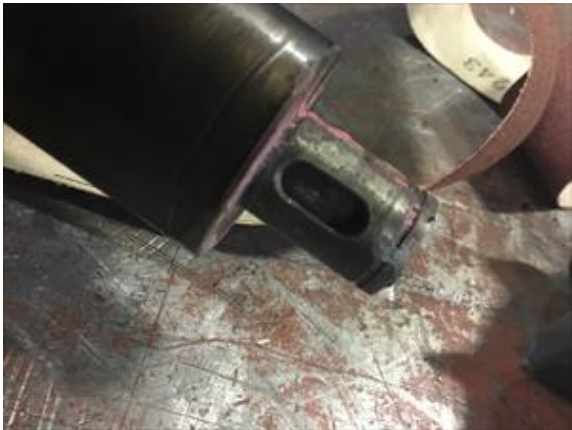
18. Broken or Missing Components	fan	P18
<div><div></div><div>Fan shaft dimensions.7487</div></div>

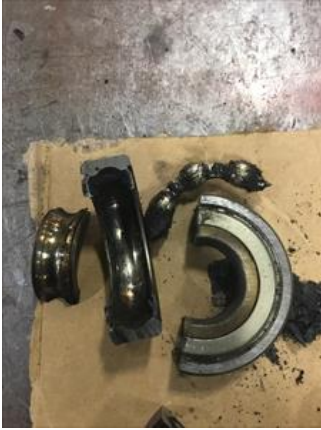
27.	Drive End Bearing Number-	6308ze	
28.	Drive End Bearing Qty.	1	
29.	Drive End Bearing Type	(Ball) Ball Bearing	
30.	Drive End Lubrication Type	(Grease) Grease Lubricated	
31.	Drive End Bearing Insulation or Grounding Device?	none	
32.	Drive End Wavy Washer/Snap-Ring Other Retention Device?	none	
33.	Drive End Bearing Condition	good	P33

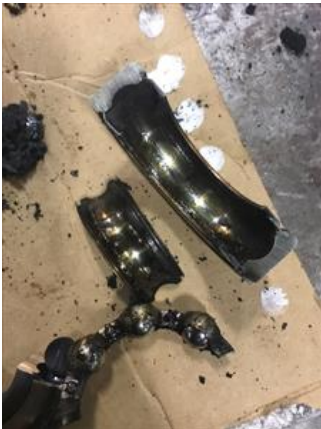
34.	Opposite Drive End Bearing Brand	nachi	
35.	Opposite Drive End Bearing Number-	6308ze	
36.	Opposite Drive End Bearing Qty.	1	
37.	Opposite Drive End Bearing Type	(Ball) Ball Bearing	
38.	Opposite Drive End Lubrication Type	(Grease) Grease Lubricated	
39.	Opposite Drive End Bearing Insulation or Grounding Device?	none	
40.	Opposite Drive End Wavy Washer/Snap-Ring Other Retention Device?	none	
41.	Opposite Drive End Bearing Condition	good	P41
