Hi-Speed Industrial Service
7030 Ryburn Dr
Millington, Tn 38053
901-873-5300

AC Inspection as Found

KTG USA MOTOR
400 Mahannah
Memphis, TN 38107

Location: Ktg
Serial Number: 4624124
Description: 757 KW ABB

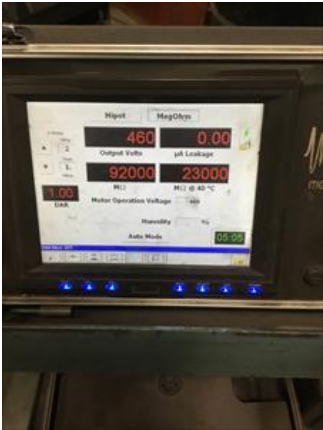
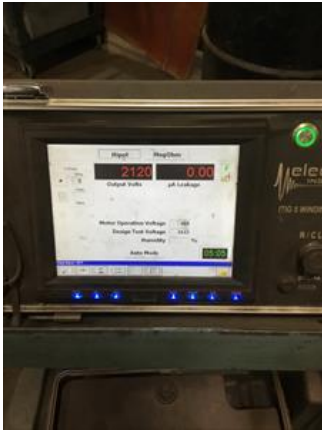
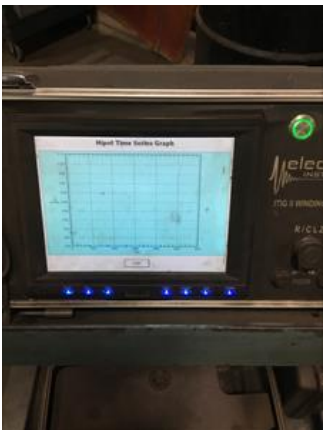
P21

92000 Megohms

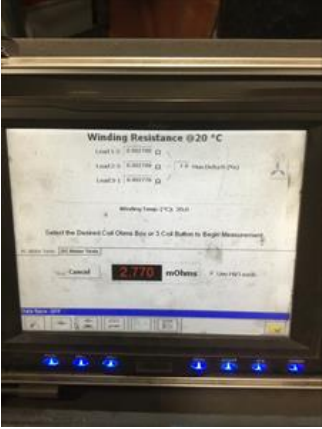
22. Winding Resistance		P22
1-2	1-3	2-3
.00279	.002799	.00277

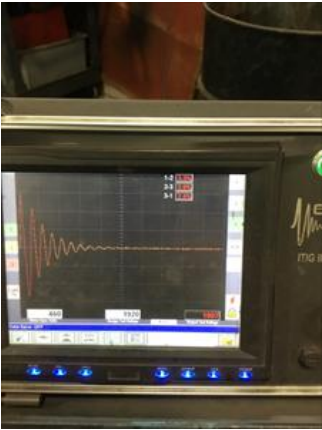
23. Perform Surge Test	(P) Pass	P23

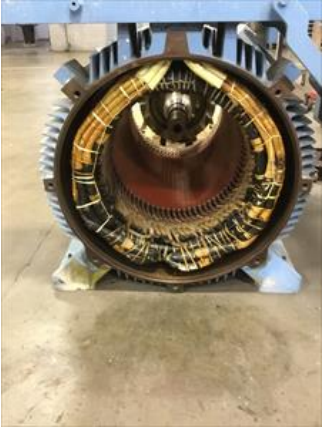
24. Number of Stator Slots	72	
25. Stator Condition	Pass	P25

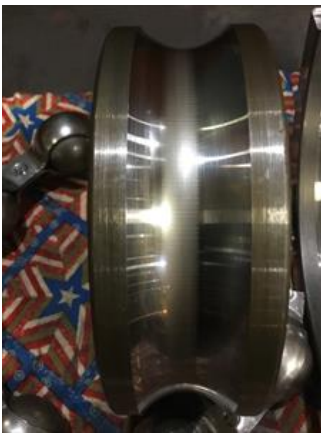
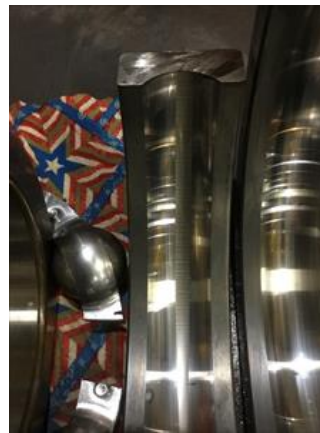
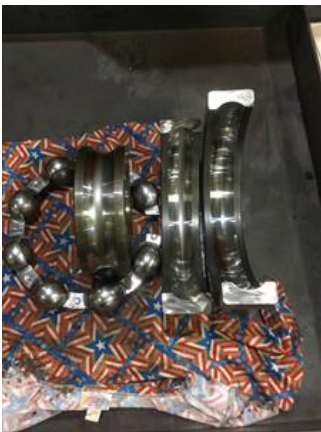
29. Drive End Bearing Number-	6324 C3
30. Drive End Bearing Qty.	1
31. Drive End Bearing Type	(Ball) Ball Bearing
32. Drive End Lubrication Type	(Grease) Grease Lubricated
33. Drive End Bearing Insulation or Grounding Device?	None
34. Drive End Wavy Washer/Snap-Ring Other Retention Device?	None
35. Drive End Bearing Condition	Significant electrical fluting.

69. Failure locations
Drive end bearing.

70. Root cause of failure
Electrical fluting

Great condition! Passed all electrical tests and no machine work required. Drive end bearing had significant electrical fluting. Recommend adding Aegis ring internal to drive end. Opposite drive endbell is insulated so no insulated bearing required.

50. List the Parts needed for the Repair Below
 6324 C3
 6322 C3
 Aegis ring SGR-133.9-3FH [Mfr# SGR-133.9-154.9-3FH]

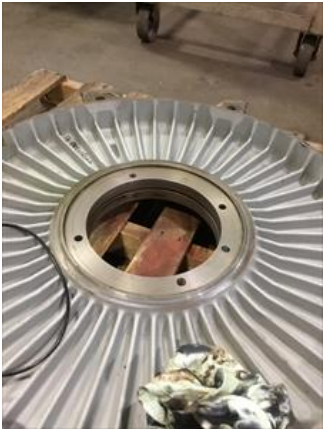
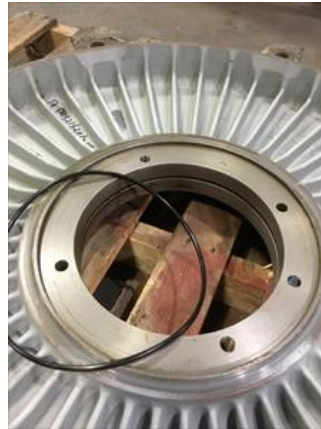
37. Opposite Drive End Bearing Number-	6322 C3	
38. Opposite Drive End Bearing Qty.	1	
39. Opposite Drive End Bearing Type	(Ball) Ball Bearing	
40. Opposite Drive End Lubrication Type	(Grease) Grease Lubricated	
41. Opposite Drive End Bearing Insulation or Grounding Device?	Insulated end bell	P41
<div>

1000 meg, 0 ohms </div>

O ring in grove of bearing housing.

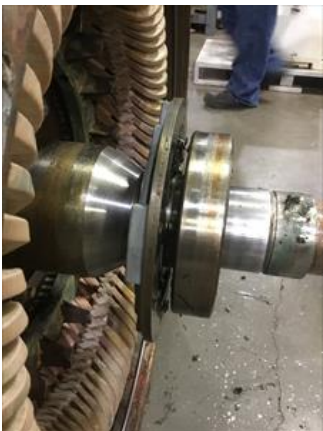
42. Opposite Drive End Wavy Washer/Snap-Ring Other Retention Device?	Springs in bearing cap	P42
--	-------------------------------	-----

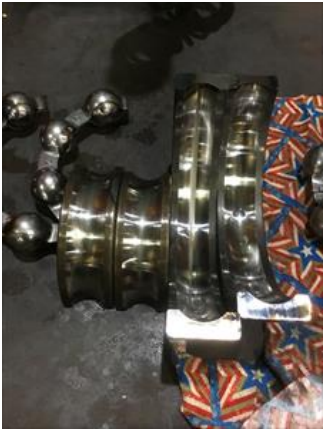
43. Opposite Drive End Bearing Condition	Normal wear	P43

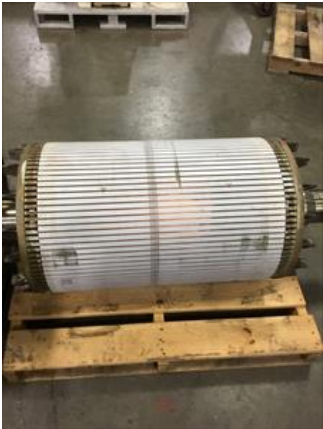
46. Rotor Type/Material	(Copper Barred) Copper Barred Rotor	P46

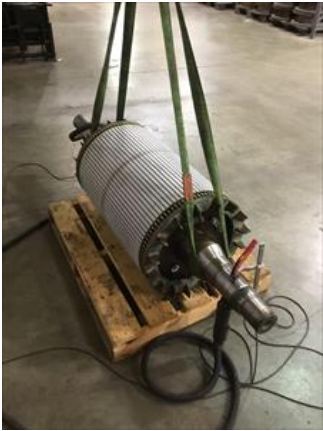
47. Growler Test	(Pass) Pass	
48. Number of Rotor Bars	86	
49. Rotor Condition	Pass	P49

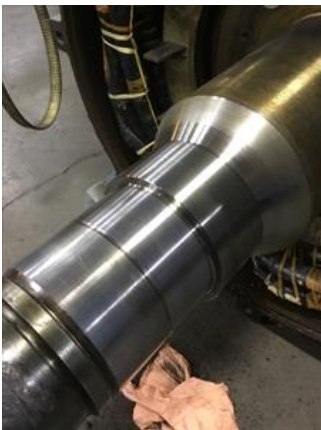
P56

0 Degrees	60 Degrees	120 Degrees
4.7255	4.7255	4.7255

Tolerance is 4.7249-4.7255

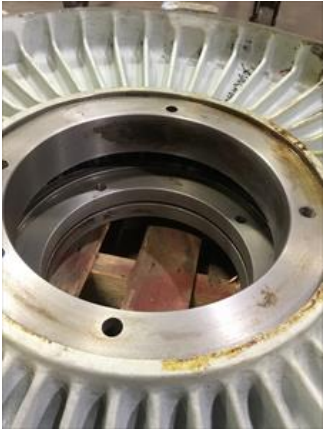
0 Degrees	60 Degrees	120 Degrees
10.2379	10.2379	10.2379

Tolerance is 10.2362-10.2375. .0003 out of Tolerance. Recommend no machine work.

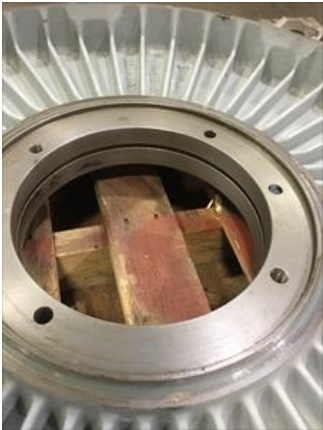
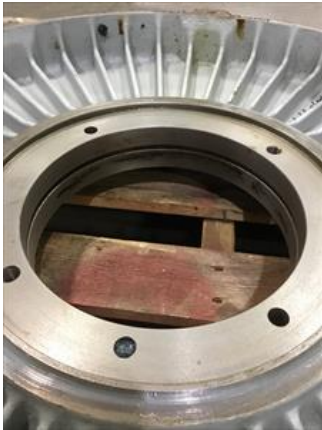
0 Degrees	60 Degrees	120 Degrees
9.4512	9.4512	9.4512

Tolerance is 9.4488-9.4499. Bearing housing is oversized for thermal growth. Bearing is locked in place with o ring to prevent outer race from spinning.
