## AC Inspection as Found

**Peco Foods**  
625 S. Allen Street  
Batesville, AR 72501

### AC Inspection - Rev. 2

**Location:** Shop  
**Serial Number:** ZHE722C005017  
**Description:** 25HP AERATOR MOTOR EVAL

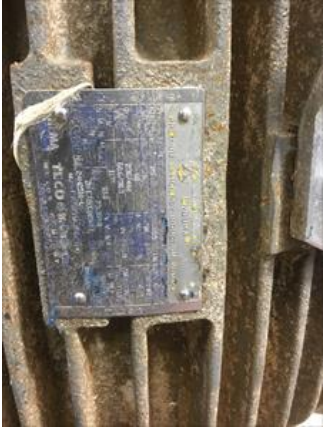
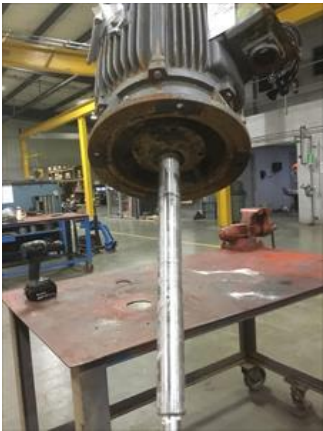
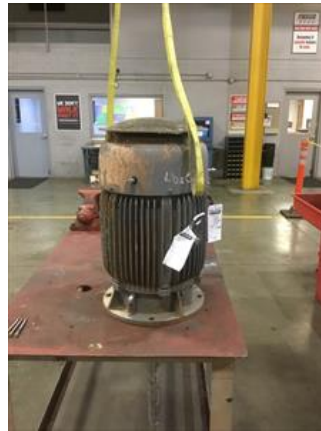
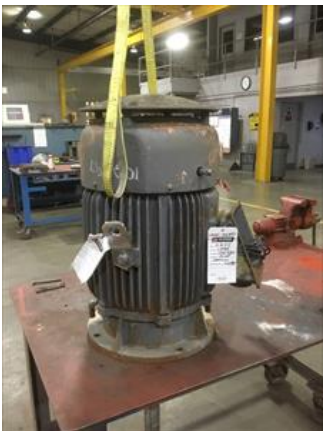
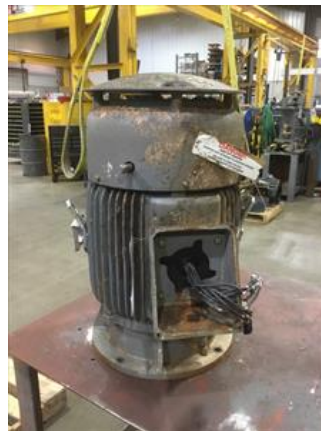
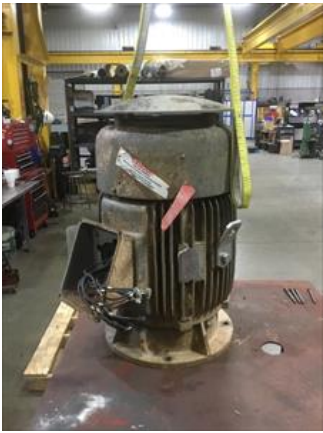
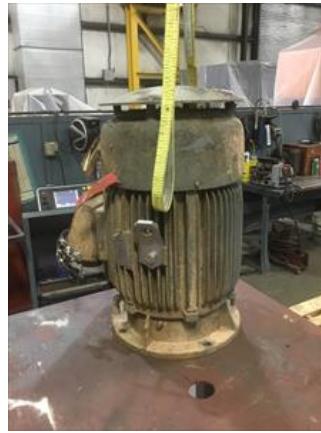
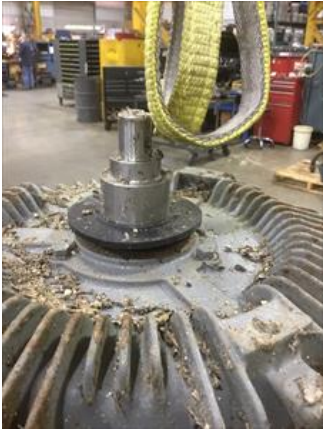
4. Describe the Overall Condition of the Equipment as Received  
*Good condition. 1 phase of windings burnt up and requires rewind.*

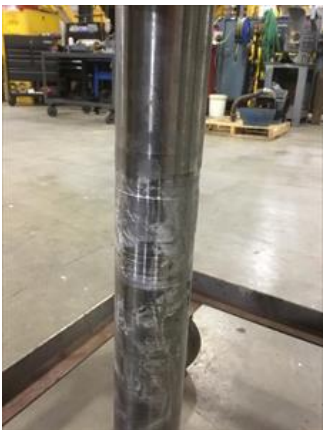
| 7. Does Shaft Have Visible Damage? | (Yes) Yes | P26 |

*From rubbing on bushing.*

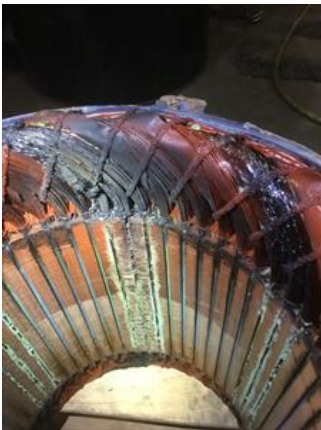
17.	Broken or Missing Components	None		
Initial Electrical Inspection				
18.	Insulation Resistance/Megger	0 Megohms		
19.	Winding Resistance			
	1-2	1-3	2-3	
	0	0	0	
20.	Perform Surge Test	(F) Fail

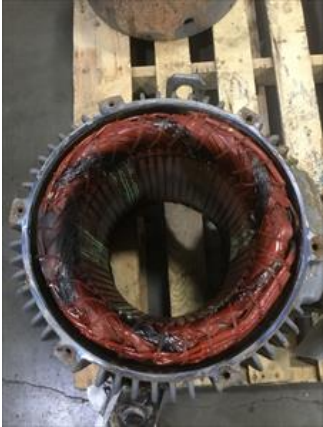
22. Stator Condition	Requires rewind	P84

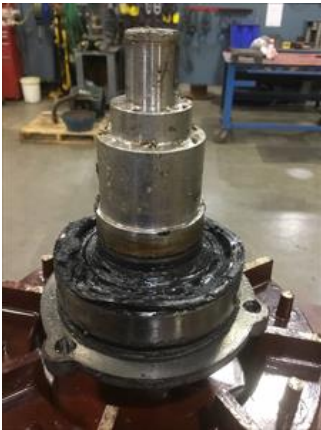
P114

40. Opposite Drive End Bearing Condition	Normal wear
41. Drive End Seal	60 82 12

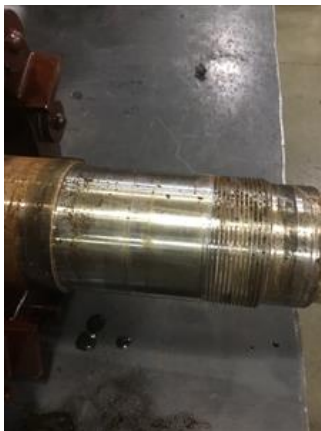
51.	Coupling Fit Closest to Bearing Housing			
	0 Degrees	90 Degrees	120 Degrees	
	1.375	1.375	1.375	
52.	Coupling Fit Closest to the end of the Shaft			
	0 Degrees	60 Degrees	120 Degrees	
	1.375	1.375	1.375	
53.	Drive End Bearing Shaft Fit			P79
	0 Degrees	60 Degrees	120 Degrees	
	2.5592	2.5592	2.5592	
	<div><div></div>Tolerance is 2.5590-2.5593</div>			
<div>

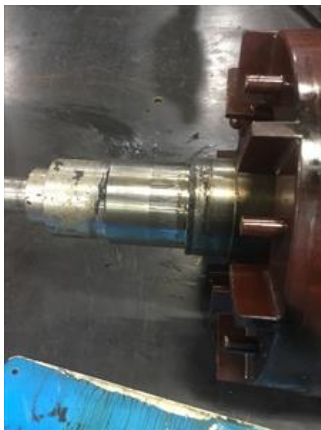
</div>				
54.	Drive End Bearing Shaft Fit Condition			(P) Pass
55.	Opposite Drive End Bearing Shaft Fit			P89
	0 Degrees	60 Degrees	120 Degrees	
	2.3624	2.3624	2.3624	
	<div><div></div>Tolerance is 2.3623-2.3628</div>			
<div>

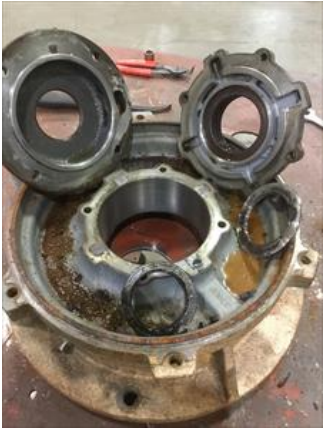
58.	Drive End - Endbell Bearing Fit		P2
	0 Degrees	60 Degrees	120 Degrees
	5.512	5.512	5.512
	<div> <div></div> Tolerance is 5.5117-5.5121 </div>

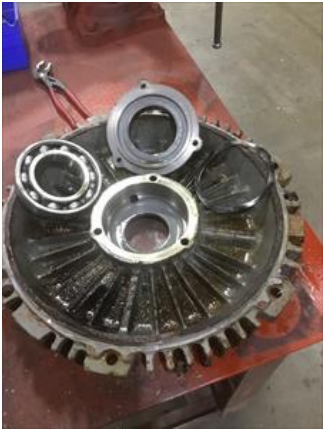
59.	Drive End - Endbell Bearing Fit Condition		(P) Pass
60.	Opposite Drive End - Endbell Bearing Fit		P30
	0 Degrees	60 Degrees	120 Degrees
	4.3316	4.3316	4.3316
	<div> <div></div> Tolerance is 4.3307-4.3316 </div>
