## AC Inspection as Found

**CERTAINEED (10520)**  
2701 E ROOSEVELT ROAD  
LITTLE ROCK, AR 72206

**Description:** 10HP MARATHON-SEND REPAIR  
QUOTE OR REPLACE

**Hi-Speed Job Number:** 102861

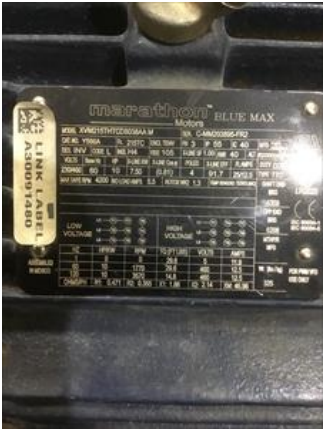
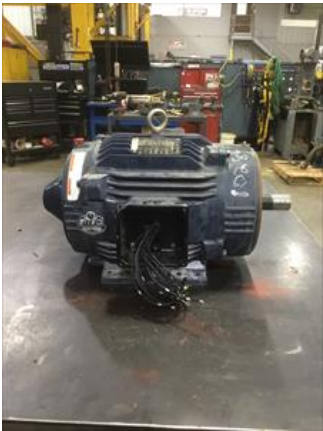
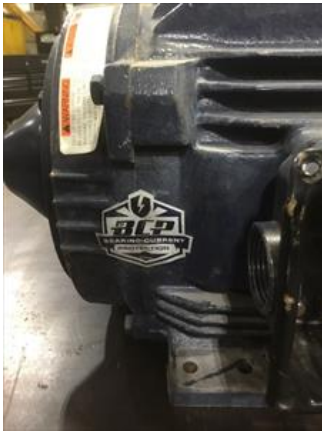
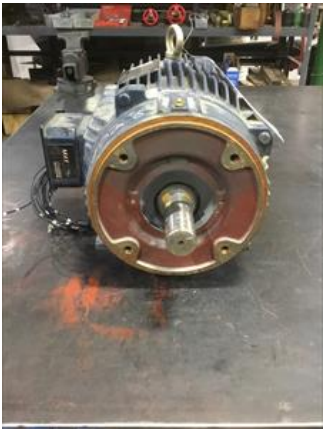
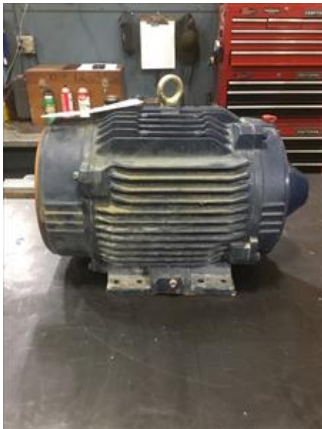
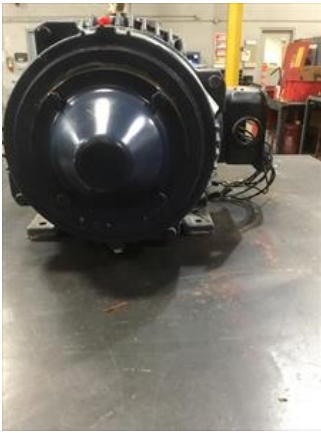
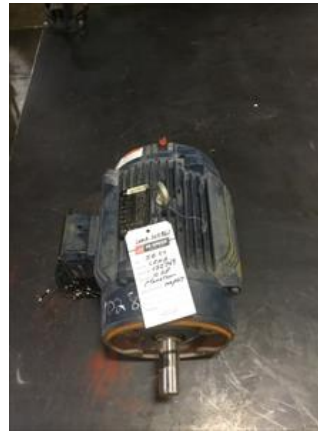
4. Describe the Overall Condition of the Equipment as Received  
*Drive end bearing failed. Grease was gritty and cause bearing to wear out. Rotor dropped into iron and blew stator windings. Requires rewind.*

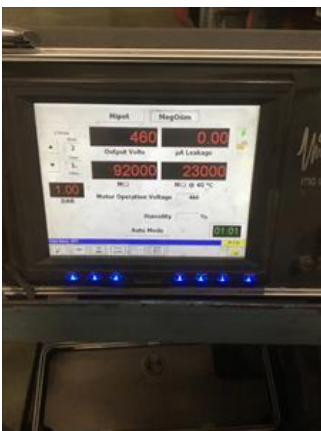
P8

18. Insulation Resistance/Megger 92000 Megohms

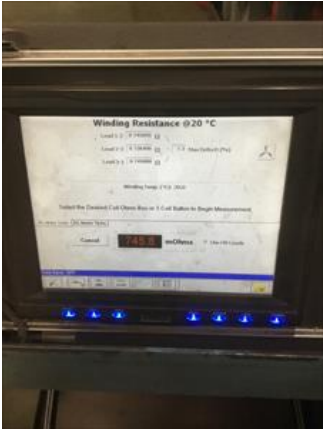
19. Winding Resistance			P20
1-2	1-3	2-3	
.7458	.7364	.7458

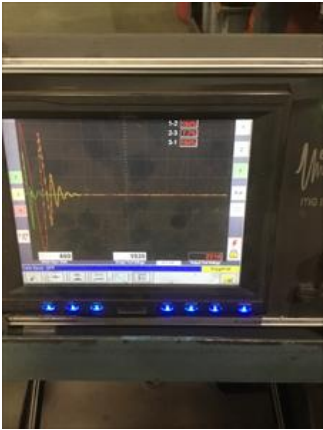
<div> <div></div> 20. Perform Surge Test </div>	(F) Fail	P57

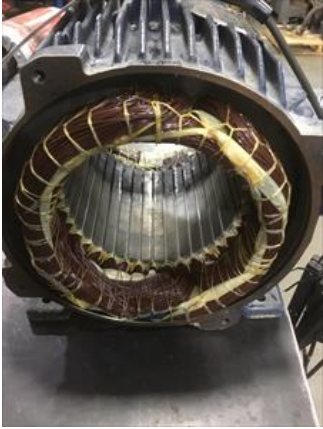
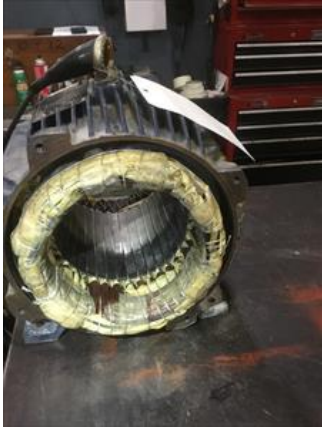
21. Number of Stator Slots	36		
22. Stator Condition	Requires rewind	P84	
<div>

*Rewind*

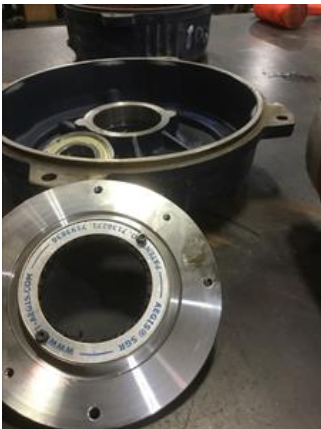
P64

AEGIS inside bearing cap.

*Aegis ring 2.165" SGR-53.5-3FH*

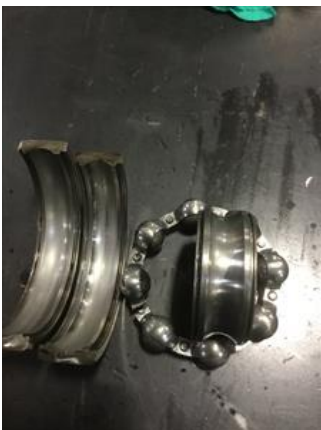
P82

32. Drive End Bearing Condition

Destroyed

Grease was consistency of lapping compound. Bearing was excessive wore out and had excessive play.

*6309 C3*

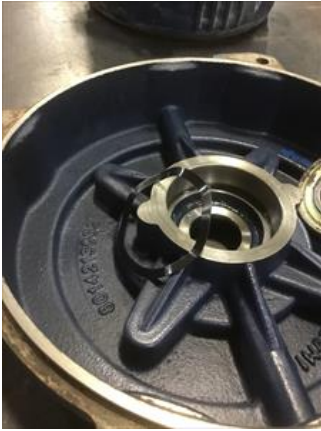
35. Opposite Drive End Bearing Qty.	1	
36. Opposite Drive End Bearing Type	(Ball) Ball Bearing	
37. Opposite Drive End Lubrication Type	(Grease) Grease Lubricated	
38. Opposite Drive End Bearing Insulation or Grounding Device?	None	
39. Opposite Drive End Wavy Washer/Snap-Ring Other Retention Device?	Wavy Washer	P114

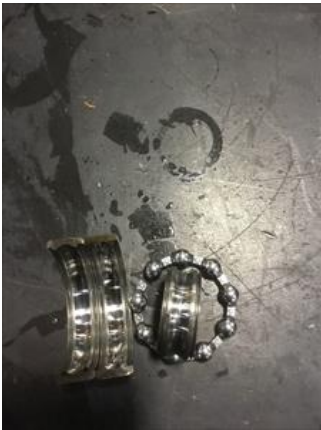
40. Opposite Drive End Bearing Condition	Normal wear	P118
--	-------------	------

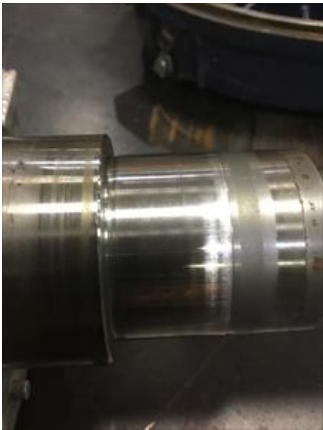
0 Degrees	60 Degrees	120 Degrees
1.7718	1.7718	1.7718

Tolerance is 1.7718-1.7722

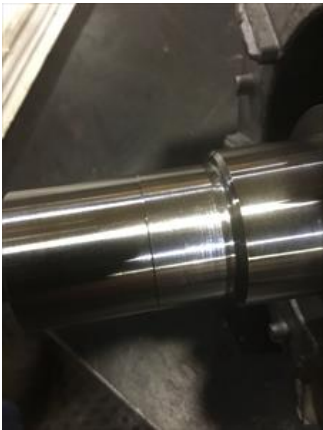
P89

0 Degrees	60 Degrees	120 Degrees
1.1812	1.1812	1.1812

Tolerance is 1.1812-1.1815

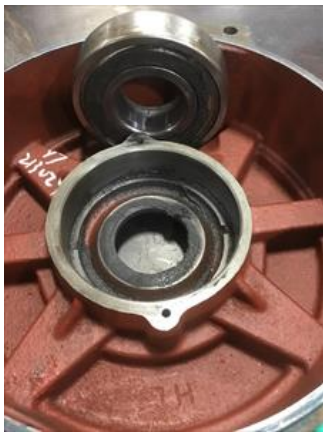
58.	Drive End - Endbell Bearing Fit			P2
	0 Degrees	60 Degrees	120 Degrees	
	3.9376	3.9376	3.9376	
	Tolerance is 3.9370-3.9379

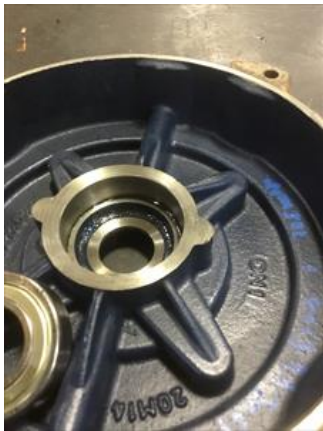
59.	Drive End - Endbell Bearing Fit Condition			(P) Pass
60.	Opposite Drive End - Endbell Bearing Fit			P30
	0 Degrees	60 Degrees	120 Degrees	
	2.4415	2.4415	2.4415	
	Tolerance is 2.4409-2.4416
