### AC Inspection as Found

NUCOR Memphis (003974-1)

#### AC Inspection - Rev. 2

Description: 25 Hp Baldor From Nucor Memphis

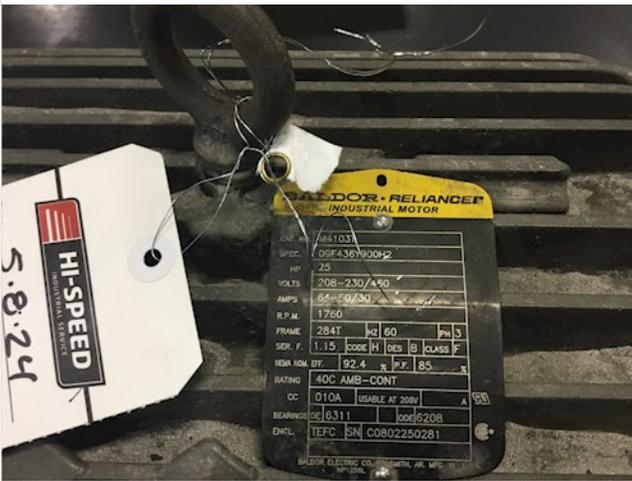
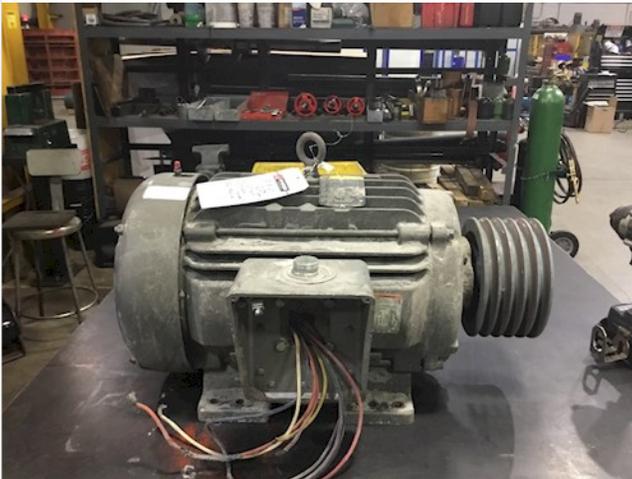
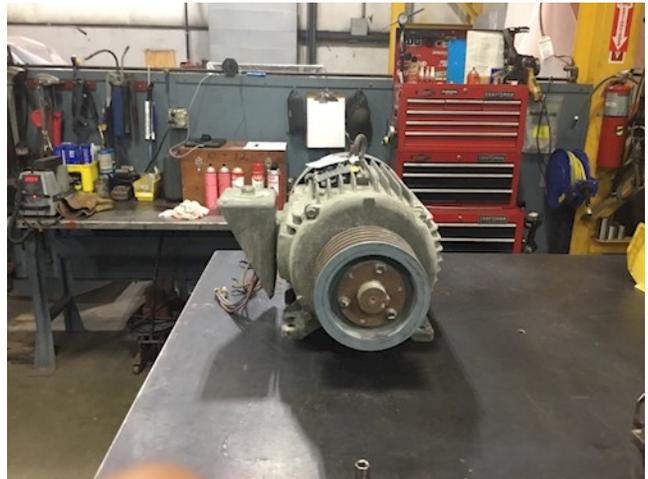
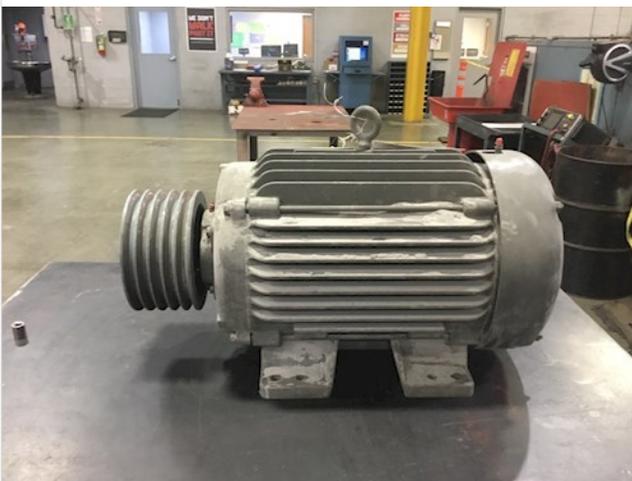
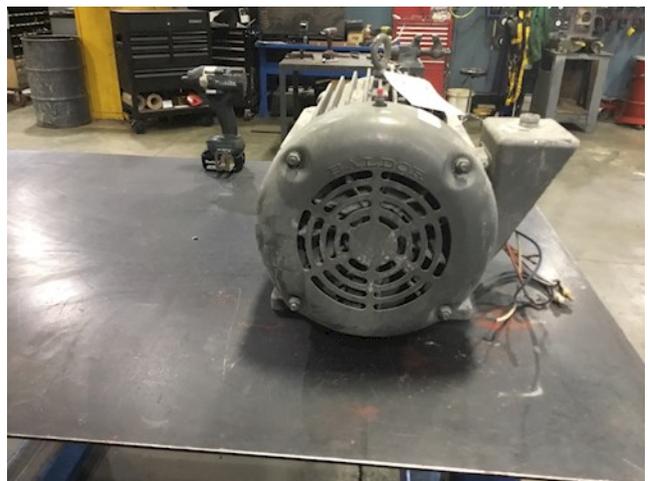
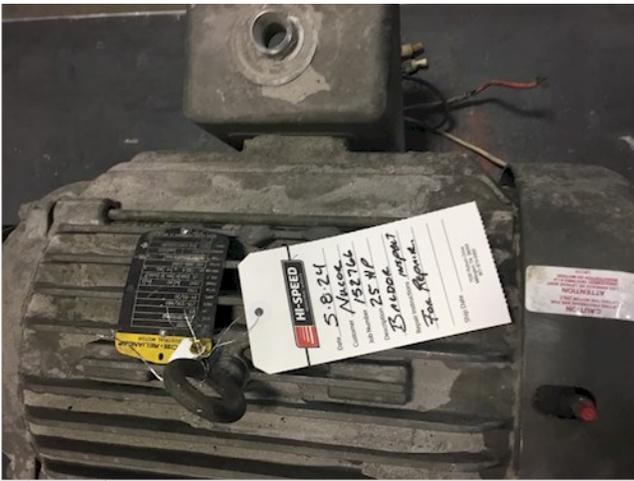
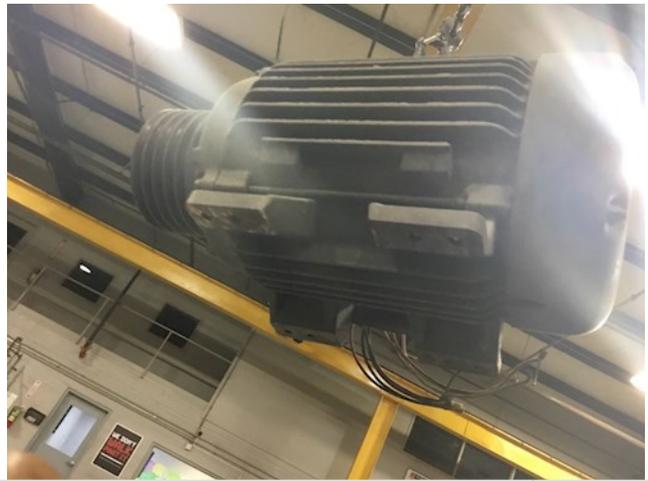
3. Photos of all six sides of the machine.

4. Describe the Overall Condition of the Equipment as Received  
*Recon with no machine work*

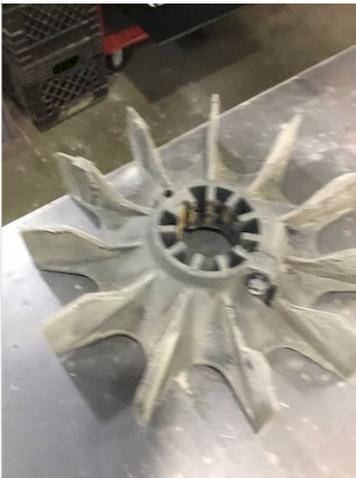
17. Fan Condition **(P) Pass** P19

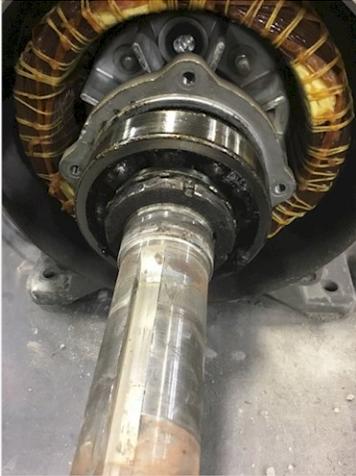
27.	Drive End Bearing Number-	6311	
28.	Drive End Bearing Qty.	1	
29.	Drive End Bearing Type	(Ball) Ball Bearing	
30.	Drive End Lubrication Type	(Grease) Grease Lubricated	
31.	Drive End Bearing Insulation or Grounding Device?	none	
32.	Drive End Wavy Washer/Snap-Ring Other Retention Device?	lock washer and nut	P35

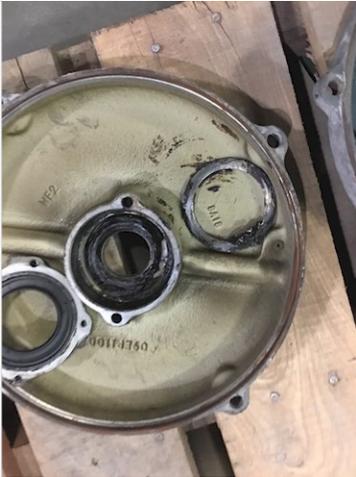
33.	Drive End Bearing Condition	good	
34.	Opposite Drive End Bearing Brand	SKF	
35.	Opposite Drive End Bearing Number-	6209	
36.	Opposite Drive End Bearing Qty.	1	
37.	Opposite Drive End Bearing Type	(Ball) Ball Bearing	
38.	Opposite Drive End Lubrication Type	(Grease) Grease Lubricated	
39.	Opposite Drive End Bearing Insulation or Grounding Device?	none	
40.	Opposite Drive End Wavy Washer/Snap-Ring Other Retention Device?	wavy washer	P43

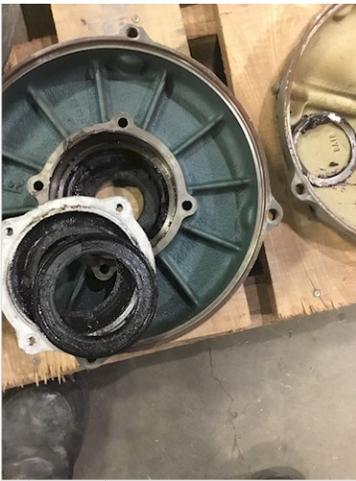
41.	Opposite Drive End Bearing Condition	good	
42.	Drive End Seal	replace	P45

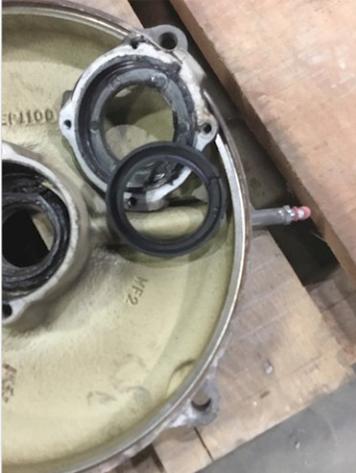
43. Opposite Drive End Seal

replace
