## AC Inspection as Found

ARKEMA, INC.  
2571 Fite Road  
Memphis, TN 38127

### AC Inspection - Rev. 2

Description: 125 HP

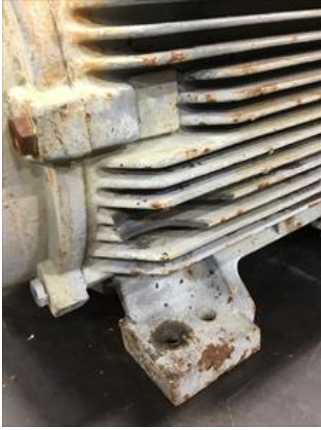
5.	Does Shaft Turn Freely?	(Y) Yes
6.	Does the shaft require T.I.R in Lathe to identify additional repairs?	(No) No
7.	Does Shaft Have Visible Damage?	(No) No
8.	Assembled Shaft Runout	0.003 Inches
9.	Assembled Shaft End Play	0.002 inches
10.	Air Gap Variation <10%	No Provisions for measurement
11.	Lead Condition	(P) Pass
12.	Lead Length	22 Inches
13.	Does it have Lugs?, If so what is the Stud Size?	(No) No
14.	Lead Numbers	11,22,33
15.	Frame Condition	Pass
16.	Fan Condition	(P) Pass

Fins broke of by fork lift driver at Arkema.

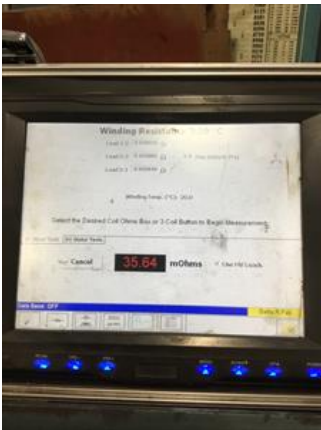
P19

19. Winding Resistance

1-2

1-3

2-3

.03603

.03396

.03564

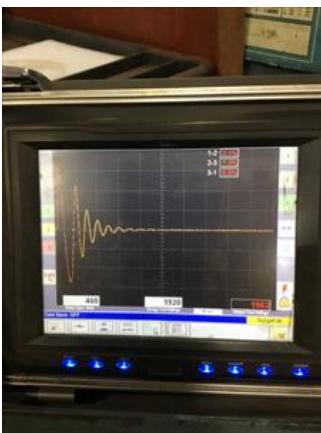
P20

20. Perform Surge Test

(F) Fail

Requires rewind

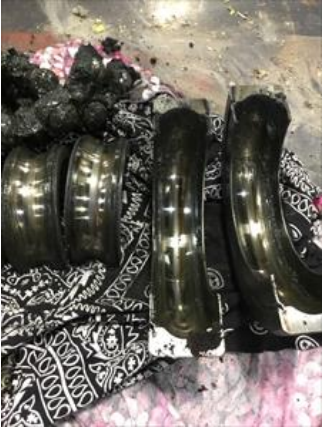
26.	Drive End Bearing Number-	6318 Z C3	
27.	Drive End Bearing Qty.	1	
28.	Drive End Bearing Type	(Ball) Ball Bearing	
29.	Drive End Lubrication Type	(Grease) Grease Lubricated	
30.	Drive End Bearing Insulation or Grounding Device?	None	
31.	Drive End Wavy Washer/Snap-Ring Other Retention Device?	Snap Ring	
32.	Drive End Bearing Condition	Normal wear	P32

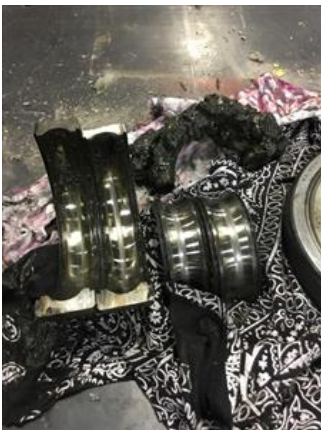
P40

34. Opposite Drive End Bearing Number-	6316 ZC3
35. Opposite Drive End Bearing Qty.	1
36. Opposite Drive End Bearing Type	(Ball) Ball Bearing
37. Opposite Drive End Lubrication Type	(Grease) Grease Lubricated
38. Opposite Drive End Bearing Insulation or Grounding Device?	None
39. Opposite Drive End Wavy Washer/Snap-Ring Other Retention Device?	Wavy Washer
40. Opposite Drive End Bearing Condition	Normal wear

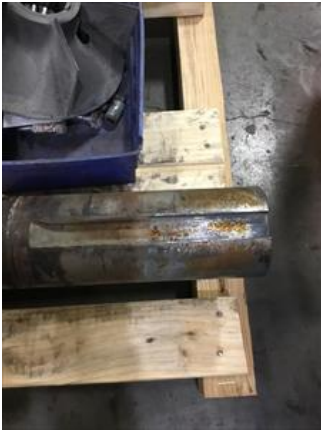
P51

51. Coupling Fit Closest to Bearing Housing

0 Degrees	90 Degrees	120 Degrees
<b>3.375</b>	<b>3.375</b>	<b>3.375</b>

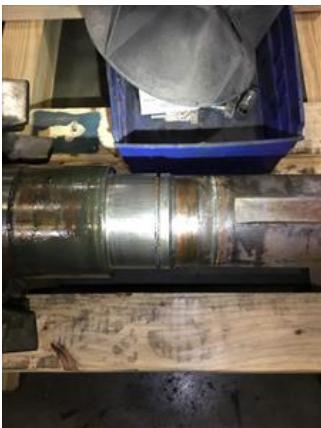
P53

53. Drive End Bearing Shaft Fit

0 Degrees	60 Degrees	120 Degrees
<b>3.5439</b>	<b>3.5439</b>	<b>3.5439</b>

*Tolerance is 3.5434-3.5440*

**(P) Pass**

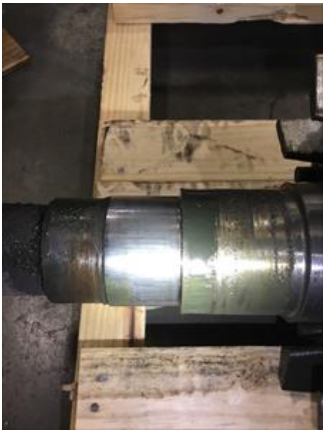
55. Opposite Drive End Bearing Shaft Fit

0 Degrees	60 Degrees	120 Degrees
3.1501	3.1501	3.1501

Tolerance is 3.1497-3.1502

(P) Pass

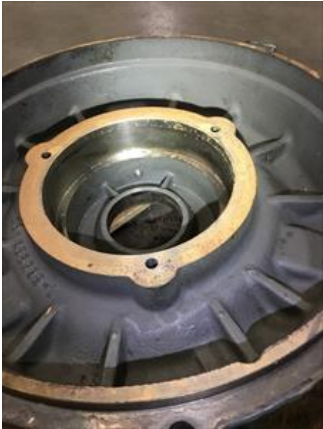
58. Drive End - Endbell Bearing Fit

0 Degrees	60 Degrees	120 Degrees
7.4815	7.4815	7.4815

Tolerance is 7.4803-7.4814

(P) Pass

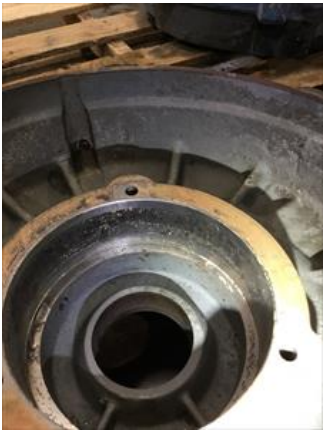
60. Opposite Drive End - Endbell Bearing Fit

0 Degrees	60 Degrees	120 Degrees
6.6968	6.6962	6.6964

Tolerance is 6.6929-6.6939. Out of tolerance and requires bore and bushing installed

61. Opposite Drive End - Endbell Bearing Fit Condition (F) Fail

Bore and install bushing in opposite drive end endbell.
